VALUE OF ANTIQUITY IN THE RESTORATION PROCESS OF THE ART NOUVEAU VILLA DUELFER IN BARLINEK

Halina RUTYNA¹

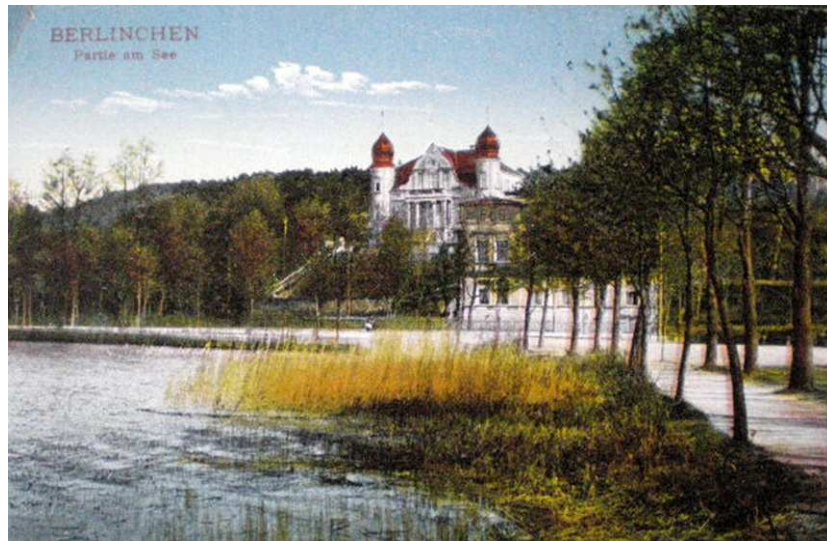
Fig. 1. Pre-war postcard of Berlinchen, showing the excellent location of the Villa Duelfer against the forest and lake. Source: Private collection

three sides is a forest (Fig. 1). Looking at the location and urban composition of the area, the villa's grounds blend into the green, tourist part of the place, which is slightly spatially separated from the centre in such a way that the two zones are axially linked by the clear, simple passage of Strzelecka street. The green areas are also still spatially combined with Barlinek's 'Old Town' area.

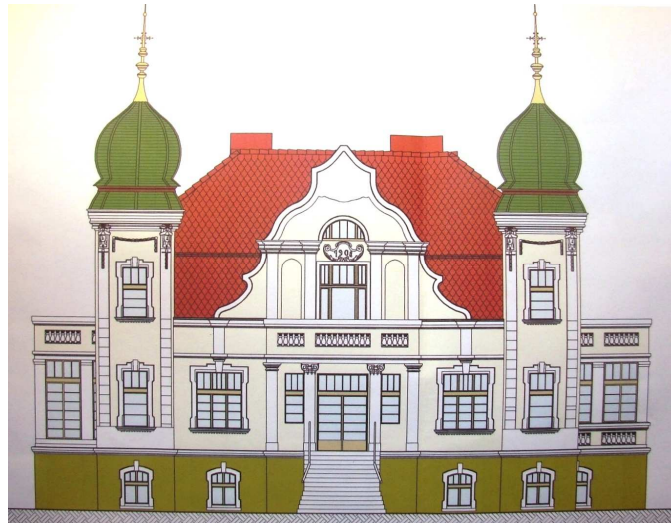
Fig. 2. Front elevation of the villa, by Halina Rutyna, 2008

Whilst maintaining the conservation documentation for the 100-year-old Villa Duelfer, I decided to cultivate the values of antiquity, which I began at the planning stage of the villa's renovation (Fig. 2). The theorist, A. Riegl, maintained that the root of scientific conservation lies in the reasoning that every human action is directed by specific values. From the perspective of the 19th-century knowledge of culture, one could attempt to extract the leading values by analysing different kinds of motivation associated with conservation activities. The diversity of active entities leads, primarily, to the differences in perception of relics of the past and the different value judgements made about these relics.
