PIPING IN LOESS-LIKE AND LOESS-DERIVED SOILS: CASE STUDY OF HALENKOVICE SITE, CZECH REPUBLIC

Bíl, M. & Kubeček, J., 2012. Piping in loess-like and loess-derived soils: case study of Halenkovice site, Czech Republic. *Annales Societatis Geologorum Poloniae*, 82: 45–50.

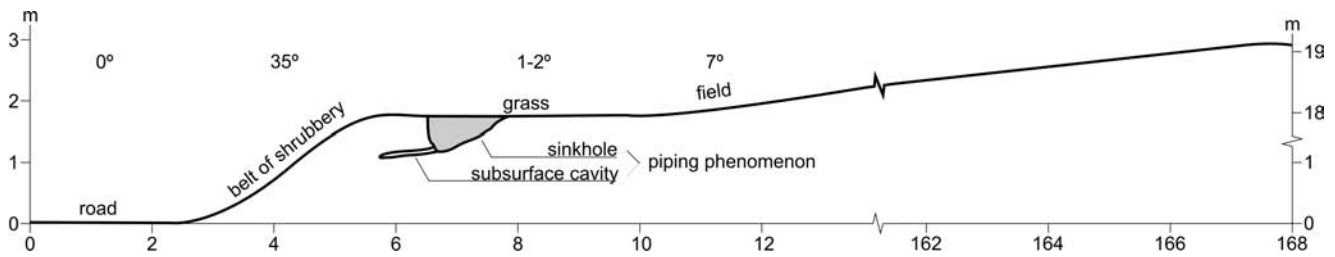
Fig. 2. Schematic profile of Halenkovice1 location, indicating the land use and slope

The Halenkovice 1 location is 90 × 10 m large and it is situated near a local road between the villages of Halenkovice and Žlutava (Fig. 2). Above the road there is a field with an average gradient of 6°, and the distance between the field and the topographic water divide is 165 m. The road is cut into the slope, creating a terrace scarp. Its vertical distance above the road surface is 2 m, with the gradient of 35°. The surface is covered with shrubs (mainly *Prunus spinosa* L.). Piping phenomena are located on the boundary between the field and the terrace scarp. In this almost flat location, the

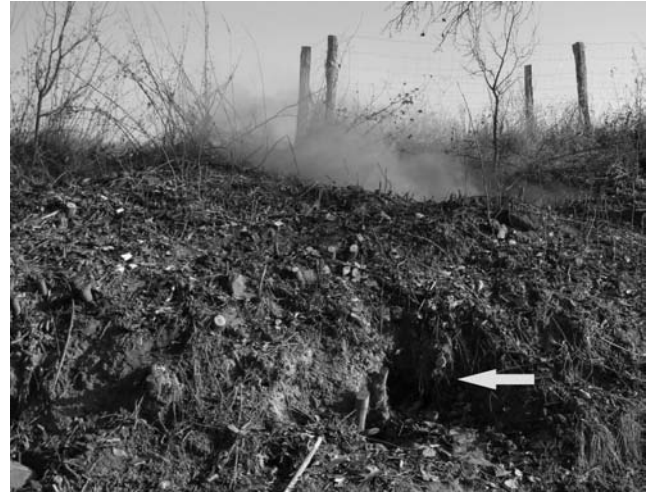
Fig. 3. Using smoke bombs to detect connectivity of soil pipes. A pipe outlet is in the foreground, smoke is rising from the opening sinkhole on the slope in the background

Several experiments were conducted in order to study the connections among individual cavities and tunnels, including a flooding experiment and a smoke experiment. Flooding was done with the help of water dyed with Brilliant Blue FCF (E133) colouring, and the discharge in the terrace wall was monitored. The smoke experiment comprised of putting a smoke bomb inside an opening of one of the tunnels, and higher up on the slope, monitoring places where orange smoke emerged on the surface (Fig. 3). Both methods seem suitable for monitoring how the subsurface tunnels interconnect.
