Durability and wear of engine parts – new methods of testing of alloys and composites

Key words: Diesel engines diagnostics, light alloys and composites, Common Rail fuel system, Acoustic Emission method

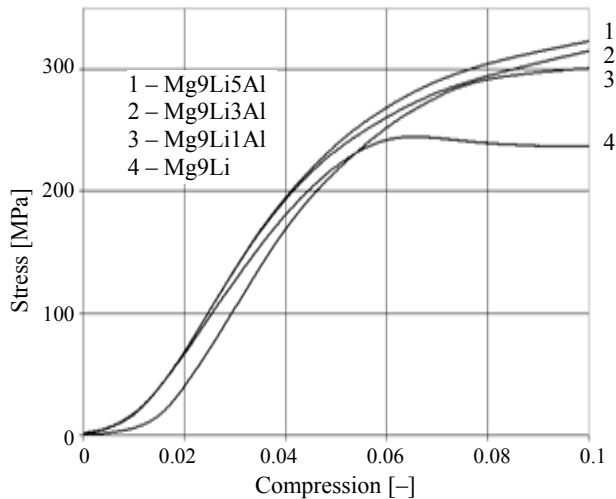
Fig. 3. The dependence stress versus compression measured in composites made of lightweight alloys with different amount of Al admixture and reinforced with Saffil fibres, 10% by weight

Figure 3 presents the dependence stress versus compression measured in composites made of lightweight alloys with different amount of Al admixture and reinforced with Saffil fibres.

The experimental results shown in figure 3 let the authors to conclude that the composites made in the basis of Mg9Li1Al, Mg9Li3Al and Mg9Li5Al alloys present the similar strength and YS, regardless on the amount of Al admixture. Their YS is remarkably higher than that determined in the alloys being the matrix of the material, which is ca. 200 MPa. Therefore, there is possibility of application of the investigated composites to become parts of lightweight engines. It should be noted that the development of destruction mechanisms in

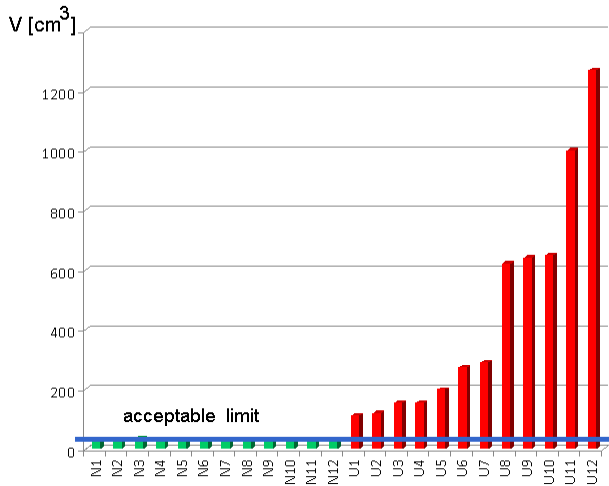
Fig. 8. The outflow measurements results performed in a population of 24 injectors

The data found in engine documentation let the authors to determine the acceptable amount of the fuel outflow in non-damaged injector to 120 cm³ per 3 minutes of operation at 1000 rev/min. of low load. The outflow measurements results performed in a population of 24 injectors are shown in figure 8. The non-damaged injectors are labelled with “N” code and the damaged ones are labelled with the “U” code.

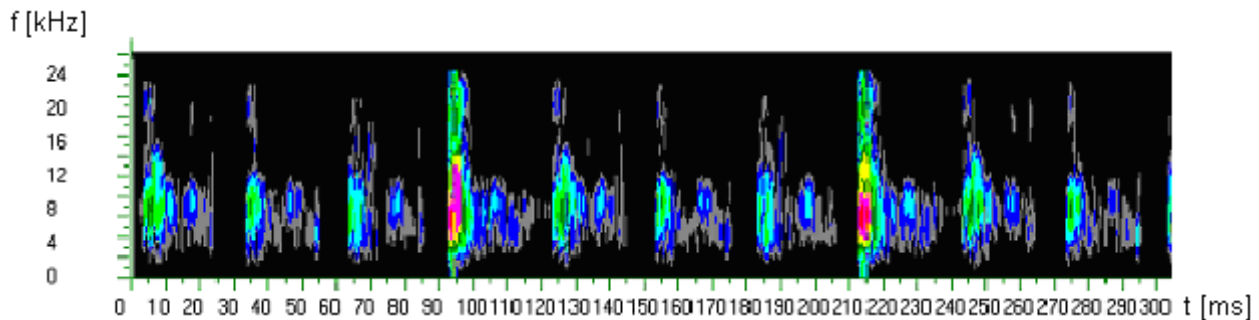
Fig. 10. A spectrogram being a result of injector operation at four cylinder engine. At the spectrogram one can determine the traces of activity of four injectors, however, the tested one produces the signal of higher energy level (red coloured one). This enables for automatic detection of a working injector

traces of activity of four injectors, however, the tested one produces the signal of higher energy level (red coloured one) because the elements of this injector lie in the vicinity of the sensor. The comparison of the spectrograms derived from the damaged and good injectors did not allow for a damage identification. The reason was an insufficient resolution in time domain of produced images of the signal. To deliver a more precise tool for a signal analysing the authors of the paper have designed a custom made software enabling for determination of characteristic segments of the investigated signal with a 100 microsecond resolution. The time dependence of the registered AE signal and applied current driving a solenoid of injection control valve, projected in high resolution is shown in figure 11.

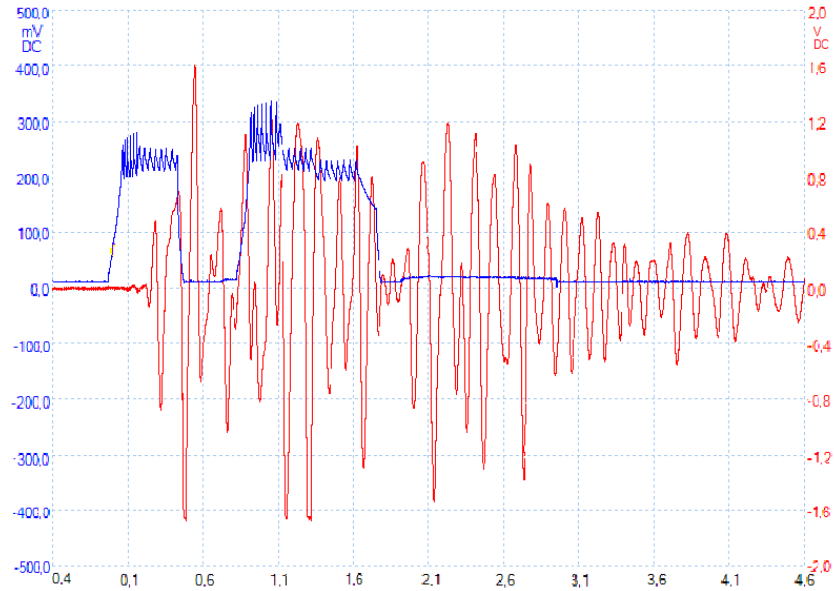
Fig. 11. The time dependence of the registered AE signal and applied current driving a solenoid of injection control valve, projected in high resolution. The time unit presented in horizontal axis is 1 millisecond

The signal of EA presented in figure 11 (bright colour) consists of a three pulses whose together last ca. 3 milliseconds. First two leading pulses are caused by the operation of electromagnetic injector dosage control valve. A ca. 0.6 millisecond dead time appears after their completion and then the contact of the injector needle and its bed generates the third pulse lasting ca. 0.8 of millisecond. The digital set of AE signal samples being a record of

this process includes 150 elements. A custom made software enabling for determination of characteristic segments delivers the information determining duration of three characteristic phases of the process mentioned above:

- I – electromagnetic injector dosage control valve activity;
- II – dead time during increase of a pressure controlling the operation of injector needle;

III – injector needle activity causing a fuel spread.
