ROLLING CONTACT FATIGUE RESISTANCE OF SHOT PEENED AUSTEMPERED DUCTILE IRON

rolling contact fatigue resistance, shot peening, austempered ductile iron

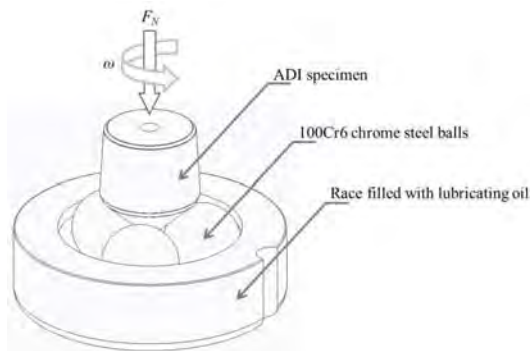
Fig. 1. The cone-three ball tribosystem used in the rolling contact fatigue tests

The contact fatigue tests were carried out using a cone-three ball tribosystem as shown in Fig. 1. The equipment used was the T-03 modified four-ball pitting tester [L. 9], and tests followed the IP 300 standard [L. 10]. This test consists of

an upper driven ADI cone that is brought into loaded contact with three lower 100Cr6 steel balls, which are polished to an R_a value of $0.032\ \mu\text{m}$. The lower balls are allowed to rotate freely in a race filled with lubricating oil, simulating pure rolling conditions. The cones used in the fatigue tests were machined from ductile iron keel blocks having the following composition: 3.26% C, 2.36% Si, 1.63% Cu, 1.58% Ni, and 0.24% Mn. After machining, the samples were austenitised at 900°C for two hours and austempered in a salt bath held at 360°C for one hour. These austempering parameters were optimised in a previous study by the same authors [L. 11].

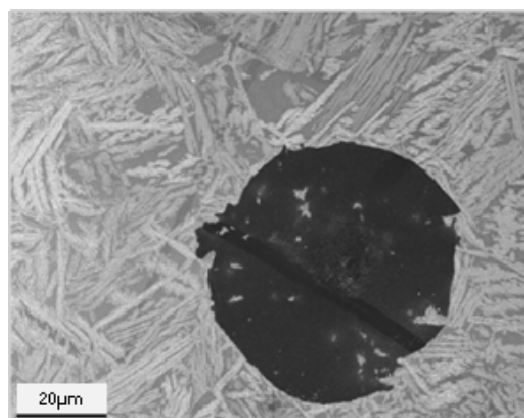
Fig. 2. ADI microstructure; etched with 2% nital

Following austempering, the resultant microstructure consisted of graphite nodules dispersed in a matrix of ferrite and high carbon retained austenite. This is presented in the micrograph shown in **Figure 2**. This microstructure has a nodule count of 200 graphite nodules per mm^2 and graphite nodularity greater than 95%.

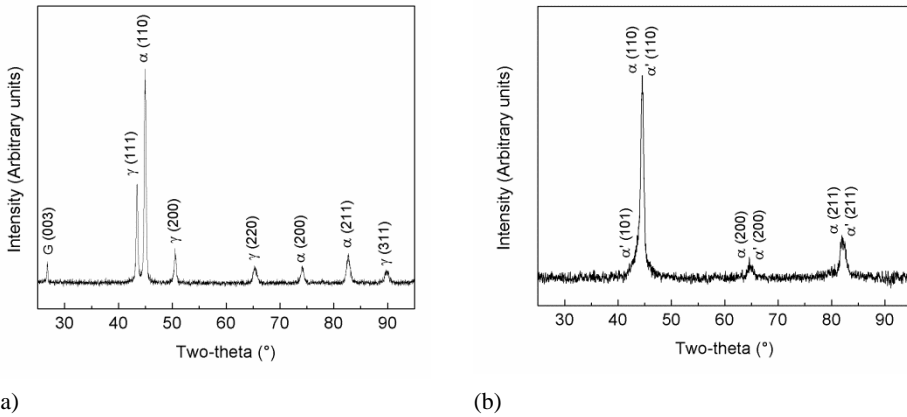
Fig. 3. XRD patterns for (a) as-austempered ADI and (b) shot peened ADI
Rys. 3. Widma XRD dla: a) żeliwa ADI w stanie wyjściowym, b) tegoż żeliwa po kulowaniu

The austenite peaks present in the XRD pattern for the as-austempered ADI structure (**Figure 3a**) are not visible in the pattern for the shot peened ADI structure (**Figure 3b**). Instead, peak broadening is present at a two-theta value

of around 44° , which is due to superimposition of the (1 0 1) and (1 1 0) martensite doublets, and the (1 1 0) ferrite peak [L. 13]. This shows that, following shot peening, the retained austenite was transformed to martensite. As a result of this phase transformation and the induced work hardening by shot peening, the microhardness at the surface increased from 370 ± 10 HV to 535 ± 6 HV. Additionally, shot peening induced residual compressive stresses, having a value of 975 ± 90 MPa in the surface of the ADI. The residual stress-depth profile is shown in Figure 4. These stresses are due to cold working by shot peening and because of the 4% increase in volume when the fcc austenite transforms to bct martensite. This leads to the creation of further sub-microscopic stresses and dislocations.

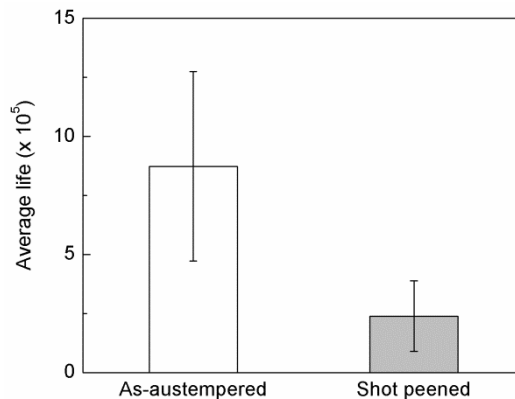
Fig. 5. Average life for the as-austempered ADI and shot peened ADI specimens

Figure 5 shows the average contact fatigue lives for the as-austempered ADI and shot peened ADI specimens. Results show that the average contact fatigue life of shot peened specimens ($\mu_x = 2.4 \times 10^5$, $s = 2.7 \times 10^5$) decreased by 72% when compared to the performance of the as-austempered specimens ($\mu_x = 8.7 \times 10^5$, $s = 7.2 \times 10^5$), $t(28) = -3.19$. The 72% decrease has an effect size r of 0.52 signifying a large effect [L. 14].

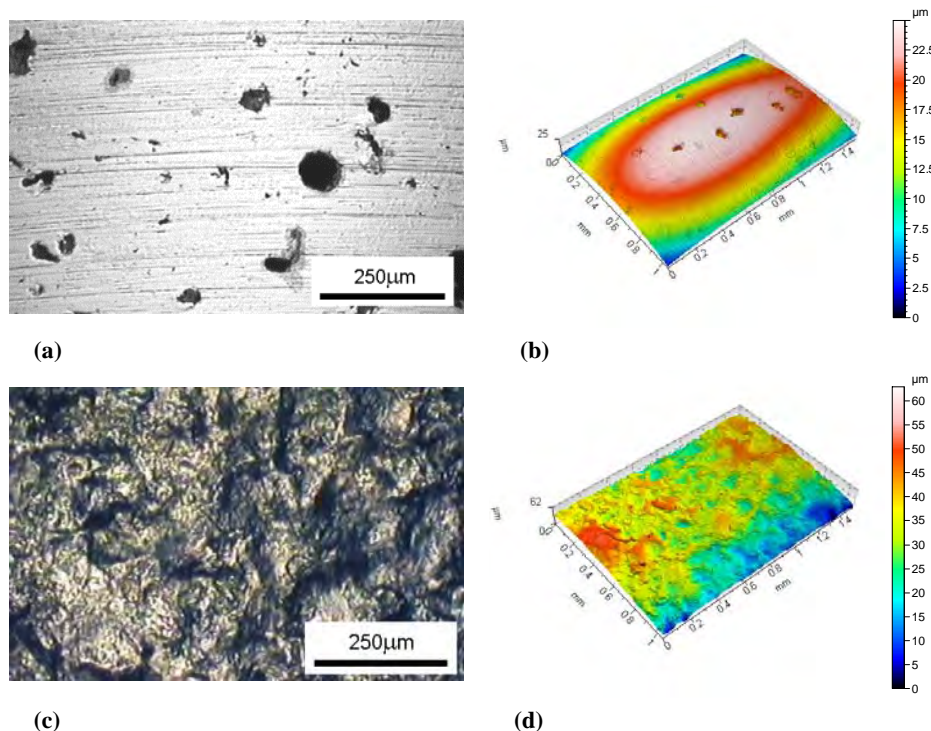
Fig. 6. Optical micrographs and 3D images of surfaces before contact fatigue tests for (a-b) as-austempered ADI and (c-d) shot peened ADI specimens; unetched

However, as shown in **Figure 6**, the surfaces of the shot peened specimens have a higher surface roughness ($R_a = 3.12 \mu\text{m}$) than their counterpart as-austempered specimens ($R_a = 0.05 \mu\text{m}$). The former leads to an extremely low value of the specific film thickness λ of 0.05, which contrasts to a corresponding value of 2.81 for the as-austempered specimens. A value of λ smaller than 0.4 denotes that a boundary lubricated condition exists, implying that peaks of the asperities of the shot peened specimens are penetrating the lubricant film. Therefore, contact occurs between the asperities of the shot peened ADI cones and balls. Metal-to-metal contact is unavoidable and nearly all the load is supported by the asperities, defying the principal purpose of lubrication. Failure

by contact fatigue starts from the surface because of a presumably high coefficient of friction.

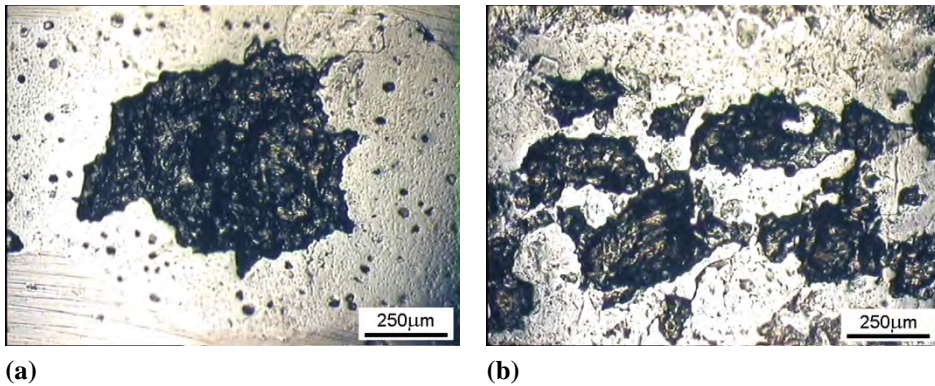
Fig. 7. OM images showing the pits present after failure of: (a) as-austempered ADI and (b) shot peened ADI specimens; unetched

As shown in **Figure 7b**, several small pits were observed on the wear track of the shot peened specimens. In contrast, solitary pits were seen on the as-austempered samples (**Figure 7a**). The pits observed in all the specimens were 50 to 100 μm deep. According to Ding and Rieger [**L. 16**], pits which are 20–100 μm deep can be classified as spalls. **Figure 8a** and **b** also show that the pits on the shot peened specimens were smaller and less deep than the as-austempered specimens. This is due to the fact that pits initiated from surface defects are usually shallower than those initiated from sub-surface defects [**L. 16–18**]. On the other hand, the absence of surface shear in the polished as-

austempered specimens was due to the full oil film between the rolling specimens that favoured sub-surface crack initiation. This is the dominant mode of failure in rolling elements having smooth surfaces and which operate under EHL conditions [L. 17].

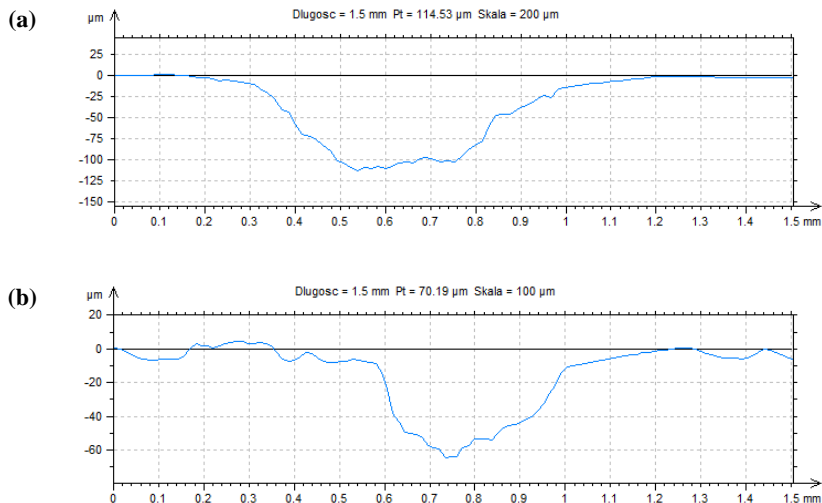
Fig. 8. Typical pit profiles for: (a) as-austempered ADI and (b) shot peened ADI specimens
