K. SIECZKOWSKI*, J. ADAMIEC*[#], G. SAWICKI**

THE STRUCTURE AND PROPERTIES OF MIXED WELDED JOINTS MADE OF X10NiCrAlTi32-21 AND X6CrNiMoTi17-12-2 STEELS

This paper describes the welding technology applied for mixed joints of tubes made of austenitic steels in the X10NiCrAlTi32 - 21 and X6CrNiMoTi17 -12-2 grades. One made a butt joint and a multi-run joint, with the inert gas welding method and a non-consumable electrode. The mechanical properties were tested in the following scope: static tensile test, bending test from the side of the face and from the side of the root, impact test of the joint and hardness measurements. The tests were supplemented by the assessment of the macrostructure and microstructure of the joint. The performed non-destructive and structural tests did not reveal any welding imperfections, and the mechanical test results confirmed high properties of the welded joint. On this basis, the joint was classified into the "B" quality level according to PN EN ISO 5817. The mechanical and structural test results constitute the basis for qualification of the welding technology according to PN EN ISO 15614 .

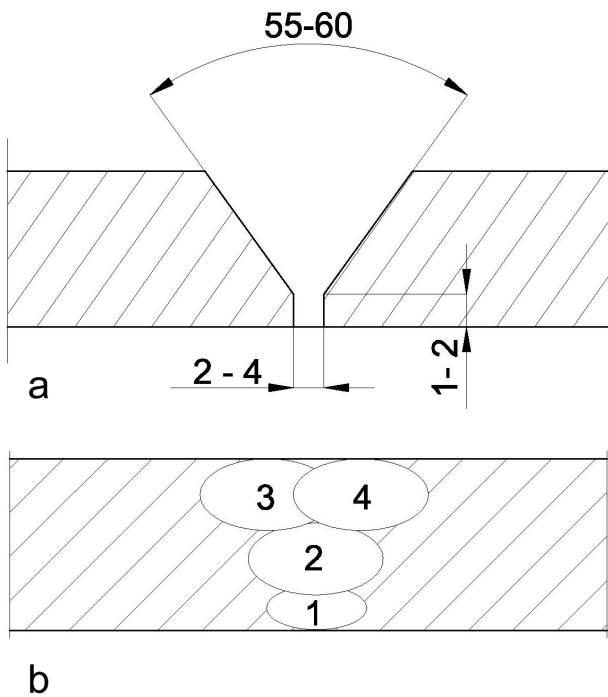
The welding tubes were bevelled at an angle of 60° (fig. 1a). The V- butt joint with a 2 mm threshold was performed with the TIG (141) method, using a direct current and linear energy of the arc not exceeding 1.2 kJ/cm, in argon shield, with the flow rate of 8-10 l/min. Figure 1.b presents the sequence of the beads. The interpass temperature did not exceed 150°C.

Fig. 1. Diagram showing a preparation of the joint for welding (a), sequence of the bead arrangement (b)

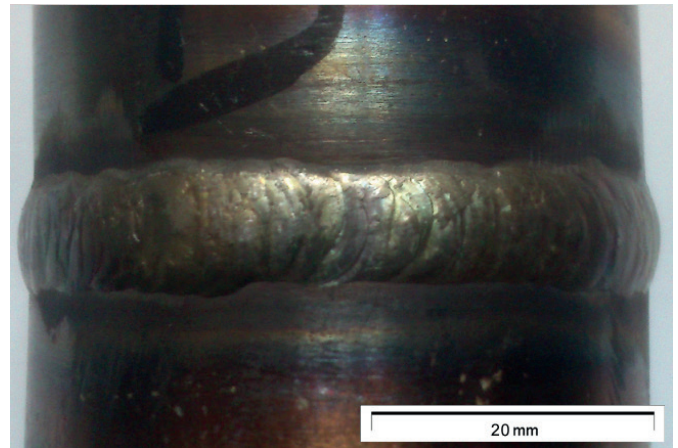
The visual tests were performed according to the requirements of the EN-ISO 17637 standard. The view of the face of the fusion weld is presented in Fig. 2. It was found that the joint had a correct even face. No black heat tints were revealed, which indicates a correct linear energy of the arc during the welding process.

Fig. 2. Face of a mixed joint made of X10NiCrAlTi32-21 and X6CrNiMoTi17-12-2 steels

The performed welding tests of tubes of ϕ 48.3 in diameter and wall thickness of 5mm, made of X10NiCrAlTi32-21 and X6CrNiMoTi17-12-2 steels, showed that it was possible to get a correct joint with no welding imperfections. The joint has a smooth and even face (Fig. 3). No excess penetration bead or discontinuity from the side of the root were found. The fusion weld shape rate was at the level of 1.2 (Fig. 4). The structure of the joint consists of three typical areas, i.e. the native material made of polygonal austenite grains, a narrow heat-affected zone in which one can observe the process of partial melting of the grains and epitaxial crystallization of the crystals of the fusion weld, and of column crystals building

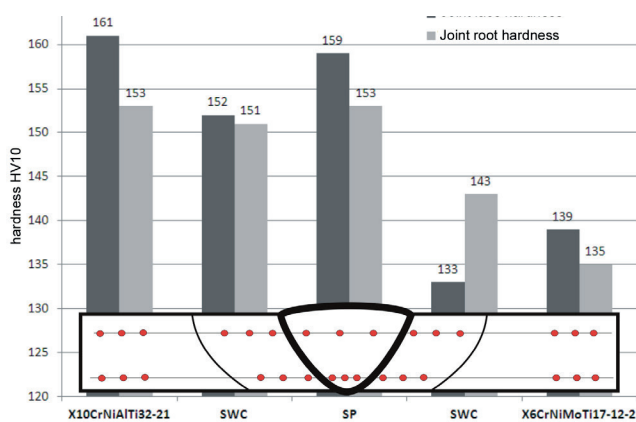
Hardness of the joint from the side of the face and from the side of the root was measured according to the PN EN ISO 6507-1:2007 and PN EN 1043-1:2000 standards. The measurements were taken with the application of the HPO 250 hardness tester, with the Vickers method, at the load of 98 N (HV10). The results (the average of three measurements) are shown in Figure 3. The hardness distribution analysis showed that the hardness of the native material made of the X10NiCrAlTi32-21 steel ranged from 146 HV to 164 HV. A similar range of hardness was measured in the HAZ (heat affected zone), i.e. from 145 HV to 160 HV. The average hardness in the fusion weld amounted to 159 HV from the side of the face (from 154HV to 163HV) and 153HV (from 152 HV to 158HV) from the side of the root. Hardness in the heat affected zone in the tube made of X6CrNiMoTi17-12-2 steel ranged from 132 HV to 149 HV, and in the material it was 137 HV (from 130 HV to 142 HV) on average (Fig. 3). The hardness of the joint is correct, one revealed no cures of the joint areas of a difference exceeding 100 HV, which is a prerequisite for the application of the developed welding technology in the power industry (according to PN EN ISO 12592).

Fig. 3. Distribution of hardness in the joint on the line from the side of the face and from the side of the root

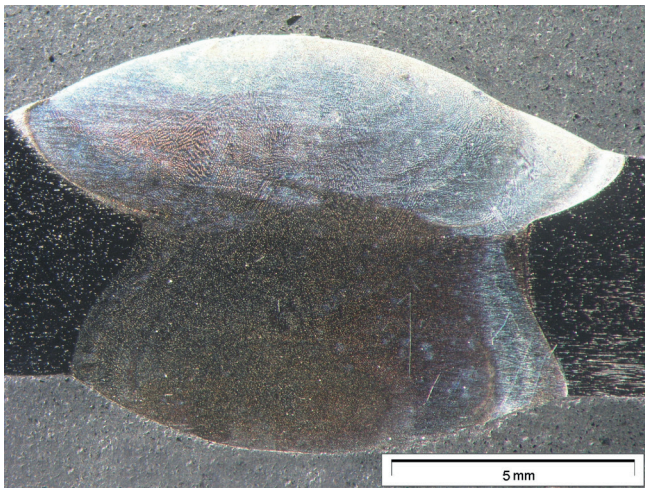
Fig. 4. Macrostructure of the mixed joint of the tubes made of X10NiCrAlTi32-21 and X6CrNiMoTi17-12-2 steels

The revealed macrostructure of the welded joint is correct and consists of three areas typical of welded joints, i.e. the native material (Fig. 4, C), a narrow heat-affected zone (Fig. 4, B) and the fusion weld area (Fig. 4, A). The shape of the fusion weld is normal, which is proved by the shape ratio (height to the width of the fusion weld) amounting to 1.2.

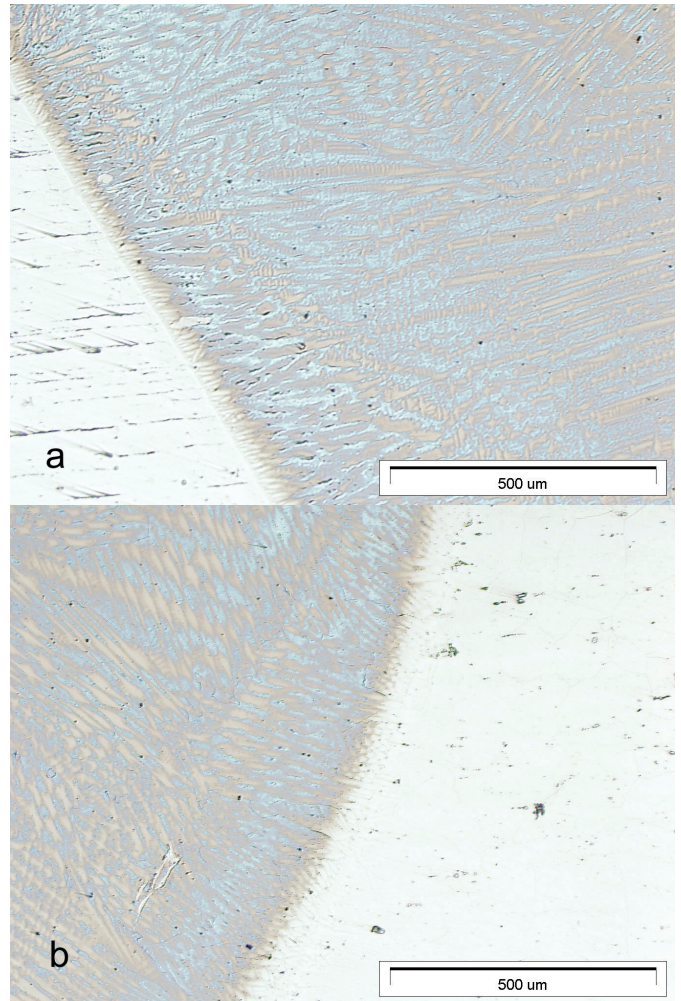
Fig. 5. Microstructure of the welded joint of the tubes made of X10NiCrAlTi32-21 and X6CrNiMoTi17-12-2 steels: a) fusion line from the side of the tube made of the X6CrNiMoTi17-12-2 steel, b) HAZ in the X10NiCrAlTi32-21 material

The native material of the tube made of X10NiCrAlTi32-21 and of X6CrNiMoTi17-12-2 steel grades consists of elongated polygonal austenite grains in a band arrangement, typical of the rolling process (figure

5a, b). In the HAZ on the fusion line the grains of the native material become partially melted and fusion weld crystals build up epitaxially (fig. 5a, b). In this area one can also see partially melted boundaries of the austenite grains, which shows that the partial melting zone was about 10 μm wide (fig. 6). The fusion weld structure is mainly made up of column austenite grains, which build up in the direction of the heat abstraction.

up in the direction of the dissipation of heat in the fusion weld (Fig. 5).

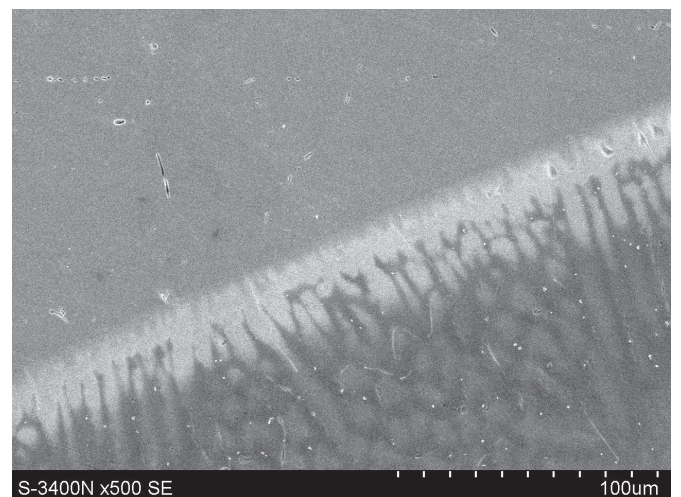
Fig. 6. Fusion line of the fusion weld into the tube made of the X10NiCrAlTi32-21 steel

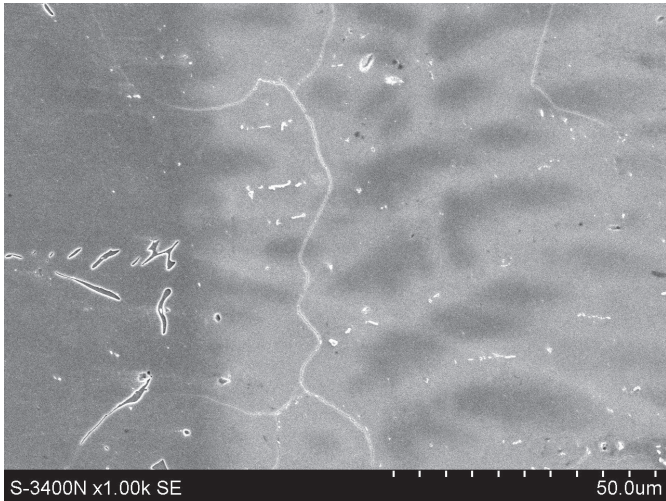
Figure 7 shows liquation cracks. The occurrence of these cracks is conditioned on the presence of a liquid metal layer on the grain boundaries during the cooling process, when thermal tensile stresses develop [5].

Fig 7. Liquation cracks in the HAZ of the fusion weld

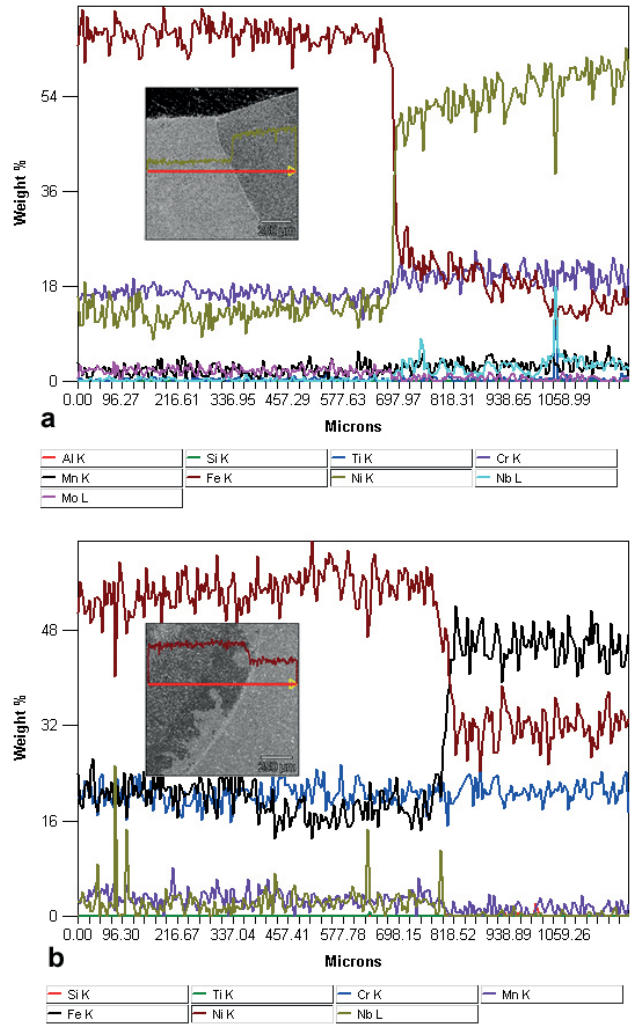
With the application of the EDS unit, one made a linear distribution of the alloying elements in both fusion lines (Fig. 8). The share of nickel in the fusion weld is about 60%. The iron content in the fusion weld decreases, while the nickel content increases. One also revealed changes in the percentage amount of chromium in the HAZ from the side of the X6CrNiMoTi17-12-2 material. However the chromium content in the fusion weld is similar to that in the X10NiCrAlTi32-21 material.

Fig 8. Linear distribution of the alloying elements: a) fusion line of the X6CrNiMoTi17-12-2 material, b) HAZ from the side of the X10NiCrAlTi32-21 material

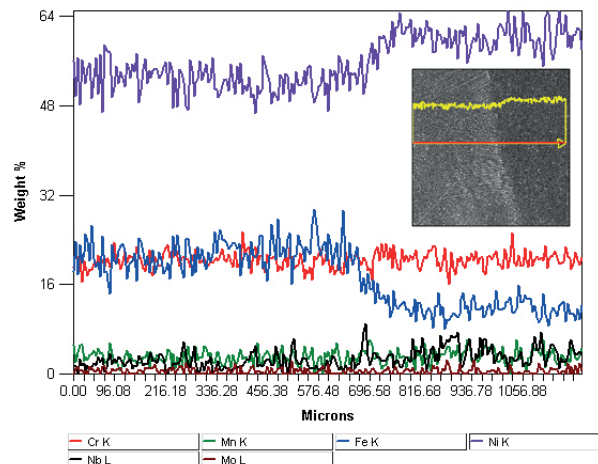
Analysis of the linear distribution of the areal share of the elements showed a difference in the share of nickel and iron in the fusion weld between particular beads, where this content also changes inversely proportionally (Fig. 9).

Fig. 9. Linear distribution of the elements on the fusion line between the layers of the applied fusion welds

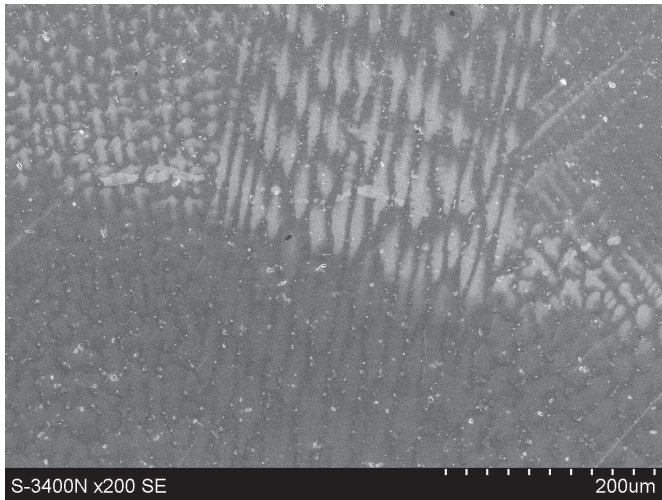
Fig. 10. Fusion line between the subsequent layers of the fusion weld

On the fusion line between the layers of the applied fusion weld, one can see the effects of the welding thermal cycle of the successively superimposed layers (Fig. 10). The occurring structures prove the existence of a dendritic and cellular crystallization. One can also see a changed crystallization direction in the form of elongated cellular- dendritic crystallites, formed following the change of the direction of bead arrangement [6].
