Hazard identification process in the selected analysis domain of the F100 turbofan engines maintenance system

Key words: hazard source, hazard, hazard identification, risk management, F100 turbofan engine, maintenance system

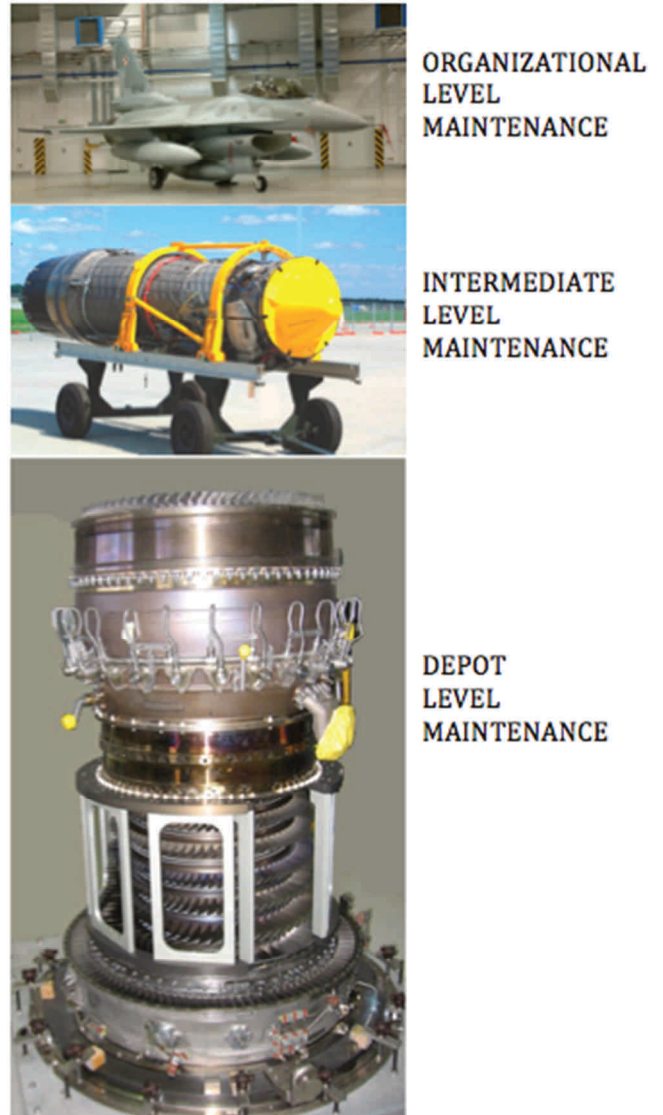
Fig. 3. Levels of maintenance

I. Organizational (O) – Level, Flightline Maintenance
Maintenance repairs and inspections with engine installed in aircraft:

II. Intermediate (I) – Level, Base Engine Shop

III. Depot (D) – Level – Centralized Engine/Module Repair

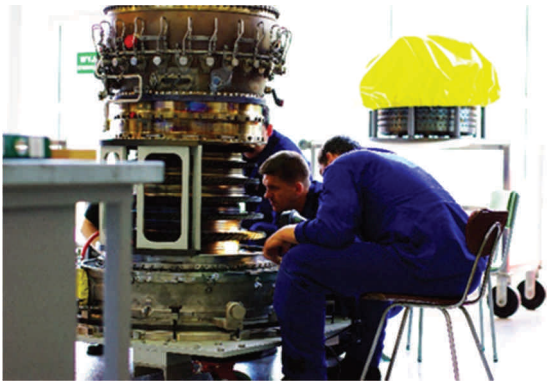
Fig. 5. Vertical repair section

1. Horizontal engine discrepancies removal (Fig. 4)
2. Vertical engine/module repair (Fig. 5)
