**PROPOSAL FOR MODERNISATION OF LARGE BLOCK  
SYSTEM BUILDINGS (LBS) - FACADES  
– Lublin University of Technology**

**A b s t r a c t**

Keywords: precast concrete, housing, modernization, extension, façade

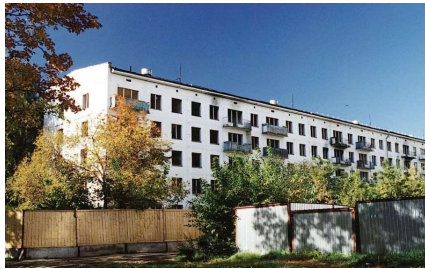
Fig. 1. Moscow, 2002. Building at 8 Khimkinskiy Bul'var before modernization [15]

involved three identical prefabricated blocks at 4-6-8 Khimkinskiy Bul'var in Severnoye Tushino District, the middle building no. 6 was demolished and replaced with a new 22-story housing tower and a 3-story underground parking. Buildings 4 and 8 were equipped with four additional stories and thoroughly modernized (Figures 1-4).

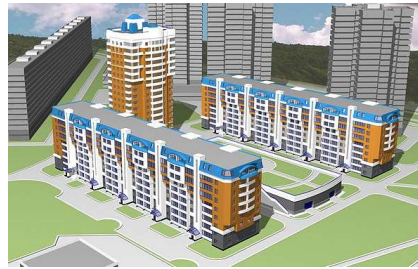
Fig. 2. Moscow, 2002. Visualization of 4-6-8 Khimkinskiy Bul'var modernization [15]

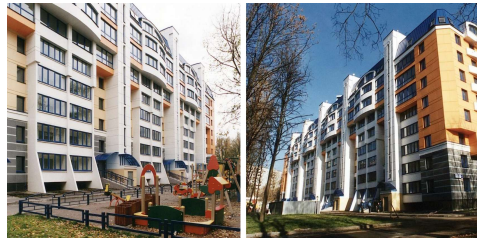
Fig. 4. Building at 8 Khimkinskiy Bul'var after modernization [15]

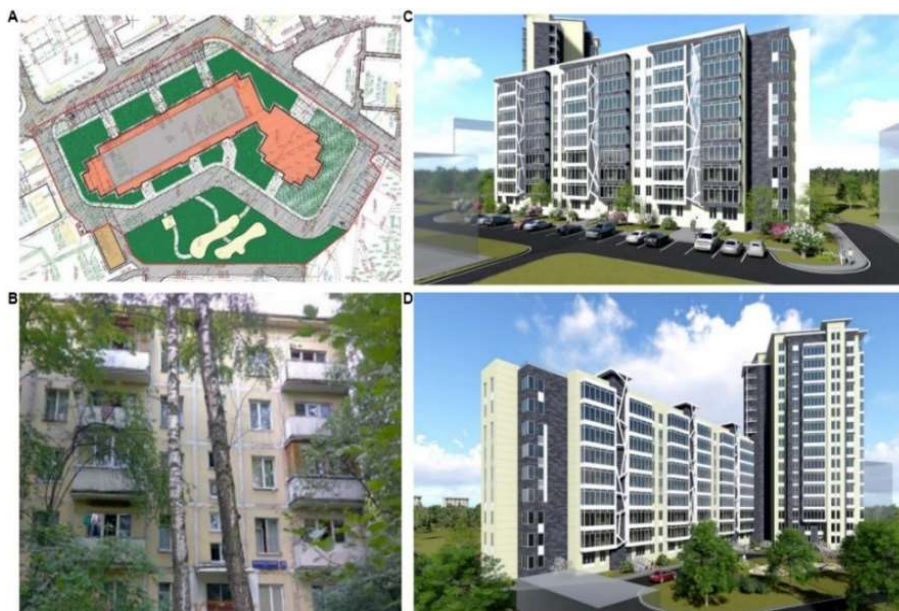
Fig. 5. Project at 14 Marshal Rybalko Street, Moscow. A – site development plan, B – south façade after modernization, C – original façade, D – north façade and new tower block. Source: B, A, C, D [15]

Another Moscow housing unit subject to thorough changes was 14 Marshal Rybalko Street (Figure 5): extended vertically and horizontally and accompanied by a new tower block.

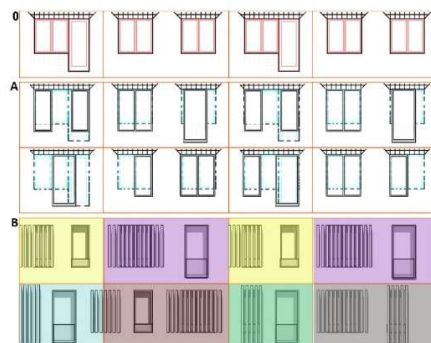
Fig. 12. Schematic of the location of the modules on the left side of the elevation [17]  
 0 - additional reinforcement of lintels with Helifix [12]; A – changes to the shape of openings; B – proposed pattern of façade modules on the example of two storeys with vertical covers made of lamellas

To adjust the façade to changes in the layout of the interior, the curtain wall panels made of integrated aerated concrete segments need to be modified. The design provides for additional reinforcement of the lintels (using e.g. Helifix system [12]) and changing shape of openings as in (Figures 12).

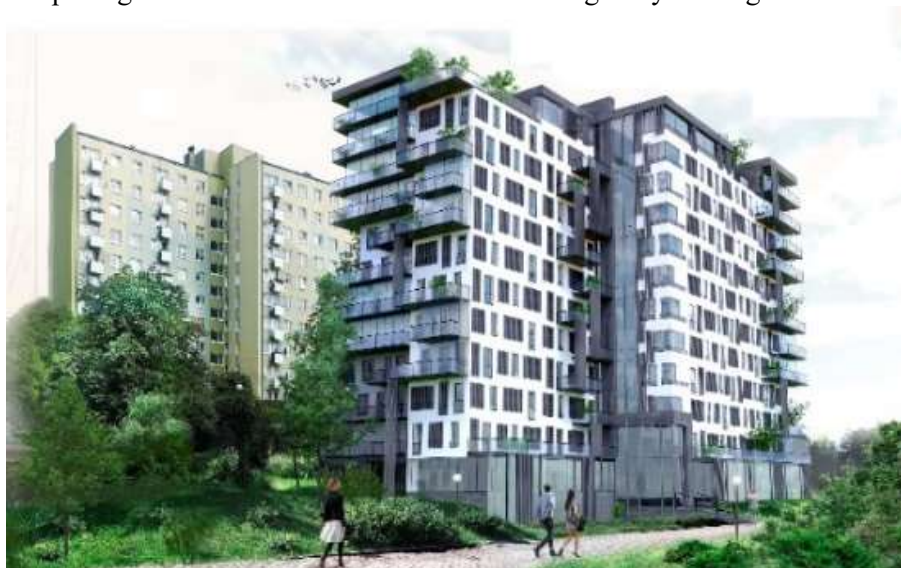
Fig. 13. Visualization of changes – unmodified neighboring building in the background [17]

The vertical communication axis of the building (stairs and corridors) was emphasized by vertical glazing over the entire height of the building (Figure 13). A modern accent is the extension of the first floor and new big but light-structure balconies (e.g. Alucomposites [11]), which were additionally enclosed by glazing. The openings and balconies were added also on originally blank gable walls.
