A HIGH RESOLUTION SYSTEM FOR AUTOMATIC DIAGNOSING THE CONDITION OF THE CORE OF CONVEYOR BELTS WITH STEEL CORDS

This paper describes a mobile system for the noninvasive diagnosis of the core of conveyor belts with steel cords. The system is based on the 4-channel magnetic head of the EyeQ system which one of the Polish opencast mines bought at the beginning of the 21st century. Because of the restructuring of the mine and the aging of the EyeQ system, measures were taken to improve the latter's resolution and performance. The upgrading consisted mainly in developing a new software for data analysis automation and in replacing the old hardware platform with a new one increasing six-fold system resolution. The system has successfully passed tests in mine conditions and is currently used to assess the condition of belts working in the mine transport system (fig. 1)

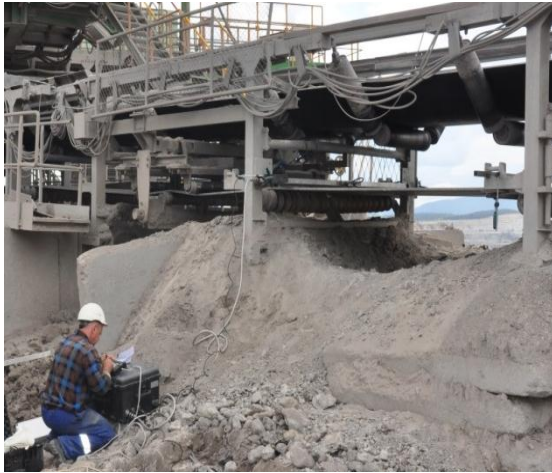
Fig.1. System during measurements in opencast mine

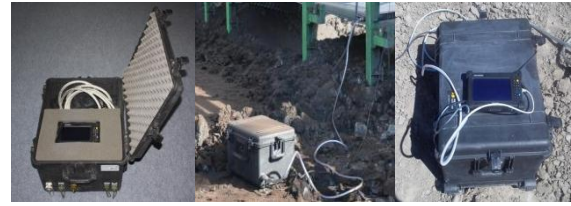
All the pieces of equipment making up the measuring system have been placed in a Peli box (fig. 3) resistant to the action of noxious and aggressive agents. The box facilitates transport and protects the system components against damage during transport and measurements. The box is equipped with outer interfaces for quick and safe setup of the measuring system devices.

Fig. 3. View of open measuring system box with visible tablet and wiring and during its operation at belt conveyor

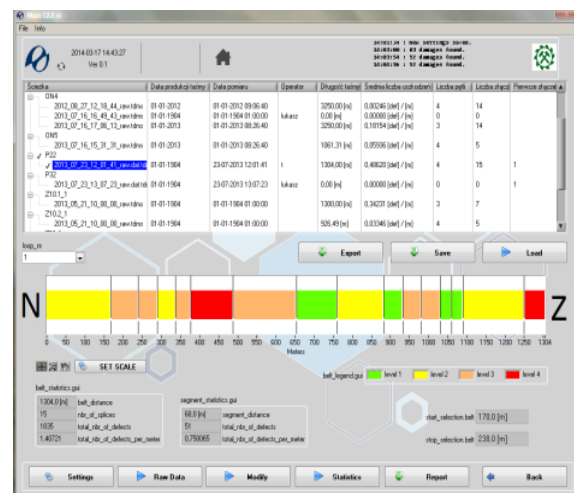
The main program window (fig. 4) has been designed having utmost simplicity and clarity of displayed information in mind.

In its top part it shows data on the measurements performed, presenting them in the alphabetical order so as to highlight the most important information about a measurement on a particular belt conveyor. The data can be saved, read in or exported.

The middle part of the window shows a conveyor belt visualization with vertical lines marking the successive belt segments between splices. The system distinguishes 4 alarm thresholds whose limit values are set by the user on the basis of his/her experience and the operational specification of a given belt conveyor.

The colours from green through yellow and orange to red represent damage intensity per 1 running meter of the belt.

Fig. 4. Main program window with visualization of results after signal analysis

The bottom part of the window shows brief statistics on the number of damage instances on the entire belt and on its selected segment. Also data about the length of the investigated belt and belt segment and the number of detected splices are shown.

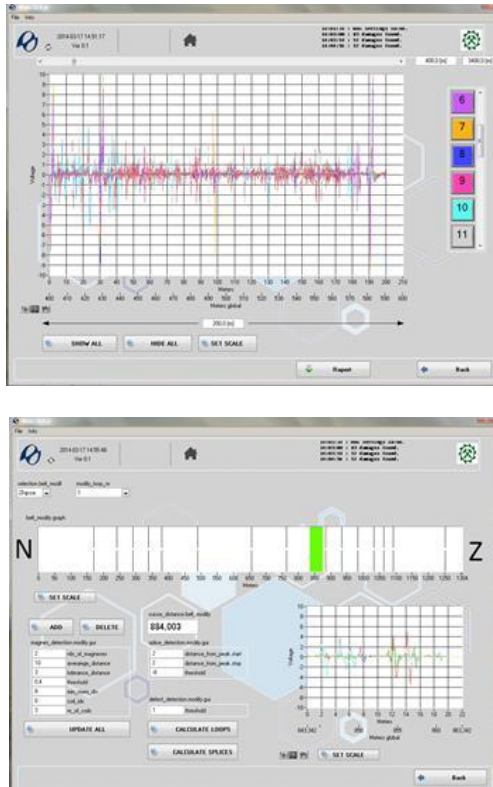
- during signal acquisition for real time detection of the presence of magnets in order to automatically determine the beginning and end of the belt to be subjected to further analysis, and to determine the number of full loops measured (fig.5);
- after measurement to carry out a post-processing procedure consisting in detecting splices and damage in the successive loops measured.

Fig. 5. RAW data analysis and loop and splice detection windows

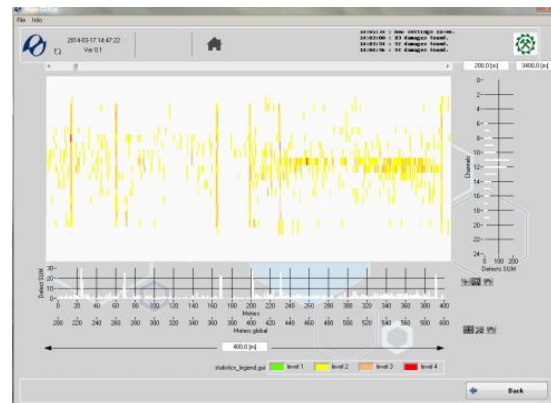
The whole belt or its part, such as a loop, a segment or a segment fragment, is presented as a damage matrix with two (vertical and horizontal) histograms illustrating damage distribution along the belt width and length. The matrix meshes contain the number of damage instances per a unit area (1 measuring

channel/1 running meter of belt) (fig. 6), and the colour representing damage intensity.

Fig. 6. Statistical analysis window with damage matrix and vertical and horizontal histograms

Using the length and size selection windows the user chooses the size of the belt fragment to be analyzed. Thanks to this way of presenting the results the user instantaneously gets information on the size of the damage instances and their distribution on the whole loop of the analyzed belt.

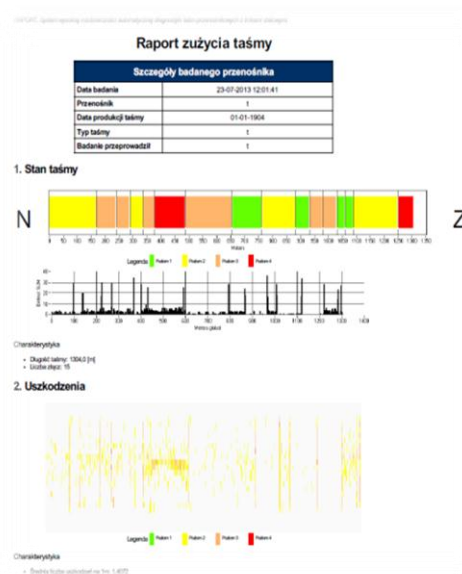
The user in a quick and easy way can print out a report on the investigated belt or save it as a pdf file (fig. 7). The content of the report has been consulted with the mine conveyor belt department in order to avoid providing unnecessary information while focusing on supplying the most important data helpful in drawing up plans for belt purchases or belt regeneration and repairs.

Fig. 7. Report showing belt condition visualization and damage histograms

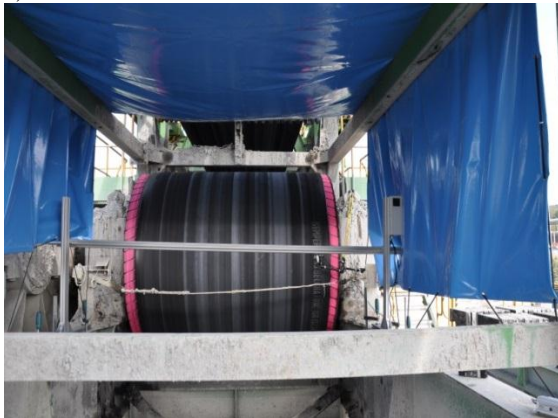
Fig. 8 Visual module during measurements on conveyor: a) view of LED illuminator, b) screen protecting against weather conditions

Initially, the maximum width inspected by the linear Dalsa camera (1) (fig. 8a) amounted to 40 cm whereby no conveyor belts used in the mining industry could be used. Therefore it was necessary to extend the camera's functionality. Work on the software resulted in wider functionality of the camera and currently it is possible to inspect belts up to 3 m wide and running with a speed of up to 7 m/s [7].

In order to obtain accurate results one must ensure optimum operating conditions for the camera. For this purpose the place of measurement is insulated from weather conditions with a screen (fig. 8b) and the belt is uniformly illuminated by a strip of LED diodes (2) (fig. 8a).

The belt is marked on a splice with a marker pen whereby the belt loop can be recognized by the vision system. The data from the camera and from the encoder (3) (fig. 8a) are transmitted in real time to the computer (4) (fig. 8a) and processed by the software which owing to its advanced binary image analysis and filtration functions makes the automatic identification of damage possible [7].

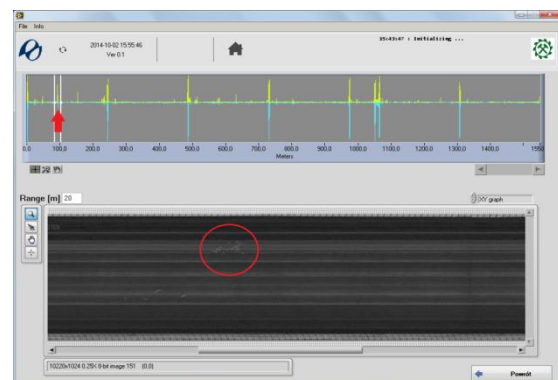
Fig. 9. Synchronized measurement results for vision module (bottom) and magnetic module (top) for belt core and cover (red)

Figure 9 shows damage detected on the inspected conveyor belt. The program enables one to easily determine the distance of the damage from the beginning of the loop. In the magnetic diagram this damage is visible as a stronger signal resulting from a change in the induced magnetic field (above the red arrow). For a given range (here 20 m) it is possible to display the image from the vision system whereby the damage to the cover (red circle), resulting from damage to the core, can be located.

The knowledge relating to damage to the steel cords can be extended to include the type and size of cover damage by using the camera image. For this purpose the two modules were synchronized (fig. 9 for damage and fig. 10 for the splice) to obtain a 2D image of the belt. Thanks to the early detection of damage the latter can be constantly monitored and decisions as to when the belt should be regenerated or replaced can be promptly made. This is of major importance for the economics of belt conveyor operation since it helps to plan down times and so to minimize financial losses caused by unforeseen stoppages in the haulage of the mine output.

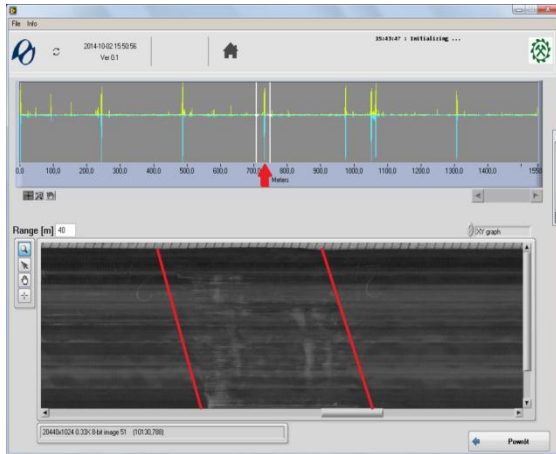
Fig. 10. Synchronized measurement results for vision module (bottom) and magnetic module (top) for belt splice (red)

Similarly is in the case of the signal for a vulcanized belt splice shown in figure 10. Magnetic signals for splices are much stronger and so easy to identify in the diagram. There are 8 splices in the considered belt. For a given range (here 40 m) it is possible to find the splice in the vision module (red lines) and to assess the condition of the cover in this place.
