ARCHIVES
 of
 FOUNDRY ENGINEERING

Evaluation of Microstructure and Tribological Properties of GX120Mn13 and GX120MnCr18-2 Cast Steels

B. Kalandyk ^{a,*}, R. Zapala ^a, J. Kasińska ^b, M. Madej ^b

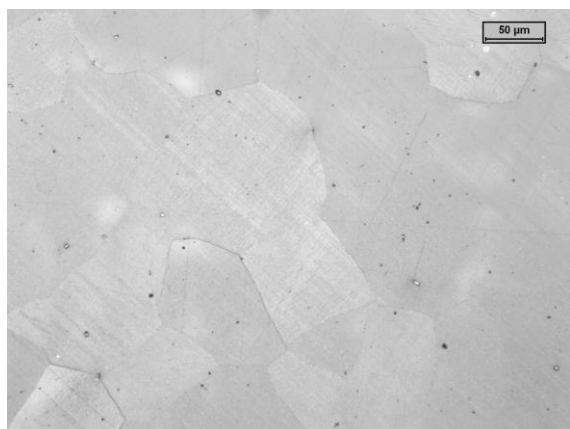
Fig. 2. Microstructure of the GX120Mn13 cast steel, light microscope, nital etching

The microstructures of GX120Mn13 and GX120MnCr18-2 cast steels subjected to solution treatment at 1080°C are shown in Figures 2 and 3, respectively. The application of this heat treatment eliminates from the cast steel matrix, composed of manganese austenite, the precipitates of carbide (Fe,Mn)₃C and phosphorus eutectic, so characteristic of the high-manganese steel and cast steel [24]. In the case of the GX120MnCr18-2 cast steel containing the addition of approx. 2% of the carbide-forming Cr, the microstructure contains complex Cr and Mn carbides with different morphology, i.e. fine and/or more compact (Fig. 3). The results of the chemical analysis of the carbide precipitates and the matrix of both alloys are shown in Table 2, 3, and Figs. 4, 5.

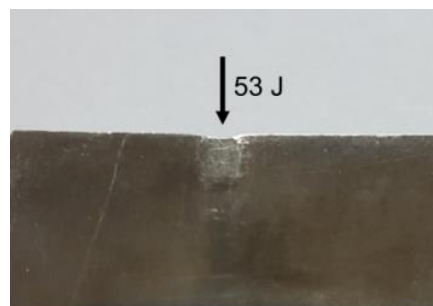
Fig. 6. View of the GX120Mn13 cast steel sample after loading

Visual assessment of changes that occurred in the tested materials as a result of the applied load has revealed the formation of a deformation (cavity) in the surface layer of the material, while a characteristic "protrusion" was observed on the side surface (Fig. 6) extending into the material to a depth of approx. 5 mm for the GX120Mn13 cast steel (Fig. 2) and approx. 2.5 mm for the GX120MnCr18-2 cast steel (Fig. 3).

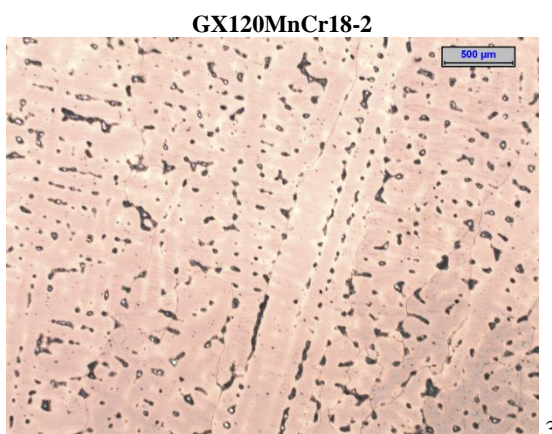
Fig. 7. Cast steel microstructure in the area of load application, 1-3 areas penetrating deep into the material as a result of impact loads - 25x; light microscope, nital etching

Hence, in the further part of the research, examinations of the microstructure of the GX120Mn13 and GX120MnCr18-2 cast steels covered areas located on the surface perpendicular to the applied load. The changes that took place in the microstructure of both tested materials are shown in Figures 7 and 8.

What makes the microstructures of both materials essentially different from each other is the presence in the GX120Mn13 cast steel, in the area of the direct impact of the applied load, of a zone surrounding the place of impact, differing from the rest of the microstructure and having a thickness of approx. 700 μm (Fig. 7a – zone 1). In the GX120MnCr18-2 cast steel, on the contrary, no significant differences in the microstructure were found when moving away from the place of the impact load application into the material (zones 1 - 3). The precipitates of complex carbides enriched in Mn and Cr, characteristic for this cast steel, occurred both on the boundaries and inside the grains and were evenly distributed throughout the microstructure, regardless of the load interaction zone (Figs. 7 and 8).

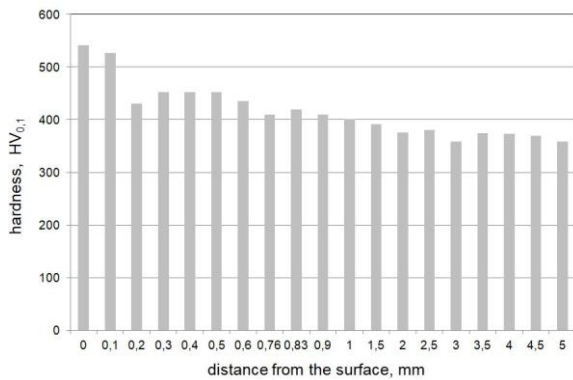
Fig. 11. Hardness changing in the tested GX120Mn13 cast steel from the surface to a depth of 5 mm

The increased content of Mn and the addition of Cr in the GX120MnCr18-2 cast steel, compared to the GX120Mn13 cast steel, increased the initial hardness from 213 HB for the GX120Mn13 cast steel to 242 HB for the GX120MnCr18-2 cast steel. As a result of the applied impact load, the hardness in the near-surface area of the GX120Mn13 cast steel increased to approx. 260 HB, i.e. by approx. 32%, while for the GX120MnCr18-2 cast steel this increase amounted to 278 HB, i.e. by approx. 13%. At a distance of 8 mm from the applied load, the hardness of the GX120Mn13 cast steel decreased to about 220 HB, while remaining practically unchanged for the GX120MnCr18-2 cast steel. Only at a distance of approx. 16 mm, the hardness of the GX120MnCr18-2 cast steel decreased by approx. 10 HB. In turn, the hardness of the GX120Mn13 cast steel was the same as at a distance of 8 mm, thus indicating some stabilization of the hardness results. The obtained results showed the tendency of the GX120Mn13 cast steel hardness values to decrease with the growing distance from the applied load. A similar result was obtained in [25]. In the case of the GX120MnCr18-2 cast steel, no such clear tendency was found, and hardness values remained at a comparable level. Therefore microhardness measurements were carried out. The measurements covered the range reaching into the material to a distance of 5 mm. The obtained results are shown in Figures 11 and 12.

In the GX120Mn13 cast steel, high microhardness was obtained in the near-surface areas, but a noticeable decrease was observed when moving deeper into the material. On the other hand, in the case of the GX120MnCr18-2 cast steel, no significant differences in microhardness were observed in the tested section.

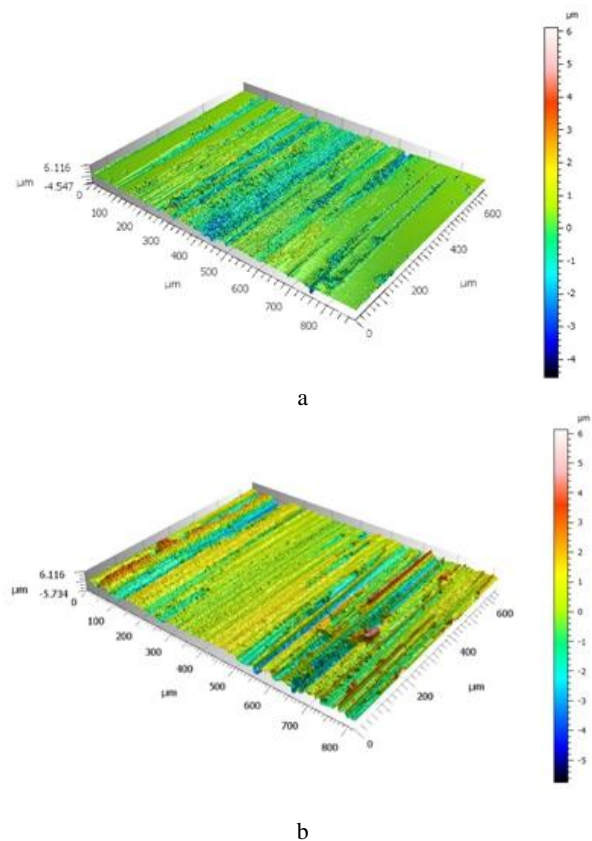
Fig. 13. View of the topography of the GX120Mn13 cast steel surface after the test - hardened at the surface (a) and at a distance of 5 mm from the surface (b)

The results of tribological tests carried out on the investigated cast steels are presented in Table 4 and shown for the GX120Mn13 cast steel in Figure 13 and for the GX120MnCr18-2 cast steel in Figure 14. As expected, for both materials, the average wear surface area was smaller at the hardened surface than at a distance of 5 mm from this surface. Definitely smaller wear areas were obtained in the hardened area of the GX120MnCr18-2 cast steel, which was accompanied by the greatest depth of wear, probably caused by chipping of Mn- and Cr-containing carbides, distributed in the microstructure, during the test. Loose particles of carbides could additionally contribute to the intensification of micro-cutting, as shown by the surface topography of the GX120MnCr18-2 cast steel (Fig. 14). Consequently, it might lead to increased abrasion through mechanical or abrasive-mechanical modes of wear.

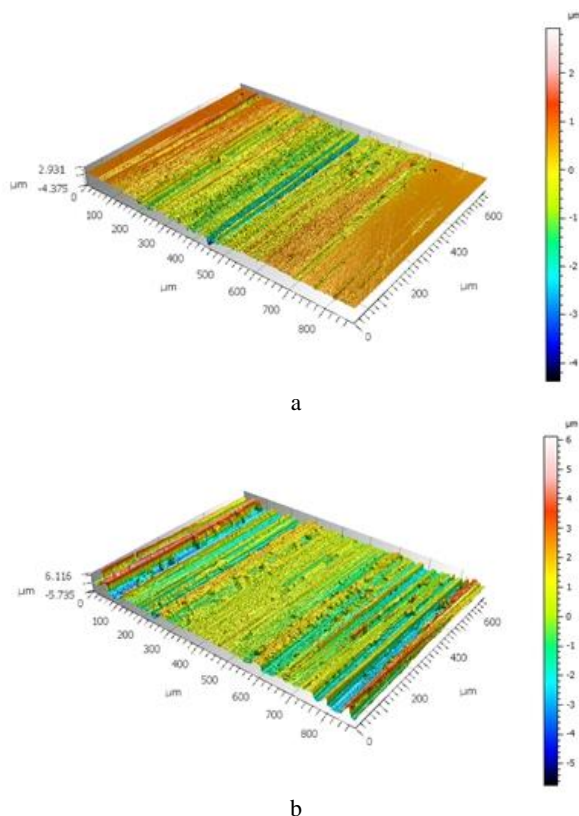
Fig. 14. View of the topography of the GX120MnCr18-2 cast steel surface after the test - hardened at the surface (a) and at a distance of 5 mm from the surface (b)
