**Henryk BĄKOWSKI\*, Piotr CZECH**  
Silesian University of Technology, Faculty of Transport  
Kraśńskiego 8, 40-019 Katowice, Poland  
\*Corresponding author. E-mail: [henryk.bakowski@polsl.pl](mailto:henryk.bakowski@polsl.pl)

## WEAR ESTIMATION OF THE WHEEL TYRE IN DIFFERENT SERVICE CONDITIONS

**Summary.** In this article presented the results of fatigue strength test aluminium alloys using in car industry. Demonstrated distributions and values of stresses the wheel tyre made of aluminium alloys by means of FEM. In fatigue test used special machine, which can allow to determine Wohler diagram. In this way to determine the allowable stresses values in which do not occurring the damages.

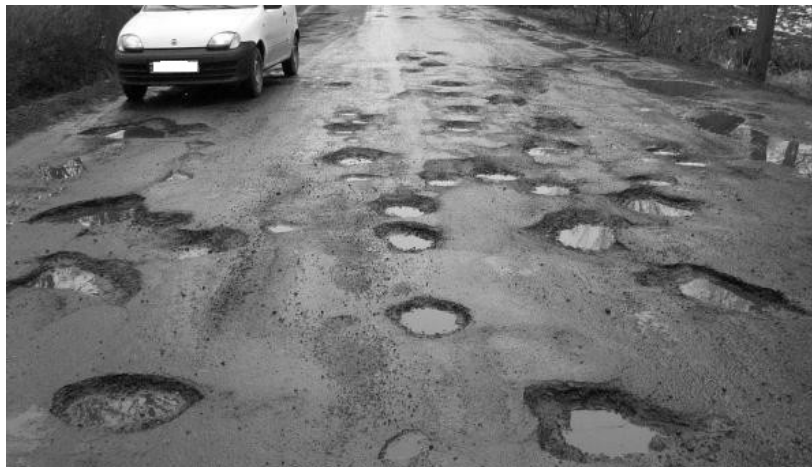
Fig. 2. Huge holes in the road  
Rys. 2. Wielkie wyrwy w jezdni

commonly reported type of structural damage, and is extremely dangerous because it is unexpected. Fatigue occurs in the motor vehicle and parts, aircraft engines, generators and a number of other structures [2]. Fatigue is the result of loads, which varies in time. It become so important to determine the stress below which no fatigue damage occurs or specify the time during which it can lead to disaster. Course load is a random variable that results from the operation [3]. The cars will be the impact of rough roads, engine and chassis vibrations which imposes a charge distribution or maneuvering while driving (Fig. 1, 2) [7].

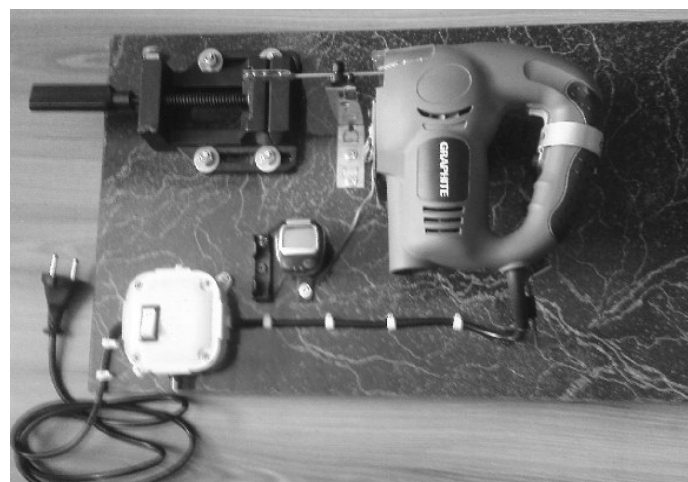
Fig. 4. General view of the machine

The device which is designed and built to test the fatigue strength of non-ferrous metals mainly aluminum alloys. The test samples are subjected to pulsating loads at both ends of pure bending. Laboratory experiments has been carried out on both sides bending [6]. Fig. 3 and 4 presents a view of the device.
