Research Paper

Acoustic Emission as a Method for Analyzing Changes and Detecting Damage in Composite Materials During Loading

Katarzyna PANASIUK^{(1)*}, Krzysztof DUDZIK⁽²⁾, Grzegorz HAJDUKIEWICZ⁽¹⁾⁽¹⁾ *Gdynia Maritime University, Faculty of Marine Engineering, Department of Engineering Sciences*
Gdynia, Poland

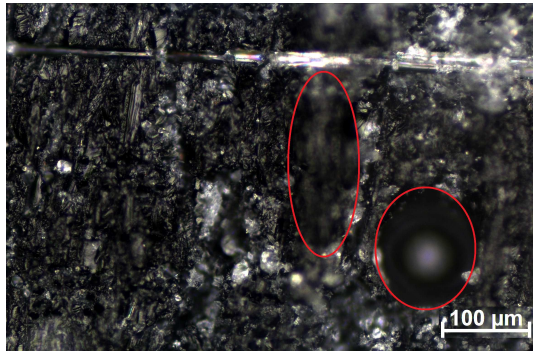
Fig. 1. A photograph of the composite structure without any glass polyester waste content, with defects marked, taken with an optical microscope.

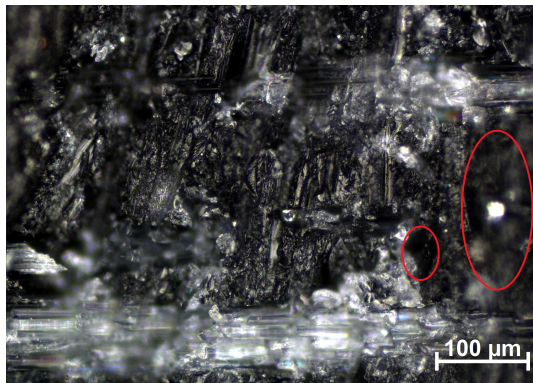
Fig. 2. A photograph of the composite structure with a 10% glass polyester waste content (≤ 1.2 mm grain size), with defects marked, taken with an optical microscope.

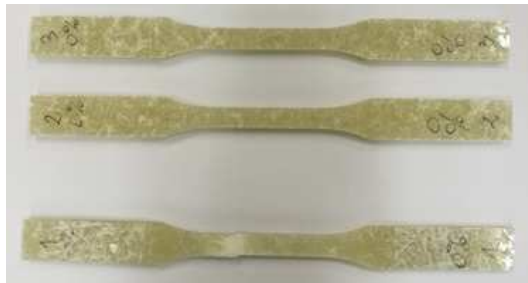
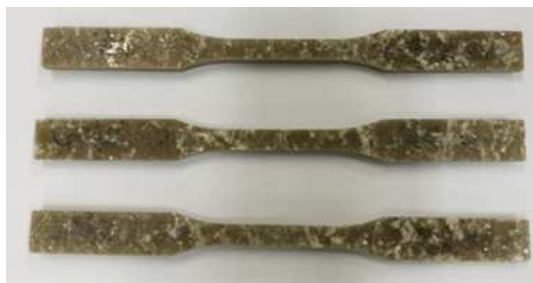
Fig. 3. View of specimens used in research: a) composite without recycle, b) composite with 10% of recycle.

To use the composite material produced in static tensile testing, samples were prepared according to PN-EN ISO 527-4_2000P and were carried out in accordance with the current standard. Composite panel samples were produced using the water-jet cutting method. The method guarantees that similar sizes are obtained for each of the samples. Figures 1 and 2 present composite structures without waste content and with a 10% glass polyester recycle content before the test, presenting the defects obtained in the production process in the form of air pores. Figure 3 presents the view of specimens used in research.

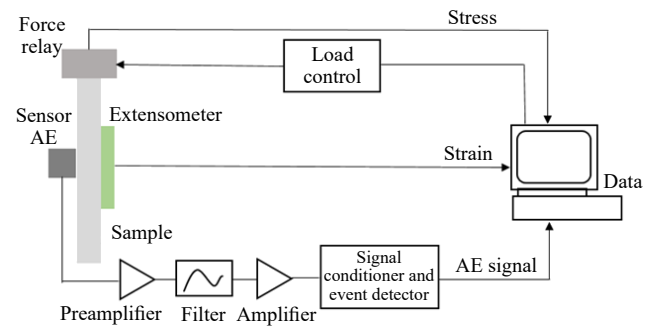
Fig. 4. Diagram of the measuring station.

Research AE was performed using set consisted of: single channel recorder USB AE Node, type 1283 with bandpass 20 kHz – 1 MHz, preamplifier with bandpass 75 kHz – 1.1 MHz, AE-Sensor VS 150M (with a frequency range of 100–450 kHz), computer with AE Win for USB Version E5.30 software for recording and analysing AE data. The tests were carried out in accordance with the applicable standards related to acoustic emission tests (PN-EN 1330-9:2017-09; PN-EN 13554:2011E; PN-EN 15857:2010E).

Between the sensor and a surface of the specimen a coupling fluid was used. AE Sensor was fixed to specimen by elastic tape.

system was used. Diagram of the measuring station is presented in Fig. 4.

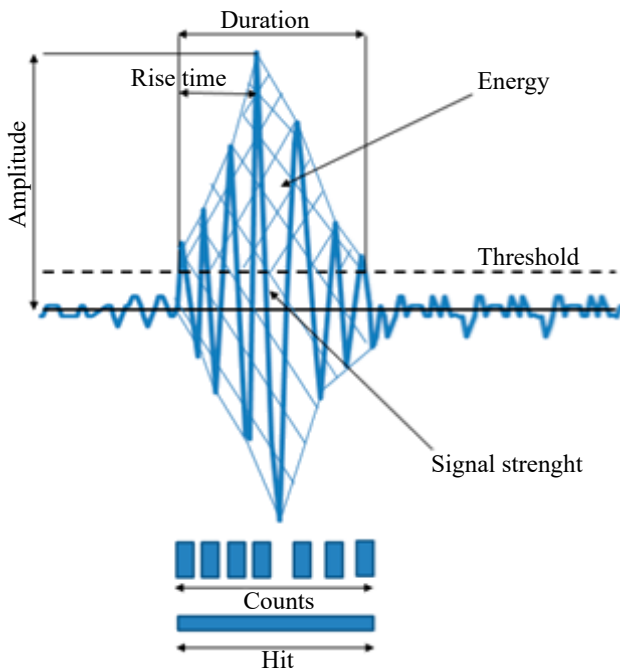
Fig. 5. Parameters reflecting of an AE waveform (ZAKI *et al.*, 2015).

During the study, the AE generated by internal friction, cracking of warp and fibers inside the sample, carried out on a test stand, recorded a number of parameters which were analyzed. Significant changes of selected parameters of AE signals were characterized with hits with duration above 30 μ s. Only those parameters for which this condition was met were selected for the analysis. These parameters were e.g.: amplitude, hits, RMS (root mean square of the AE source signal) and duration and are shown in Fig. 5 (ZAKI *et al.*, 2015).

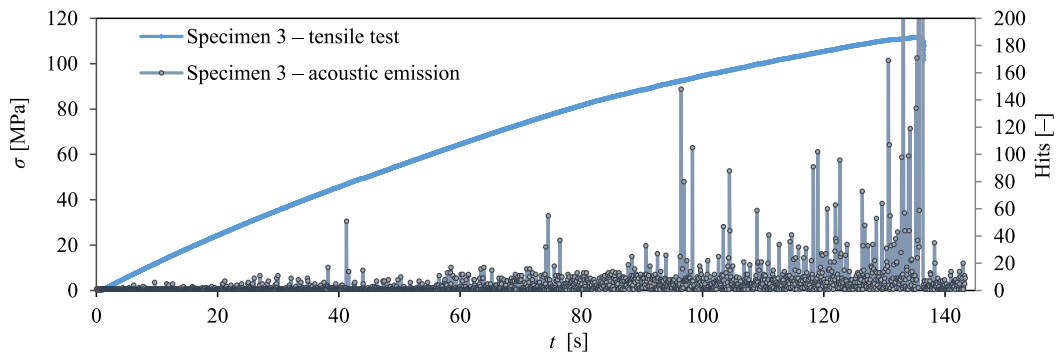
Figure 6 presents a graph of stress and the number of acoustic emission hits as a function of time for material without recycle.

Fig. 6. Graph of stress and number of AE hits, as a function of time for a selected sample without recycle.

Analyzing the graphs of stress and number of AE hits as a function of time (Figs 6 and 7), it is concluded that by adding recycle, we notice an increase

in the number of acoustic emission signals at the very beginning of loading, compared to material without recycle. For material without recycle, a greater number of hits (40) are observed at a stress of approx. 40 MPa, similarly to material with recycle. Based on the entire loading process for samples with and without recycle, an increase in this amount is observed with composite with recycle. With composite without recycle, the increase in the number of acoustic emission signals occurs only at approx. 75 s, corresponding to a stress of approx. 80 MPa. However, in the case of a sample with 10% recycle content, the next ones occur after 50 s, corresponding to about 50 MPa. The value of the intensity parameter for the occurrence of acoustic emission signals allows the determination of a stress value typical of a material without causing major damage.

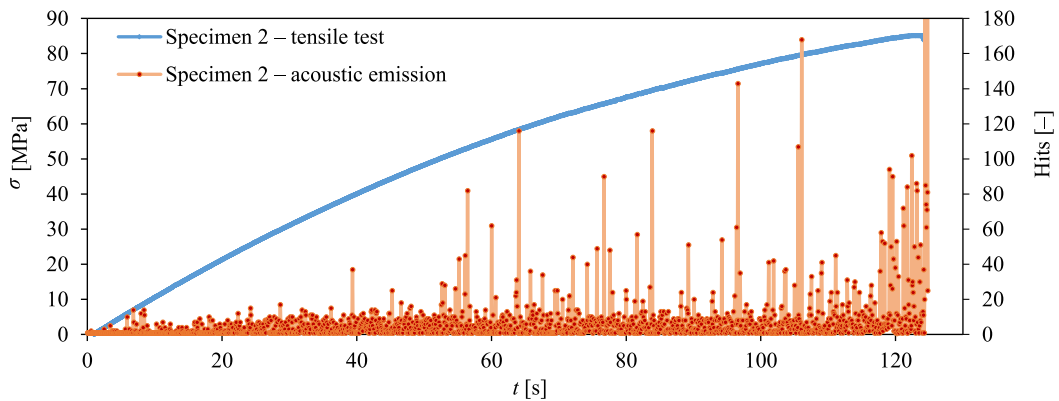
Fig. 7. Graph of stress and number of AE hits as a function of time for a selected sample with 10% recycle content.

Figure 7 presents a graph of stress and the number of acoustic emission hits for a selected sample with 10% polyester-glass recycle.

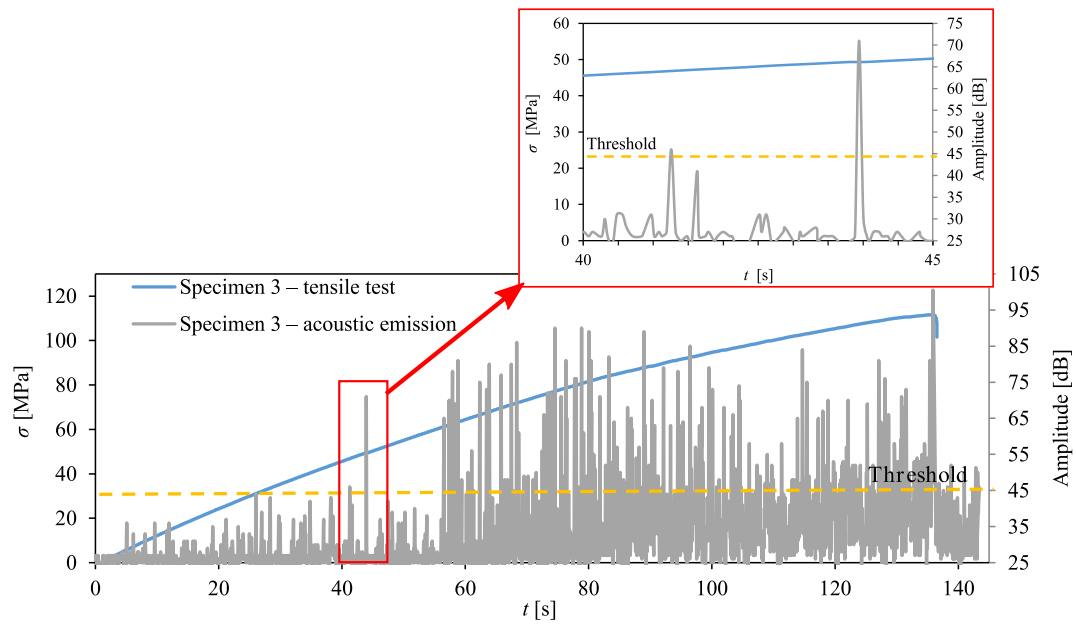
Figure 8 presents a graph of stress and amplitude of the acoustic emission signal as a function of time and a marked threshold of 45 dB.

Fig. 8. Graph of stress and amplitude of acoustic emission signals as a function of time for a sample without recycle.

The signal amplitude as a function of time shown in Fig. 8 takes into account all events occurring during the process of loading the sample.

Amplitude values reflect the characteristics of events occurring during material loading. Due to the fact that the material without recyclate is composed of warp and reinforcement in the form of fiberglass, the obtained amplitude values can be divided into those related to warp cracking and those with fiber cracking, as well as at the fiber-warp boundary. At high loads, the elastic wave defining warp cracking is characterized by a higher amplitude value than those associated with glass fiber cracking. Warp fracture occurs at an amplitude in the range of 76–90 dB. Hence, it can be seen that the first warp crack occurs at a stress of about 60 MPa. Further changes occurring in the material, in addition to fiber and warp, are associated with fiber-warp cracking.

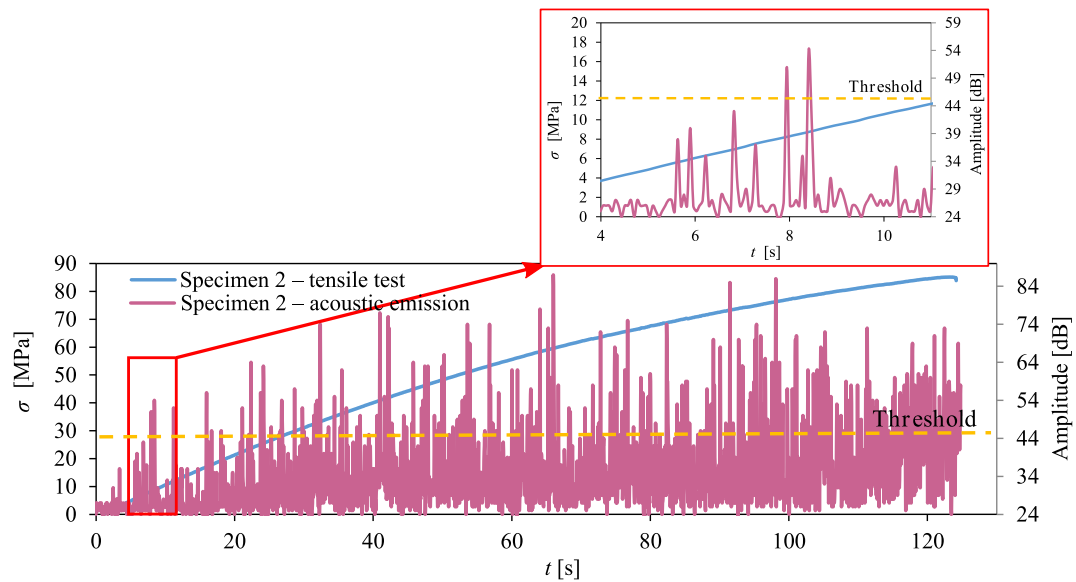
Figure 9 presents a graph of stress and amplitude as a function of time, with a set threshold of 45 dB, as in the case of material without recycle.

Fig. 9. Graph of stress and amplitude of acoustic emission signals as a function of time for a sample with 10% polyester-glass recycle content.

Figure 9 presents the force versus time graph with the amplitude versus time graph plotted for a sample with 10% polyester-glass recyclate content. The material with 10% recyclate content is characterized by a smaller value of the amplitude of the acoustic emission signal, by replacing reinforcement, by adding recyclate to the warp. The recyclate connected to the warp, at the same time weakens it, and thereby reduces the amplitude of the acoustic emission signals caused by its breakage.

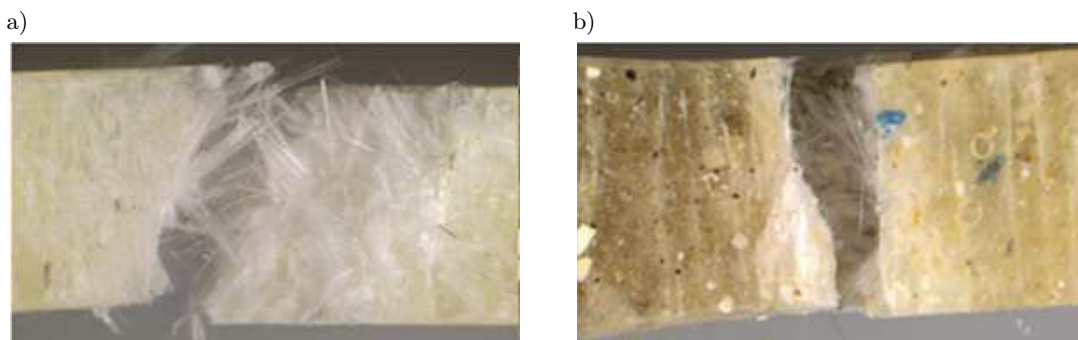
Figure 10 shows samples without recycle and with 10% recycle content after static tensile test.

Fig. 10. Samples after static tensile testing:
 a) sample without recycle, b) sample with 10% recycle content.

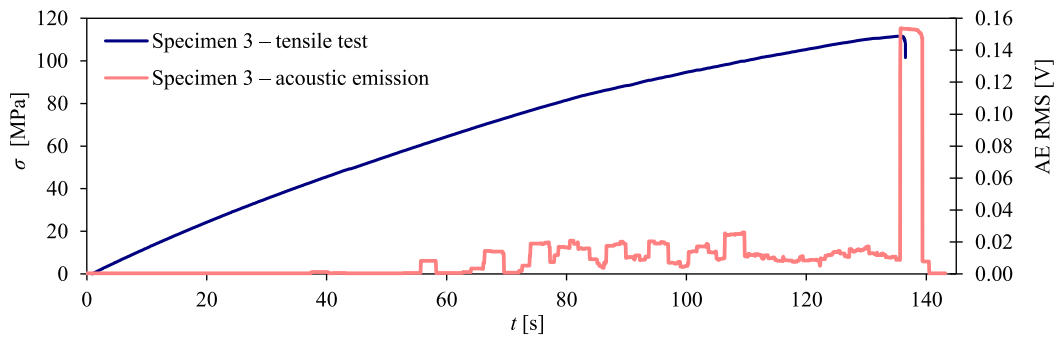
Figure 11 shows the stress and RMS graph as a function of time for non-recycle material.

Figure 11 presents a graph showing the RMS of the acoustic emission signal as a function of time, indicating that small changes occur at the beginning of loading. At approx. 60 s, corresponding to a value of 60 MPa, a higher effective value appears. The highest RMS signal value was recorded at maximum strength, corresponding to sample destruction.

Fig. 11. Stress and RMS graph as a function of time for a sample without recycle.

The graphs obtained by the acoustic emission method (Figs 11 and 12) show the relationship between the RMS of the signal as a function of time and the force acting on the sample. They reveal the occurrence of various mechanisms of destruction in the tested materials due to clear differences in the values of received signals. For samples without recyclate, the value of the root mean square of the AE source signal up to about 55 s, which corresponds to a stress of 60 MPa, does not indicate major changes in the material. Only after exceeding 55 s the effective value increase is visible. For samples with 10% recyclate content, the root mean square of the AE source signal value up to about 35 s, which corresponds to a stress of 35 MPa, does not indicate any major deviations. Only after exceeding 35 s is the deviation visible for all selected samples.

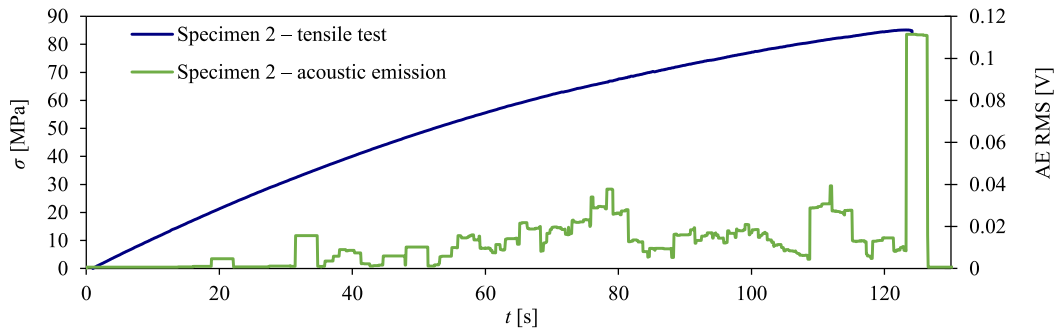
Figure 12 presents a stress and RMS graph as a function of time for a sample with 10% recycle content.

Fig. 12. Stress and RMS graph as a function of time for a sample with 10% polyester-glass recycle content.

The earlier appearance of a higher AE RMS at lower stress values for samples with 10% recyclate content is closely related to the inclusion of waste in the composite structure. The addition of recyclate affects the entire process of destroying the final composite and accelerates it. Analyzing the charts for the above-mentioned materials, it is clearly seen that in the case of samples without recyclate, the deviations of the RMS of the signal are lower compared to samples with a waste content of 10%.
