MONITORING OF TRICHLOROETHENE AND TETRACHLOROETHENE CONTENT IN SOIL-WATER ENVIRONMENT IN THIRD PHASE OF ECOLOGICAL AUDIT OF LAND

AGNIESZKA PUSZ*, ANDRZEJ KULIG

Warsaw University of Technology
Faculty of Environmental Engineering
Chair of Environment Protection and Management
Land Protection Group,
Nowowiejska 20, 00-653 Warsaw

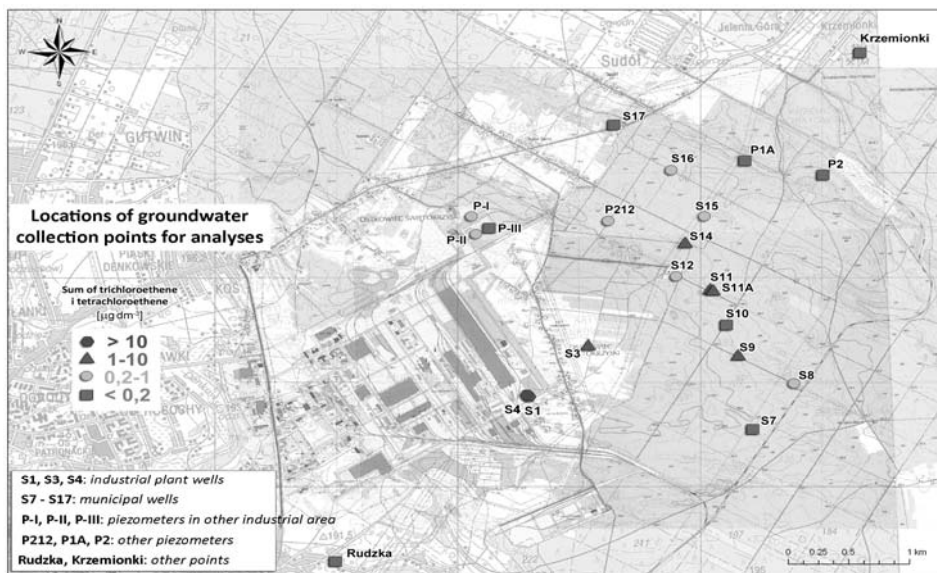
Fig. 1. Locations of groundwater collection points for analyses and characteristics of groundwater in terms of trichloroethene and tetrachloroethene contamination levels in particular testing points

Groundwater samples were taken for research purposes in the period from 2008 to 2010. The samples were collected, first and foremost, from drilled wells but also from piezometers. In the case of the drilled wells the samples were collected directly from test valves fitted on pressure conduits in pits except for S-3 well where water was taken as it was done from piezometers but, for technical reasons, without pumping out. Sample collection from piezometers involved the use of a special small bucket put down the pipe below the water level: for technical reasons (mainly due to the level of the water table) water was not fully pumped out from the piezometer hole nor replaced. Locations of particular points where groundwater samples were collected for research purposes can be found in Figure 1.

Summarised results of the determination of trichloroethene and tetrachloroethene contents are shown in Figure 1 where research points have been classified with correct ranges of total concentrations of both examined compounds. The following figures have been assigned to particular ranges: the range $< 0.2 \mu\text{g}\cdot\text{dm}^{-3}$ points marked with squares; the range from 0.2 to $1.0 \mu\text{g}\cdot\text{dm}^{-3}$ points marked with circles; the range from 1.0 to $10 \mu\text{g}\cdot\text{dm}^{-3}$ points marked with triangles and the range $> 10 \mu\text{g}\cdot\text{dm}^{-3}$ points marked with hexagons. One can see in the figure that the highest levels of total concentrations of trichloroethene and tetrachloroethene (in excess of $10 \mu\text{g}\cdot\text{dm}^{-3}$) were found in wells S-1 and S-4. The following wells: S-3, S-9, S-11, S-11A and S-14 have been classified within the range from 1.0 to $10 \mu\text{g}\cdot\text{dm}^{-3}$. The range from 0.2 to $1.0 \mu\text{g}\cdot\text{dm}^{-3}$ included 4 wells of the municipal water intake (S-8, S-12, S-15 and S-16) as well as 3 piezometers. Two piezometers are situated on the premises of a different than the industrial plant covered by the research (P-I and P-II) and P-212 piezometer. The last range $< 0.2 \mu\text{g}\cdot\text{dm}^{-3}$ included three wells of the municipal water intake (S-7, S-10, S-17 – under construction), 3 piezometers, including one (P-III) situated on the premises of a different industrial plant and two (P-1A and P-2) situated near the former industrial waste dump, as well as the water samples collected in the reserve and from the well drilled on a private property.

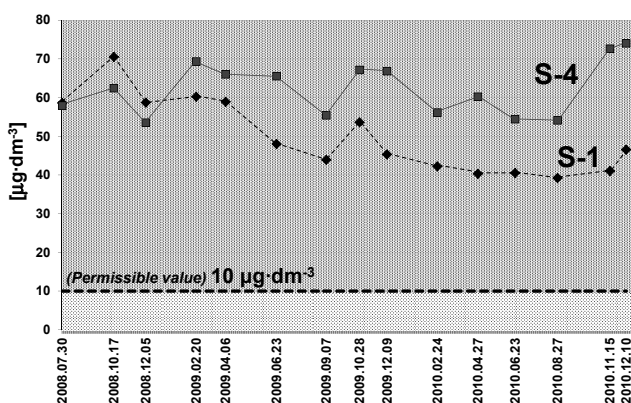
Fig. 2. Sum of trichloroethene and tetrachloroethene content in S-1 and S-4 wells situated in the examined industrial area (in the period of 2008 to 2010)

The wells S-1 and S-4 situated on the premises of the discussed plant were the first measurement points used in the research. The results of trichloroethene and tetrachloroethene concentration tests and the total concentration of the two substances found in the water taken from the deep wells: S-1 and S-4 in the period from July 30, 2008 to December 10, 2010 can be found in Figure 2.

In the water samples collected from deep wells S-1 and S-4 the total concentration of both compounds varied from around 40 to 74 $\mu\text{g}\cdot\text{dm}^{-3}$ which is equivalent to 4–7 times

more than the maximum permissible concentration set in the Regulation on the quality of water to be used for human consumption. The sum of total trichloroethene and tetrachloroethene concentrations in S-1 well differs from the concentration found in S-4 well. Comparing year 2009 to year 2010, it is important to point out that the results of the trichloroethene and tetrachloroethene concentration tests carried out with samples collected in 2010 from S-1 well situated on the premises of the industrial plant are lower than those obtained in 2009 and show a clear downward trend. The total concentration levels of both compounds recorded in S-4 well in the period from 2009 to 2010 remained quite stable and did not show any significant changes.

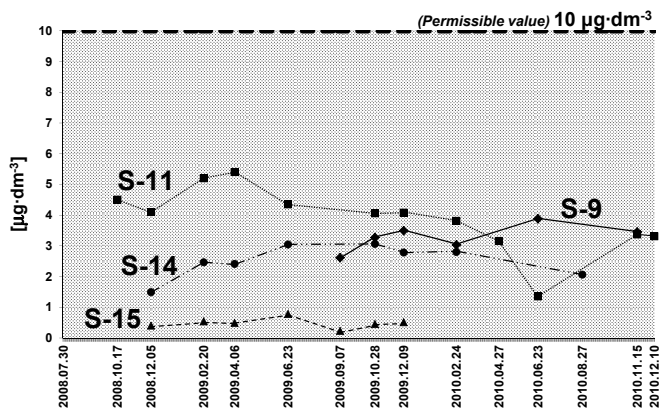
Fig. 3. Sum of trichloroethene and tetrachloroethene content in S-9, S-11, S-14 and S-15 wells situated at a municipal water intake (in the period of 2008 to 2010)

In general, it can be concluded that trichloroethene and tetrachloroethene concentrations show diverse changes, clearly depending on the location of a given measurement point. One can see that the total concentration of trichloroethene and tetrachloroethene in the municipal water intake well (S-9) did not exceed $4 \mu\text{g}\cdot\text{dm}^{-3}$ and its maximum value for 2010 was $3.88 \mu\text{g}\cdot\text{dm}^{-3}$.

The pollutant concentrations found at S-11 point are characterised by a slight downward trend recorded in the second half of 2009 and variable changes in 2010. In the next well (S-14) slightly increased and, at the same time, rather stable concentrations of trichloroethene and tetrachloroethene were found.

Recapitulating the data shown in Figure 3, one can conclude that the water samples collected from wells: S-9, S-11 and S-14 are clearly contaminated and the sum of trichloroethene and tetrachloroethene concentrations amount to: up to $3.88 \mu\text{g}\cdot\text{dm}^{-3}$ for

S-9; $5.40 \mu\text{g}\cdot\text{dm}^{-3}$ for S-11; and $3.06 \mu\text{g}\cdot\text{dm}^{-3}$ for S-14 respectively. Those values have not exceeded the permissible level yet but they point to a clear influence exercised by an unidentified (existing) source of pollution. In S-15 well stable levels of pollutant concentrations were found, below $1.0 \mu\text{g}\cdot\text{dm}^{-3}$.

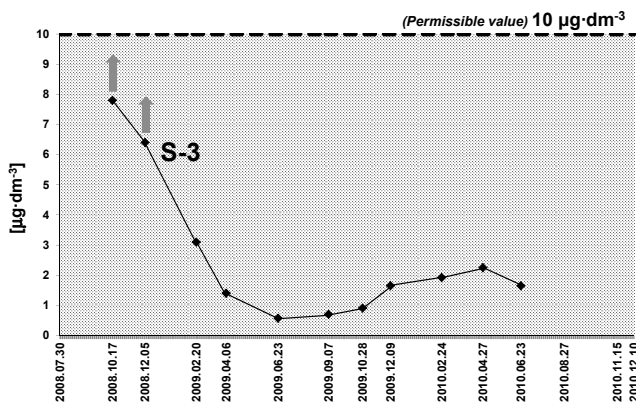
Fig. 4. Sum of trichloroethene and tetrachloroethene content in S-3 well situated in the vicinity of the industrial plant covered by the research (in the period of 2008 to 2010)

Another important stage was to find a well between the investigated industrial plant and municipal water intakes. Such a well has been successfully identified (S-3) although it has been out of operation and disused for many years. Changes in concentrations of trichloroethene and tetrachloroethene and the total concentrations of those substances in the water collected from S-3 deep well in the period from October 17, 2008 to June 23, 2010 can be found in Figure 4. The diagram shows a downward trend in concentrations of both examined compounds in late 2008 and early 2009, and a slight increase of the concentrations in late 2009. The well had not been used as a water intake point for quite a long time therefore the first and the second opening of the well was probably followed by evaporation of both examined compounds [1].

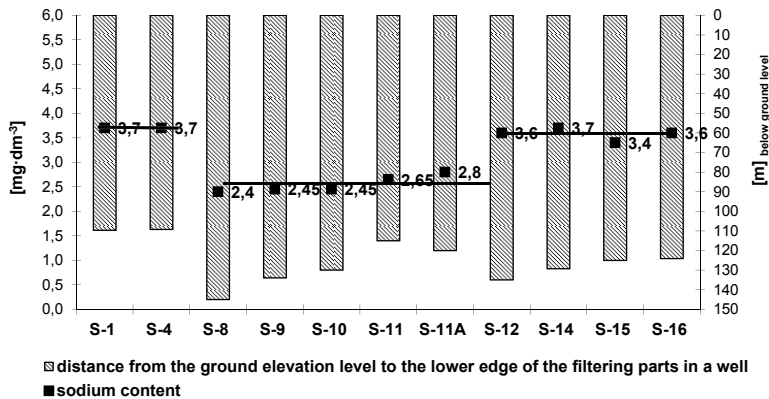
Fig. 5. Sodium content in water samples from selected measurements points

The analysis of the obtained data indicates that sodium concentration in wells S-1 and S-4 (from 3.6 to $3.8 \text{mg}\cdot\text{dm}^{-3}$) is clearly higher than the concentration recorded in wells: S-3, S-8, S-9, S-10, S-11 and S-11A (2.4 – $2.8 \text{mg}\cdot\text{dm}^{-3}$). In the following wells: S-12, S-14, S-15 and S-16 sodium concentration has been determined at the level of 3.4 – $3.9 \text{mg}\cdot\text{dm}^{-3}$. Piezometers P-1A and P-2 show higher variability of sodium concentrations: from 2.8 to $5.0 \text{mg}\cdot\text{dm}^{-3}$ due to, probably, the impact of a nearby former industrial waste dump which is currently under reclamation. The water in P-I piezometer is characterised by substantially higher sodium contents ($12 \text{mg}\cdot\text{dm}^{-3}$). The water in the well situated on the private property at Rudzka shows similar characteristics. Sodium concentration levels in the water samples collected from S-17 well and from the reserve amount to 4.1 and $3.1 \text{mg}\cdot\text{dm}^{-3}$, respectively. Figure 5 shows a breakdown of distances from the ground elevation level to the lower edge of the filtering part in particular wells, compared with the sodium concentration in water samples collected from the municipal wells and the wells owned by the investigated industrial plant.

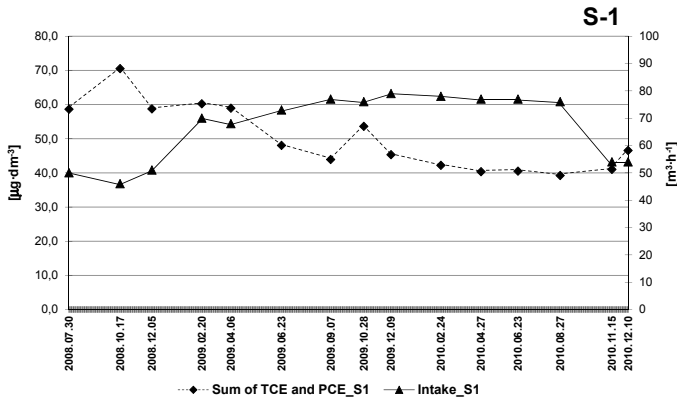
Fig. 6. Comparison of water intake performance for S-1 well with sum of trichloroethene and tetrachloroethene concentrations

Changes of the sum of trichloroethene and tetrachloroethene concentrations in S-1 well differ from the concentration variability observed in S-4 well. The rate of delivery of the pump in the research period was maintained on a high and stable level of around 75 m³/h for the period of 14 months (June 2009 to August 2010). In the same period of time a stabilisation of the sum of trichloroethene and tetrachloroethene concentrations at the level of around 40 µg·dm⁻³ (i.e. much lower than in S-4 well) was observed in S-1 well (in spite of a higher rate of delivery of the pump). A reduction of the rate of delivery of the pump in S-1 well in the final period of time (August 2010 to December 2010) down to around 50 m³/h resulted in an increase in the sum of trichloroethene and tetrachloroethene concentrations up to the level of around 45 µg·dm⁻³. As it was in the case of S-4 well this final period of time was too short to draw any firm and documented conclusions about an increase in the concentration levels.

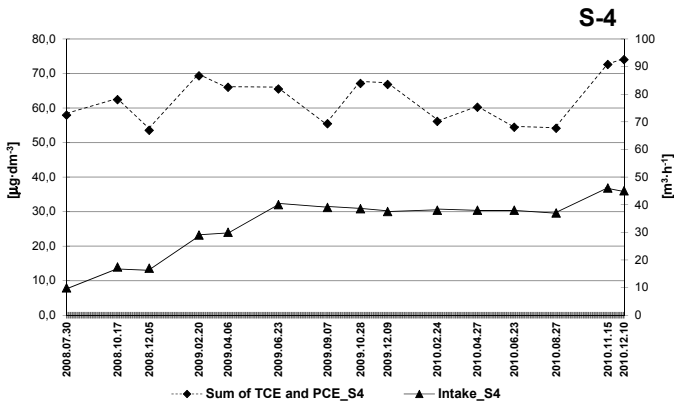
Fig. 7. Comparison of water intake performance for S-4 well with sum of trichloroethene and tetrachloroethene concentrations

The highest concentration levels of trichloroethene and tetrachloroethene were found in S-4 well where the rate of delivery of the pump in the research period was maintained on a stable level of around 38 m^3/h for the period of 14 months (June 2009 to August 2010). In the same period of time the well showed variations in the sum of trichloroethene and tetrachloroethene concentrations centred at around 60 $\mu\text{g}\cdot\text{dm}^{-3}$. An increase in the rate of delivery of the pump at S-4 well in the final period of time (August 2010 to December 2010) up to around 45 m^3/h resulted in a significant increase in the sum of trichloroethene and tetrachloroethene concentrations up to the level of 75 $\mu\text{g}\cdot\text{dm}^{-3}$. Although this final period of time was too short to draw any firm and documented conclusions about an increase in the concentration levels, nevertheless the observed relationship between the concentrations and the water production of the well would confirm the assumption that S-4 well produces groundwater contaminated with trichloroethene and tetrachloroethene released (in a dissolved form and diffusing) by a compact liquid source located on the floor of the Jurassic layer.
