# Animal transitions on the section of the S17 expressway between junctions "Kurów West" and "Lublin Felin"

**Abstract:** The article describes service parameters and effectiveness of the environmental elements of animal crossings on the S17 expressway. Animal transitions on the section of S17 expressway between junctions "Kurów West" and "Lublin Felin" were described. The requirements of environmental protection at the design stage and during the construction works were shown. Article gives an account of the works performed in order to protect the natural environment in areas adjacent to the route, and solutions provided to design objects and the basic functions of animal transitions. Paper summarizes the relevance of the applied solutions and their locations in the field.

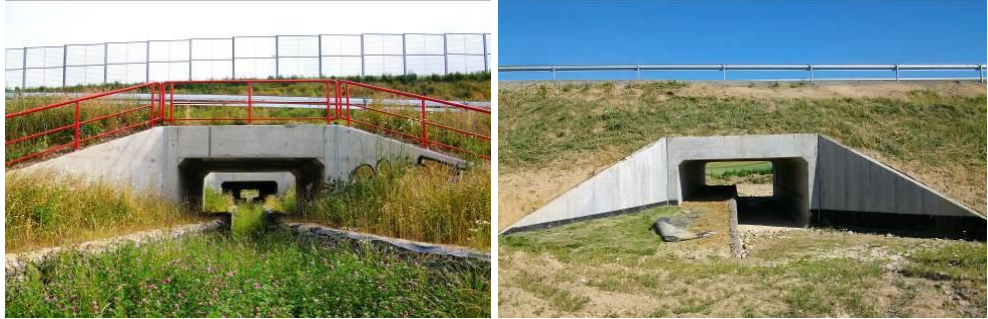
walls of the culvert (made of steel or reinforced concrete), with shelves covered with a layer of mineral soil. The second structure is a passage on the layer of ground covering the bottom of the passage. The third structure of the culvert is shelves made from gabions covered with a layer of hummus (fig. 1 and 2).

Fig. 1. The solution for animals crossing in the form of shelves with gabions in the facility PZM 33

Fig. 2. The solution for animals crossing in the form of shelves with gabions in the facility PZM 29

The sections of the expressway were designed by several design companies, which resulted in some insignificant diversity of passage structures for small animals (Figs. 1, 2, 7, 8). Within Task 1 (“Kurów West” – “Jastków”), all 22 passages for small animals and amphibians were built as corrugated-iron structures. A few structures were constructed in the proximity of culverts under the expressways and on existing minor watercourses. Here animal passages were made from steel shelves covered with a layer of ground. Along Task 2 (“Jastków” – “Lublin Sławinek”), the structures of the passages for small animals were slightly differentiated. In those places where directly above the culvert, road pavements or small road embankments were placed, structures made of reinforced concrete were designed. In total, 5 structures made of reinforced concrete and 8 steel structures serving as

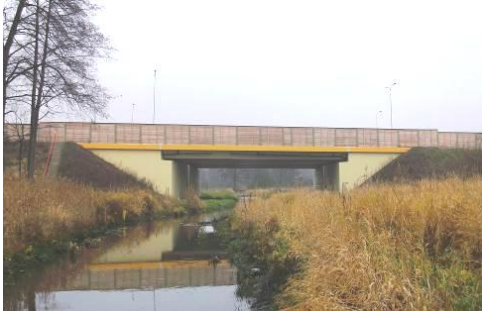
Fig. 3. Crossing for large animals PZDzd3 near the “Kurów Wschód” junction

Examples of passage for large animals are shown in Fig. 3; medium in Fig. 4 - 6; small in Figs. 1, 2, 7, 8.

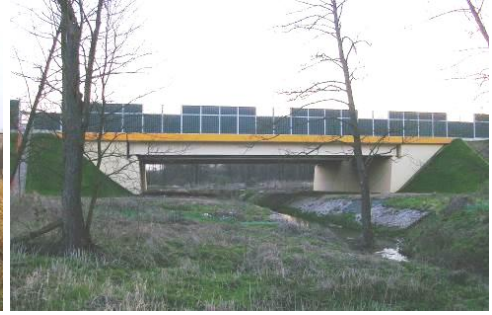
Fig. 4. Crossing for medium-sized animals PZSzd5 in the Ciemięga River valley

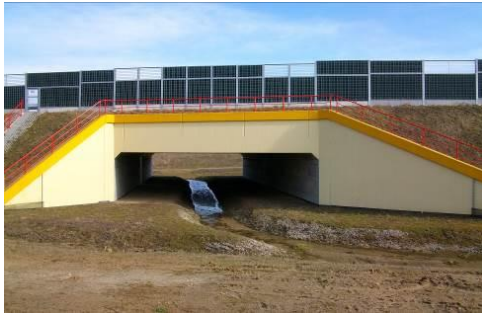
Fig. 5. Crossing for medium-sized animals PZSzd6 near Sieprawice

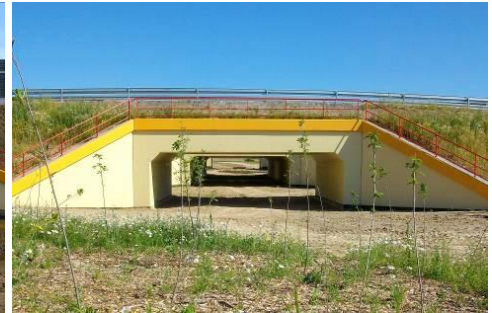
Fig. 6. Crossing for medium-sized animals PZSzd11 within the North ring road of Lublin

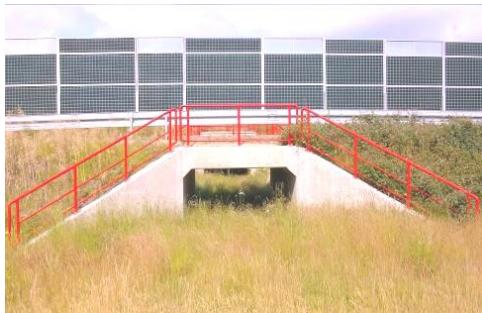
Fig. 7. Group of crossings for small-sized animals PZM37

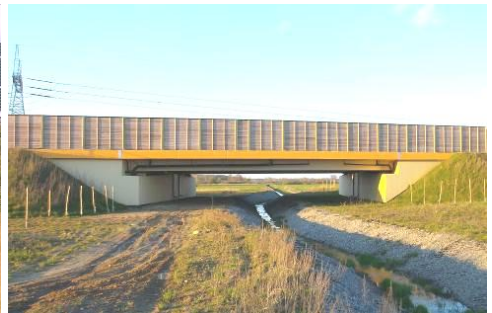
Fig. 8. Crossing for medium-sized animals PZSzd1 near the “Nałęczów” junction

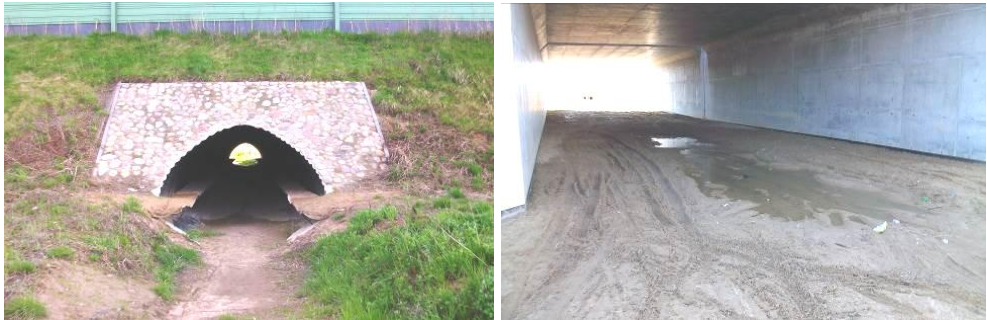
Fig. 9. Traces of use by people of crossings for small-sized animals

Fig. 10. Visible signs of wheeled vehicles within the bottom crossing for medium-sized animals

In analysing the appropriateness of the solutions implemented, a number of positive and negative aspects should be taken into account. As already discussed in Kowal’s publication [10], the location of the PZSzd8 passage of Task 2 (fig. 10) is a debatable issue. The structure was located directly in the proximity of farm buildings, which can significantly minimise its use by wild animals. The authors’ own observations show that the concerns were not groundless. It is difficult to notice trails of wild animals in the proximity of this passage, which does not mean that the object is not used by wild animals. The weakening of the basic function of the structure can be additionally influenced by its use by the locals. The structure is a perfect farm crossing. A similar situation applies to several passages for small animals, which perform the function of a crossing for local people (fig. 9).

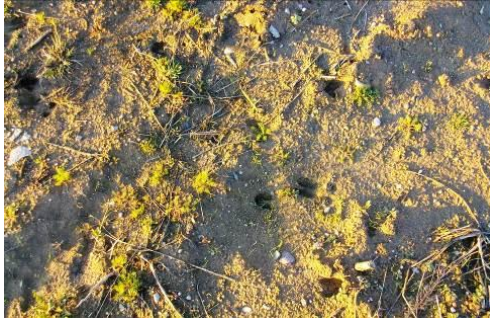
Fig. 11. Animal traces within the crossing for medium-sized animals PZSzd1

A problem discussed in [10] was the relevance of placing street lamps in the proximity of and directly on the underpasses for animals (PZDzd1, PZDzd3, PZSzd1 – all along the “Kurów West” – “Jastków” section). Almost three years since the road was opened to traffic, it can be observed that the fauna, to some extent, has adapted to the new reality. In the proximity of the PZDzd3 structure (MS-05) and underneath it, there is a visible wild boar’s trail. Furthermore, the structure has probably become an interesting convenience for members of the game-hunting club of this area since a hunting look-out was placed 150 m north off the structure,. In the proximity of the PZSzd1 (MS-10) object, trails of roe deer have been observed (fig. 11).

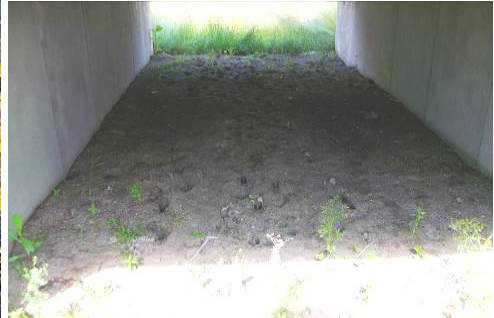
Fig. 12. Animal traces within the group of crossings for small-sized animals PZM37

The traces of roe deer trails were also noted by the authors in the group of passages for small animals PZM37 (fig. 12). This is interesting because the dimensions of the diameter in these structures are 3.0 m horizontally and 1.5 m and 2.0 m vertically. The openness ratio in these structures is 0.59 for the structure with the smaller diameter, and 0.181 for the other one.
