TECHNOLOGY OF WELDING JOINTS MIXED WITH DUPLEX STEEL

Results of the examinations of sample plates of mixed joints with the duplex steel were discussed. Examinations were taken on the sample plates of mixed joints of sheet plates type P355NL1 and X2CrNiMoN22-5-3 welded by the flux-cored wire DW-329A by the Kobelco company of the following category T 22 9 3 NL RC/M3 in the gas shroud M21 (Ar+18%CO₂) (plate no.1), and nickel covered electrodes E Ni 6082 by the Böhler company (plate no. 2). Results of the side bend test of welded joint, transverse tensile test, stretching of the weld metal, impact strength, micro and macroscopic metallographic examinations, and measurements of the delta ferrite content were presented.

Keywords: welding, duplex steel, mixed joints

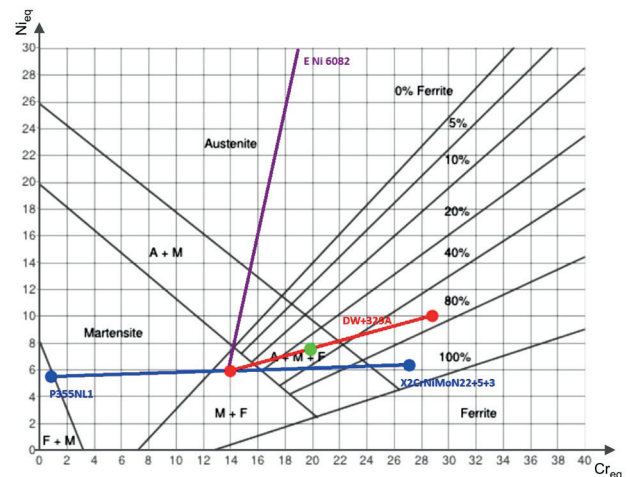
Fig. 1 The Schaeffler's diagram [17]

On the base of a chemical composition of both metal sheets and used filler materials, expected structures of the welds' materials made during processes were specified. The Schaeffler's diagram was used to illustrate it. (Fig. 1)

After calculating an equivalent of chromium and nickel (formula 1, 2) and applying the results to the diagram, following data was obtained:

- an austenite-ferrite-martensite mixed structure with an approximate value of ferrite 10% by using a flux-cored duplex wire.
- a diagram does not cover in its range material of such high content of nickel (clearly shows a plain austenite structure) by using nickel covered electrodes

It is necessary to point that the Schaeffler's diagram relates to the constant cooling conditions of the weld, thus a real result

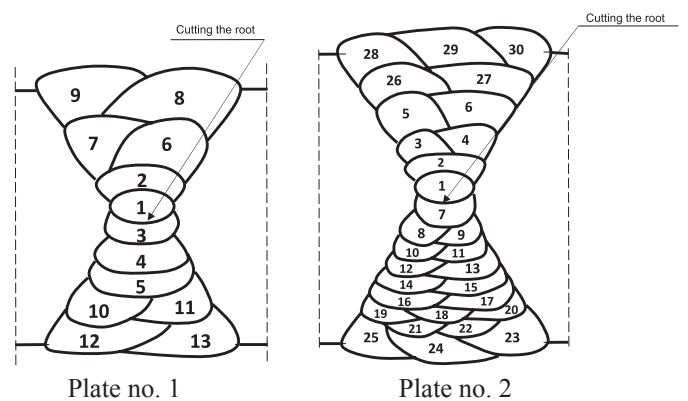
Fig. 2. An order of applying beads

An order of applying beads is presented in the picture 2, while the real parameters obtained during the process of welding are included in the table 6.

Used parameters allowed to obtain a proper amount of inserted heat (linear energy ranges from 0,3 to 1,7 kJ/mm), does not exceed recommended values (maximum value of a linear energy is 2,5 kJ/mm).

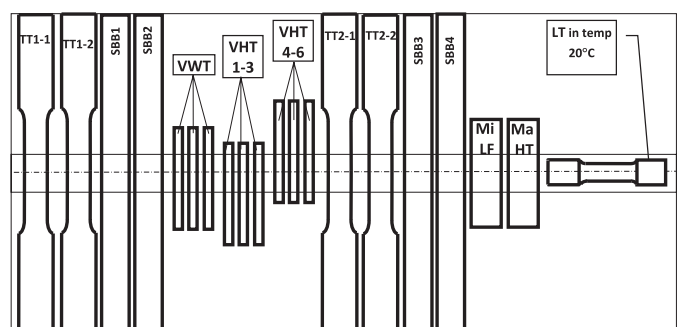
Fig. 3. Places of collecting samples from the sample plates. TT – tension-torsion, SBB – surface band bending, Mi – micro, Ma – macro, VWT, VHT – notch impact value, HT – hardness testing, LF – ferrite number, LT – tension of weld metal [15,22]

A way of collecting samples according to the PN-EN ISO 15614-1 is depicted in the picture 3.

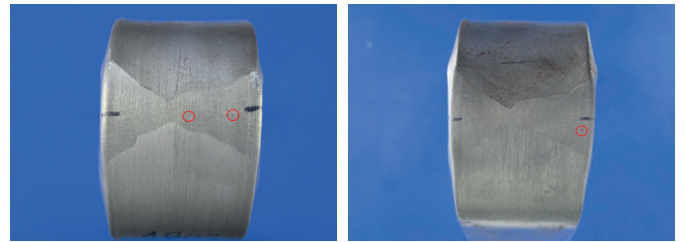
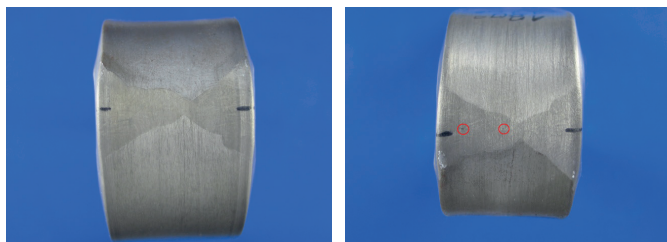
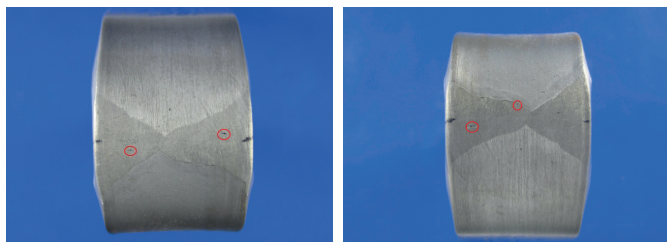
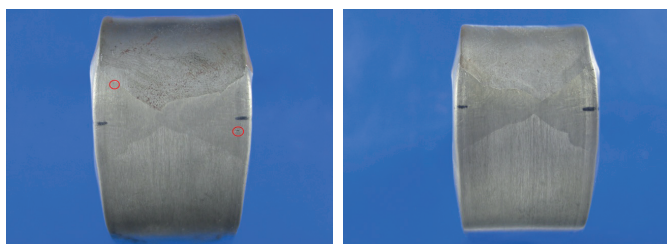
Fig. 5 Pictures of the samples after side bend

Bending tests did not reveal any discrepancies in the base materials, welds and heat-affected zones. In case of both sample plates there appeared only slight cracks, which do not disqualify the joint. A result of an examination was positive (table 8, Fig. 5)

Sample	An angle of bend, °	Plate 1 (136)	Plate 2 (111)
SBB1	180	Lack of cracks	Openings l1=0.2mm. l2=0.8 mm
SBB2	180	Openings l1=1.2mm. l2=0.4mm	Openings l1=1.7mm. l2=0.5 mm
SBB3	180	Openings l1=0.7mm. l2=1.2mm	Lack of cracks
SBB4	180	Openings l1=1.5mm. d=0.5mm	Opening l1=1.3mm

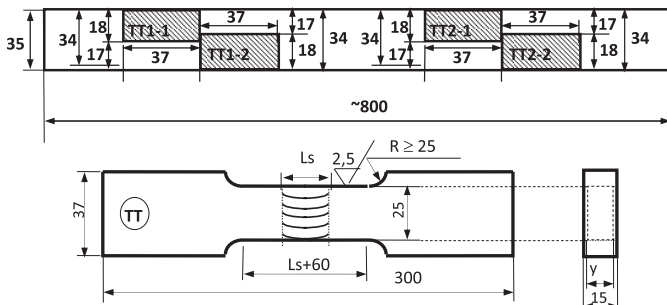
Fig. 7. A way of taking and preparing samples for tension [23]

Transverse tensile test was done on four samples prepared according to the picture 7 in the room temperature in accordance with the PN-EN ISO 4136 standard. Sizes of the samples were fixed to the possibilities of the tensile testing machine of 400kN power. Taking into account a high tensile

strength of the duplex steel, it was necessary to take two samples from the joint. A minimum criteria for the joint was equal to 470MPa [23].

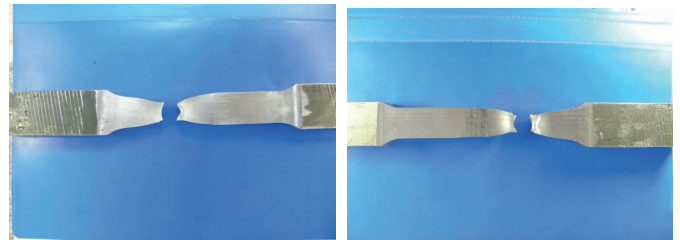
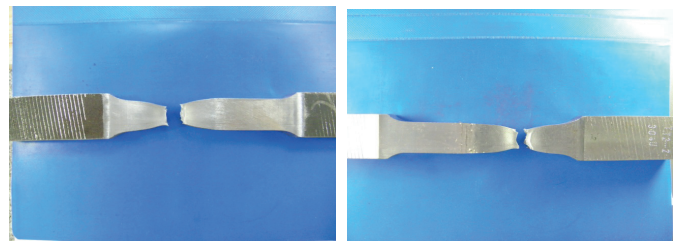
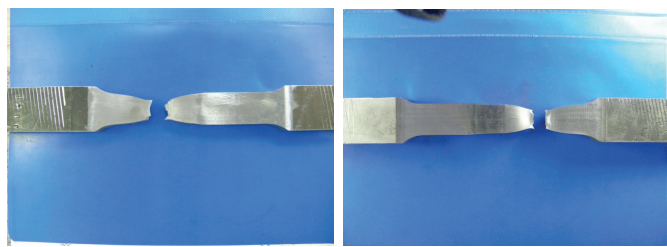
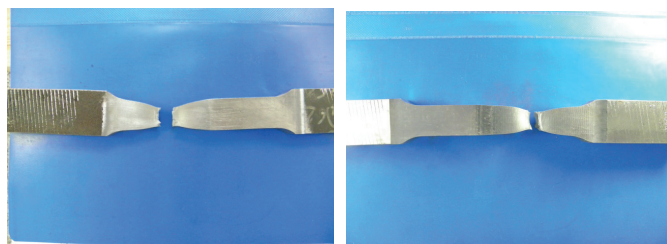
Fig. 8. Pictures of the samples after transverse tensile

Pictures of the samples after transverse tensile are presented in the picture 8.

Sample	Plate 1 - 136		Plate 2 - 111	
	Rm, MPa	Breaking place	Rm, MPa	Breaking place
TT1-1	536	P355NL1 material	557	P355NL1 material
TT1-2	525	P355NL1 material	558	P355NL1 material
TT2-1	520	P355NL1 material	559	P355NL1 material
TT2-2	524	P355NL1 material	546	P355NL1 material

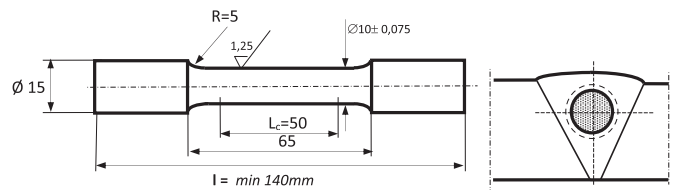
Fig. 9. A way of taking and preparing a sample to stretch the weld metal. [26]

Weld metal tensile test was done according to the PN-EN ISO 876 standard in order to measure tensile strength of the same weld. A way of preparing a sample presents picture 9 [13].

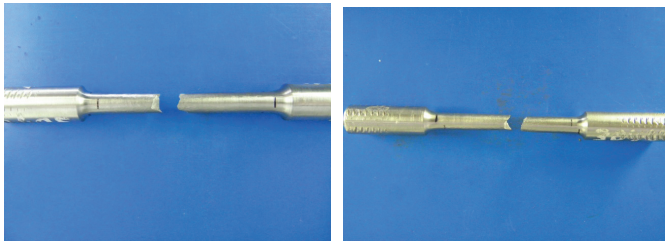
LT - 1 - Plate 1 - 136 LT - 1 - Plate 2 - 111
 Fig. 10 Pictures of the samples after tension of the weld metal

Pictures of the samples after tensile testing of the weld metal are presented in the picture 10.

limit of plasticity. An examination was taken in the room temperature. Following criteria were taken into account: $R_e \geq 315\text{MPa}$, $A \geq 21\%$, $R_m \geq 470\text{MPa}$ (table 10) [26]. Higher resistance and plasticity values were obtained in case of the plate no. 2, which is the result of using nickel based electrodes.

Sample	Re, MPa	Rm, MPa	Elongation, %	Result of the examination
LT1-1- Plate 1 - 136	384	513	27.8	Positive
LT1-1- Plate 2 - 111	416	675	44.4	Positive

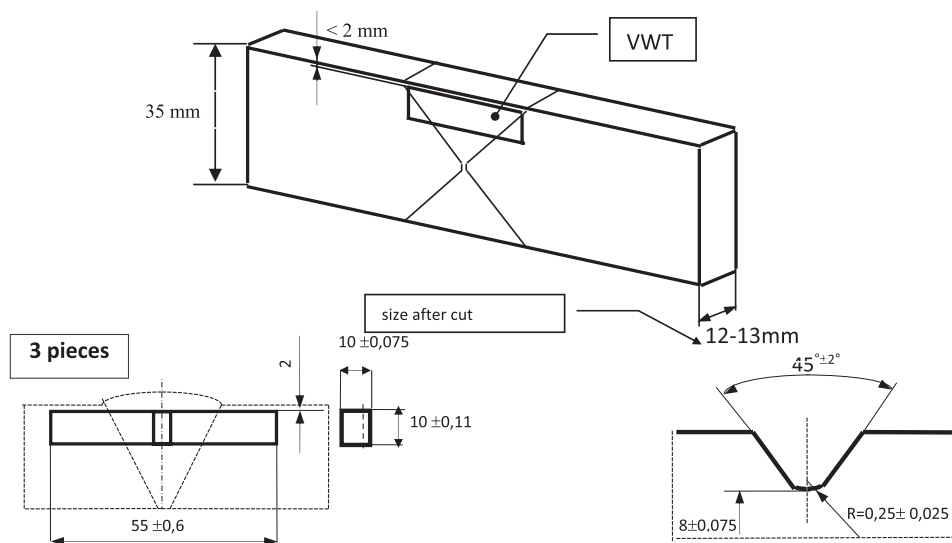
Fig. 11. A way of preparing samples taken from the weld to the impact strength tests [14]

Due to the mixed connection, except of a standard three-set samples taken from the weld and three from heat-affected zones, an additional set was used from the heat-affected zone of the second material. Recommendations from PN-EN ISO 9016 and PN-EN ISO 148-1 standards were used. Pictures 11 and 12 depict a way of taking each set. An examination was

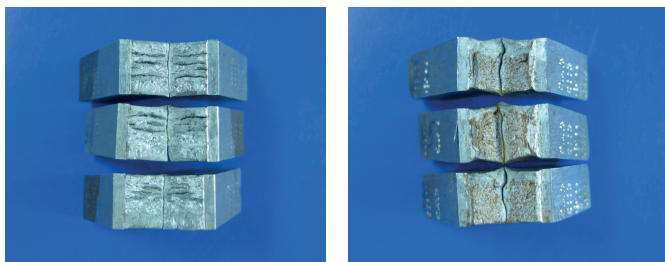
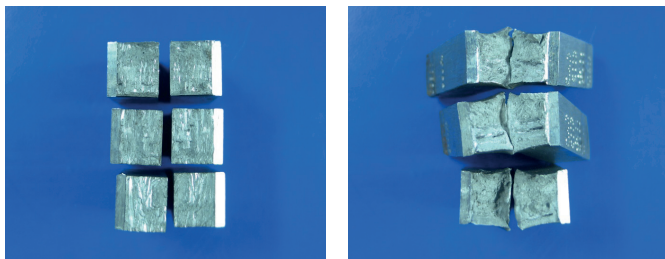
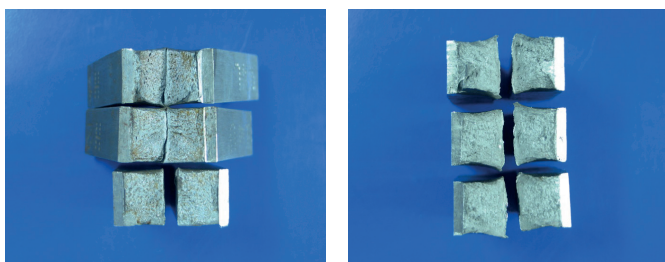
Fig. 13. Pictures of samples after an impact strength test

Impact strength tests have finished negatively in case of the plate no. 1. A required value of breaking operation equals to 27 J was not obtained both for P355N11 material, and also 40 J for the duplex steel (table 11). It is caused by an increase of embrittlement activated by the carbon diffusion from the carbon steel into the weld during a thermal treatment, and an occurrence of the brittle sigma phase.

In case of using nickel based filler material (plate no. 2) much higher breaking operation values were obtained. Elements included in the chemical composition of used

electrodes mostly nickel, niobium and titanium, which are stabilizers, stopped carbon diffusion. Moreover, they caused appearance of carbides, which increase embrittlement and decrease resistance of the material to corrosion. Pictures prove that samples taken from the nickel welded joint (plate no. 2) broke in a plastic way, while the fracture of samples from the plate no. 1 is evidently brittle.

Plate	Sample	1, J	2, J	3, J	Average, J
1 – 136	VWT1/2 – P355NL1	88	26	26	47
	VHT1/2 – weld	14	5	6	8
	VHT1/2 - X2CrNiMoN22-5-3	33	36	18	29
2 – 111	VWT1/2 – P355NL1	140	130	138	136
	VHT1/2 – weld	128	128	133	130
	VHT1/2 - X2CrNiMoN22-5-3	75	110	59	81

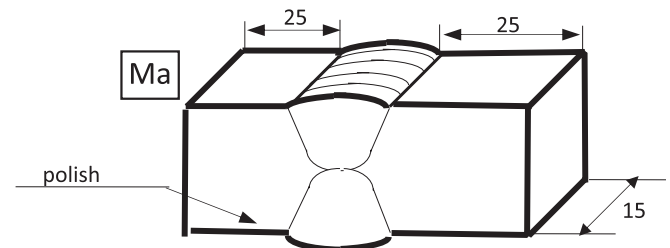
Fig. 14. A way of preparing a metallographic specimen [10]

Macroscopic examination was taken according to PN-EN 1321 standard on a previously taken and etched metallographic specimen (fig. 14). Adler's solution was used to etch. [20]

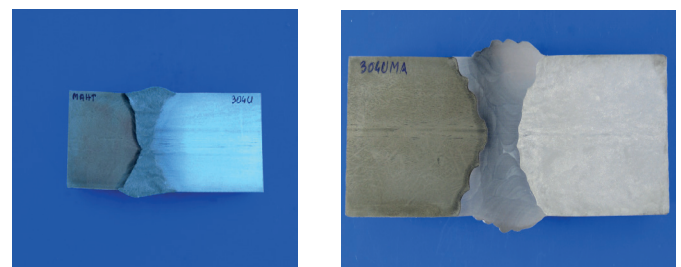
Fig. 15. Macroscopic pictures of plates

Macroscopic examination did not reveal any of unaccepted discrepancies in the section of examined plates (fig. 15)

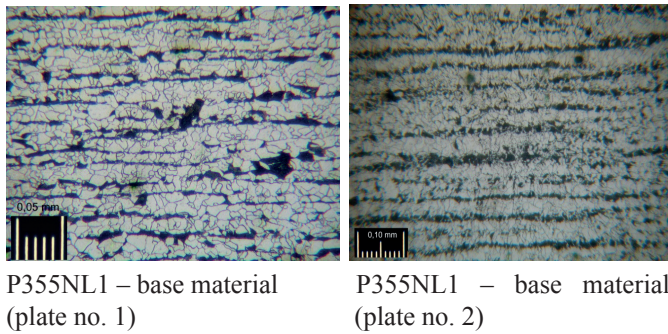
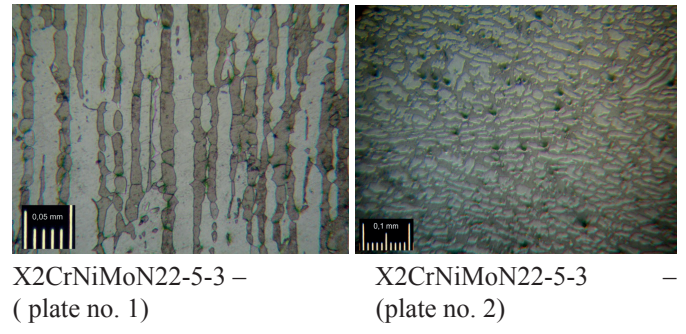
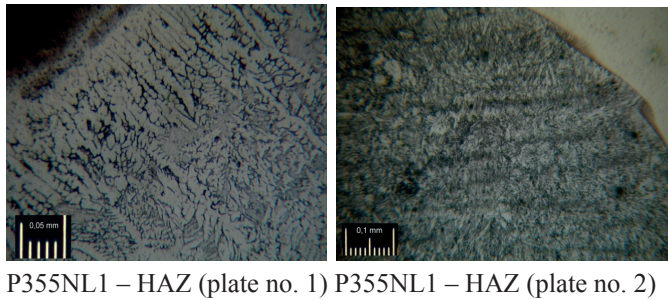
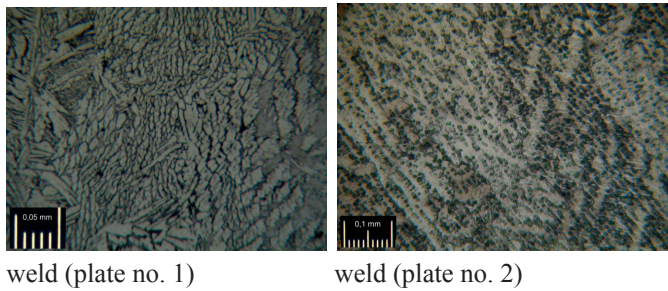
Fig. 16. Microscopic pictures of plates

Microscopic images were taken on the metallographic specimen etched by the agent consisting of nital and Mi20Fe (fig. 16). Zoom 200:1 was used. An examination was taken according to the PN-EN 1321 standard [20]

A structure of a heat-affected zone on the side of the duplex steel in case of the plate no. 1 includes about 40-50% ferrite. The weld indicates a ferrite-austenite structure with a required share of ferrite i.e. 30-70%

Microscopic examination in case of the plate no. 2 does not reveal any microcracks or other discrepancies. It was stated that the base material on the side of the carbon steel has a ferrite-pearlite structure, and on the side of the duplex steel has a ferrite-austenite structure with a ferrite content of about 45%. The weld is characterised by the ferrite-austenite structure of grown austenite grains with a ferrite content not exceeding a value of 85% near the weld line (fig. 16).

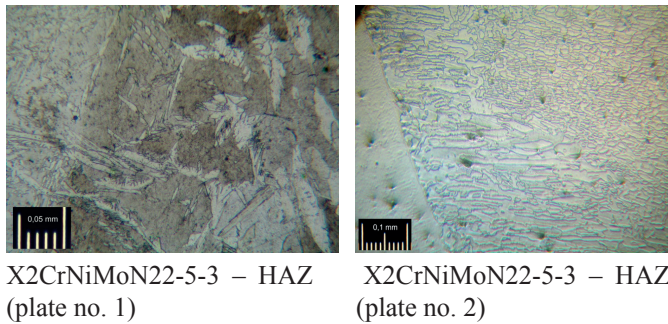
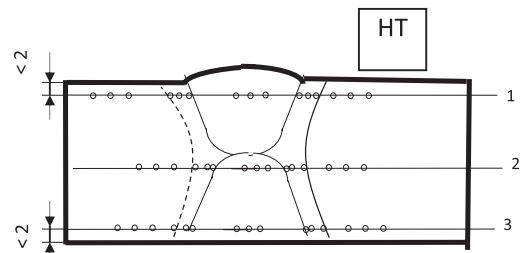
Fig. 17. A way of doing a hardness test [19]

Hardness test by the Vickers method was done on the metallographic specimen, previously used in the macroscopic examination. Hardness test was done according to the PN-EN ISO 9015-1 standard along specified measurement lines (fig. 17). Vickers testing device was used 430 SVD with the load of HV10 [19].

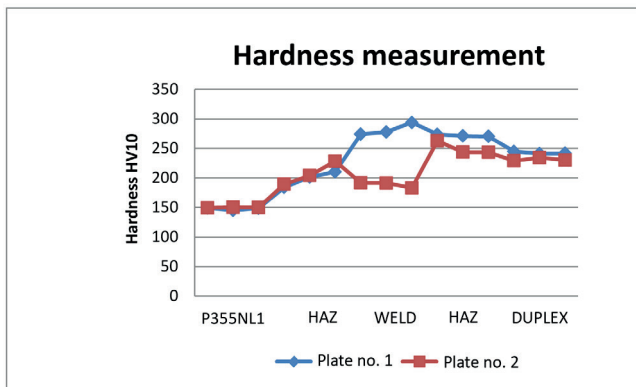
Fig. 18. Results of the hardness measurement

Results of the hardness tests are depicted in the picture 18

In case of the plate no. 1, the lowest hardness was stated inside the P355NL1 metal sheet, its value is much higher in the duplex steel, and definitely the highest in the weld (table 12, 13). Hardness of both base materials plate no. 2 is very close to the measurement of the plate no. 1, whereas in case of the weld much lower hardness was observed in the joint made by the nickel based electrodes. It is caused by the high plastic properties of mentioned electrodes.

It is vital to point that according to the PN-EN ISO 15614-1 standard hardness test is not done for the materials from the group 10 including duplex steel. In case of above sample plates an examination was taken only to do an experiment [15].

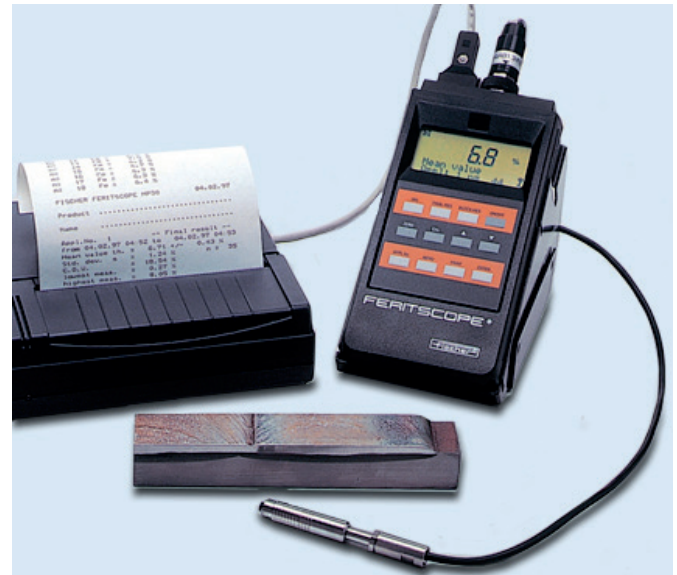
Fig. 19. The Fisher MP 30E-S Feritscope

Examining a content of delta ferrite was taken according to the PN-EN ISO 8249 standard by the Fischer MP 30E-S Feritscope (fig. 19) on the previously used for an examination a metallographic specimen. Measurements refer an area of the weld, the duplex steel, and the black steel [21].
