CRACK GROWTH DIAGNOSTIC OF BALL BEARING USING VIBRATION ANALYSIS

It is known that supported ball bearings have great effects on the vibrations of the gear transmission system, above in all the presence of local faults as well as the crack growths. For this purpose, this paper focuses on shock and vibration crack growth diagnostic of ball bearing using vibration analysis. Our work is devoted first to a study the static behaviour of the ball bearing by determining the stress, strain and displacement, then its dynamic behaviour by determining the first four natural frequencies. Secondly, a dynamic analysis study of the bearing was carried with defects as a function of crack size and location. The obtained results clearly show that the natural frequencies decrease in a non-linear way with the growth of the length of the crack, on the other hand the stress increases with the presence of the singular points of the crack. Finally, this residual decrease in natural frequencies can be used as an indicator of the state of failure, as well as a parameter used for the diagnosis and screening, and to highlight the fatigue life of the bearing

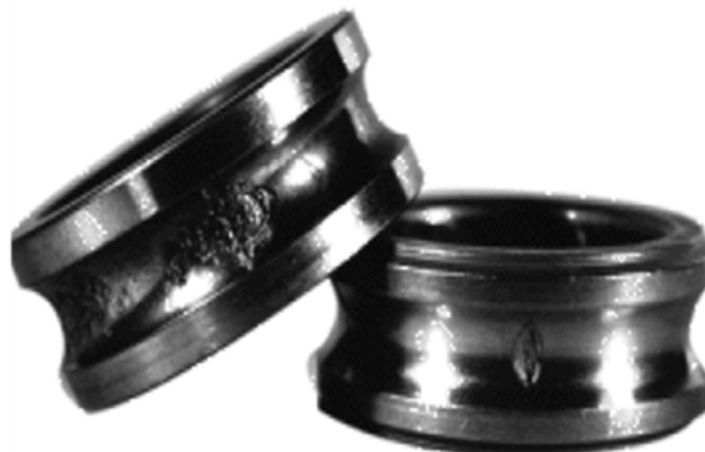
Fig.2. Inner ring with defect [28].

Physical defects can occur on bearing elements such as the inner ring, outer ring, and ball. These defects cause vibrations of great amplitude.
