Nidal H. Abu-Hamdeh¹

Experimental and theoretical study of a vane pass frequency for a centrifugal pump

¹King Abdulaziz University, Jeddah, Saudi Arabia.

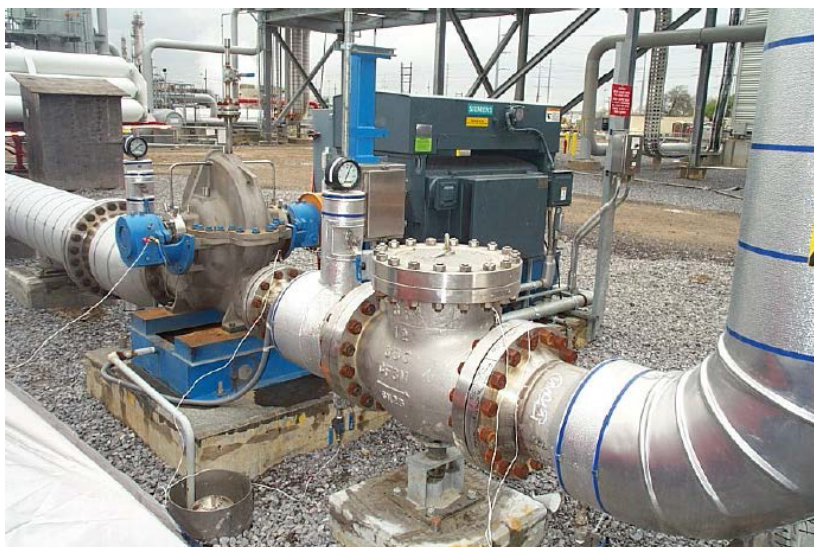
Fig. 1. Pump configuration

The structure of each pump in the pump station is shown in Fig. 1. The diameter of the intake line, which is shown on the left of the figure, is 0.46 m, with a 0.46×0.30 m reducer located exactly before the 0.30 m pump intake flange. On the 0.20 m pump discharge, which is to the right of the figure, there is a 0.20 × 0.30 m reducer, tracked via a tiny spool portion fixed to a 0.30 m check valve. Precisely preceding the valve is a perpendicular elbow inside the 0.30 m line of discharge.

All length measurements were with ± 0.005 m uncertainty. It is the first elbow in a group of elbows comprised of 4 elbows which outline the upright loop which links the discharge of the pump to a joint header. The further 2 pumps in the station are designed and constructed in the same way.

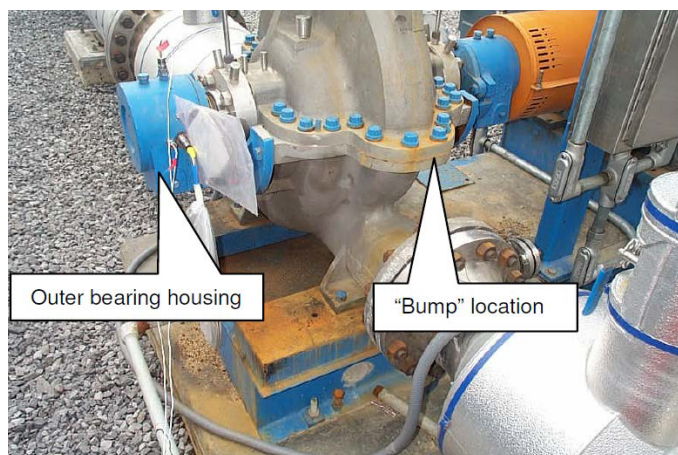
Fig. 3. Locations where the second round of measurements were taken

With the intention to additionally explore the source of the vibrations and the impact solution, a sequence of pulsation and vibration assessments was carried out. These assessments were made for the vibration accompanying the running of the pump at around 10 positions, although the pump was running at a minimal volume of $150 \pm 1 \text{ m}^3/\text{h}$. In the major part of these positions, assessments were carried out together in the horizontal direction, that is in line with the axis of the pump discharge track, and in the vertical direction. The assessments, on the exterior bearing housing, were carried out on the housing at a right angle with the pump shaft centerline. Accordingly, the horizontal assessments were undertaken on the lateral of the housing and the vertical assessments were documented on the uppermost of the housing, as showed in Fig. 3. On the termination of the housing, only axial (in line with the pump shaft) assessments were documented.

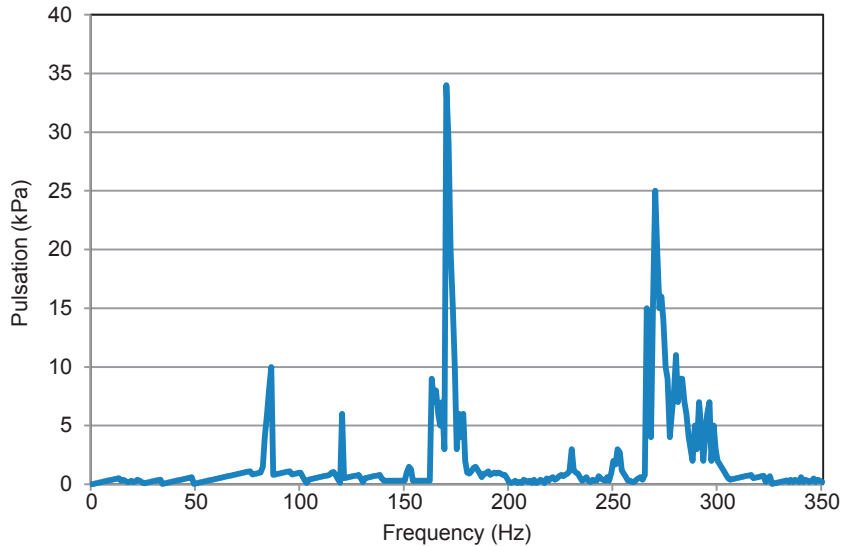
Fig. 4. Pulsations in the discharge piping over 1500–2000 rpm

At the beginning, topmost hold pulsations were calculated at the pump discharge over a velocity extent of $1500 \div 2000 \pm 0.5$ revolutions per minute (rpm). As the velocity increased, the pulsation in the discharge track changed and dropped down at the peak end of the velocity extent as shown in Fig. 4. The topmost pulsation was equal to $34 \pm 0.5 \text{ kPa}$. The maximum pulsation frequency in the discharge line was equal to $170 \pm 1 \text{ Hz}$ which coincides with the pass frequency of the pump vane. It was observed that functioning at varied flow rates (the flow rate was modified by a step at a time by means of a regulating valve in the discharge track), however, at a fixed velocity of $1700 \pm 0.5 \text{ rpm}$, the level of pulsation dropped as the flow

via the pump remained within the area of peak pump efficiency. This was almost certainly caused by the cleaner run off at the tips of the vane inside the cutwater and the pump volute.

It was noticed that $13 \div 34 \pm 0.5$ kPa levels of fluid pulsation in the pump lines, at the VPF of the pump, result in shaking of the connected piping. Similarly, the discharge line loop, which is set up to compensate for the typical expansion joint deficiency at the discharge line of the pump, intensifies the vibrations due to pulsation. In addition, the piping vibration has an insignificant amplitude of displacement at the VPF (of the order of ~ 0.1 mm), resulting in real difficulty in suppressing the piping.

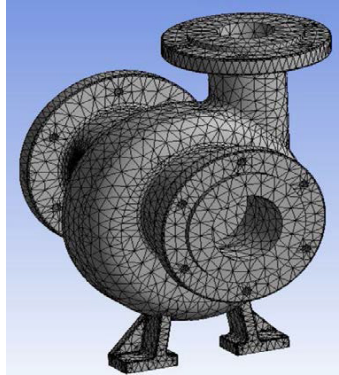
Fig. 5. The pump after meshing

Pump system parts included in the analysis were the pump shaft, the impeller, the motor, the discharge tube, the volute section, the drive shaft, the couplings and the bearings. The discharge tube was represented as a conical profile and the volute part as an envelope generated as a result of rotating adjusted half circles around the revelation axis. The rotation hub distance from the center of the circles increased in analogous order about the volute. Several assumptions were made in constructing the ANSYS model to represent the pump system. The three translations of the shaft line, at motor end, were assumed to be zero at the universal joint. The shaft line bearings' axial displacement was taken to be zero. The shaft of the pump was connected to the frame at the two locations of bearings via four spring elements. Stiffness of the springs were equivalent to the radial stiffness of the particular bearings. The base of pump was attached to the ground at spots of footing bolts. Also, damping was ignored in the simulation and the structure was considered linear-elastic. Material properties of the pump used in the simulation are given in Table 2. Prior to the simulations, a mesh was created as shown in Fig. 5. The pump

was made up of 334841 tetrahedral elements of type SOLID187. This is a 10-node tetrahedral element with three displacement degrees of freedom and quadratic displacement behavior.

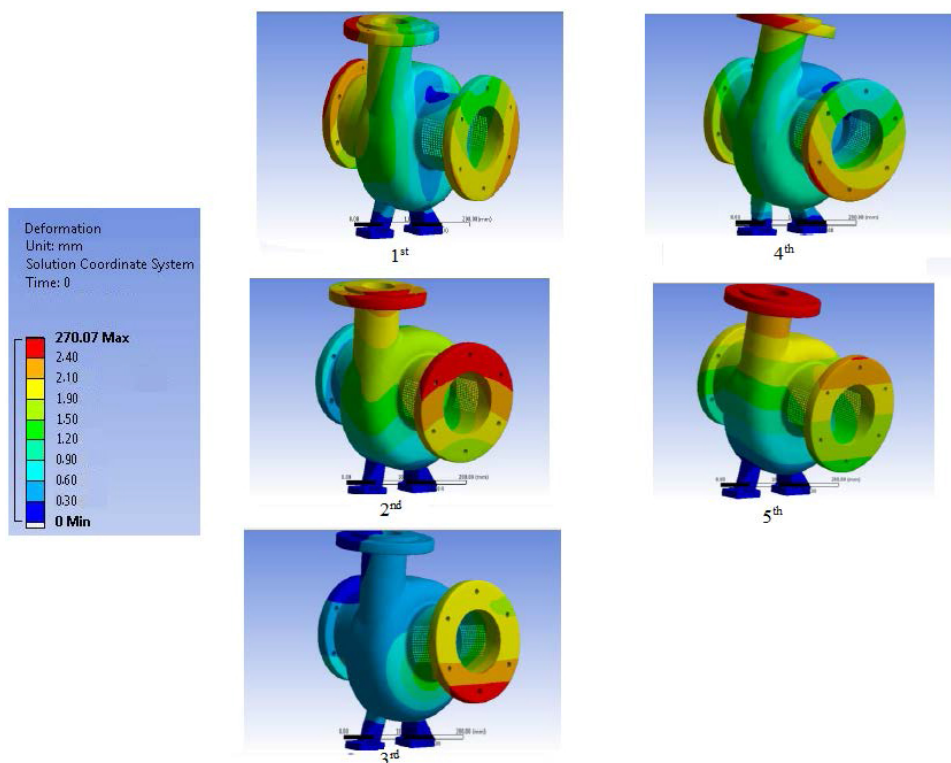
Fig. 6. The mode shapes corresponding to the natural frequencies obtained from ANSYS

Mode shapes and natural frequencies were determined following the procedure given in [17]. The finite element model of the pump was used to investigate the forced vibration response situation by solving the linear matrix equation given in [17]. The impeller rotating force vector was taken as the harmonic excitation in the system, which was represented by complex notation with a shift phase. In order to solve these equations, it is necessary to find the eigenvalue and eigenvector. Needless to say, the eigenvalue is connected to the natural frequency, while the eigenvector is related to the mode shape. From the analysis, several predicted natural frequencies for the pump system were obtained, as shown in Table 3. The corresponding mode shapes are presented in Fig. 6.

Among the several predicted natural frequencies obtained for the pump system, interestingly, one of the frequencies was almost an exact match to the measured frequency at the peak vibration amplitude (171 ± 1 Hz vs. 170 Hz) indicating mechanical resonance generation at this frequency. Therefore, it was decided to modify the characteristics of the vibrating system via fixing an expansion joint in exchange for the exiting spool piece in the discharge line.

In order to place the dynamic absorber at a convenient place for maximum energy dissipation, the structure mode shapes were investigated. Then, the system vibration was alleviated through application of an element to control the system vibration; specifically the spool piece was removed and substituted by a flexible coupling of bellows type, as shown in Fig. 7. Even though the coupling was still rigid, it was remarkably of less rigidity in bending than the spool piece it substituted. Forced harmonic response analysis of the pump system with an absorber installed revealed that the levels of vibration were reduced by a factor of 2. According to field testing, after placing the coupling in the pump system, there was a reduction in the structure's vibration by more than 2-fold at the VDF, as shown in Fig. 8. Thus, the modification of the rigidity of the system significantly led to the removal of the mechanical resonance away from the VPF leading to the generation of reasonable and acceptable levels of vibration.
