Influence of the environment aggressiveness on durability of girders made of S355 steel in Poland

Anna Śpiewak¹, Małgorzata Ulewicz¹, Josef Vičan²

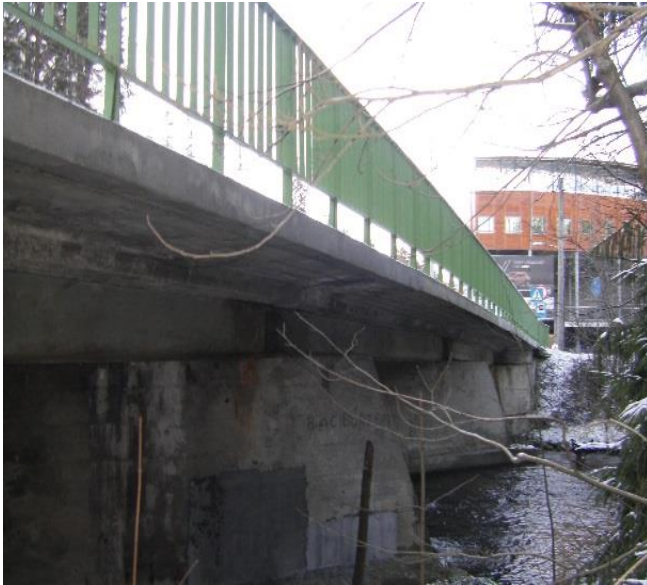
Fig 2. The analyzed bridges -stream Malinka in Wisla

For the analysis a bridge in Wisla (Fig. 1), which is part of the inter-regional road 942, and the bridge, which is part of the inter-district road 1661D in Wroclaw (Fig. 2), were chosen. The analysis was carried out based on the data from

Table 2. Data for the analyzed bridge in Wisla

BRIDGE IN WISLA – Silesian province			
Type of barrier		stream Malinka	
Road number	942	Placement	km 36+566
Durability reduction coefficient			
S_A	K_R	β	W
0.98	0.923	0.96	54
T_w	T_i	T_D	
0.98	0.90	-	
Level of shortening the time between failures of structures			S_T 0.850
Time between failures of structure due to corrosion			T_c 27

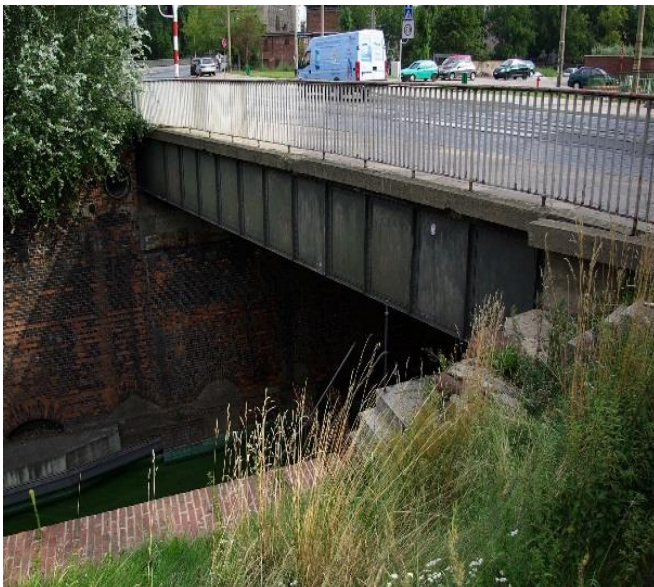
Fig 2. The analyzed bridges -lock in the city in Wrocław

Table 3. Data for the analyzed bridge in Wrocław

BRIDGE IN WROCŁAW – Lower Silesian province			
Type of barrier		lock in the city	
Road number	1661D	Placement	Sienkiewicza Street
Durability reduction coefficient			
S_A	K_R	β	W
0.98	0.891	0.99	81
T_w	T_i	T_D	
0.99	0.96	0.96	
Level of shortening the time between failures of structures			S_T 0.847
Time between failures of structure due to corrosion			T_c 3
