FLOOD PROTECTION ON THE Odra RIVER IN THE SEGMENT BETWEEN NOWA SÓL AND CIGACICE

The paper presents the flood protection on the Odra River in the segment between Nowa Sól and Cigacice, with special emphasis on the possibility of reconstructing the former flood polders in the Middle Odra Region that existed before the year 1945, including the polder in Milsko.

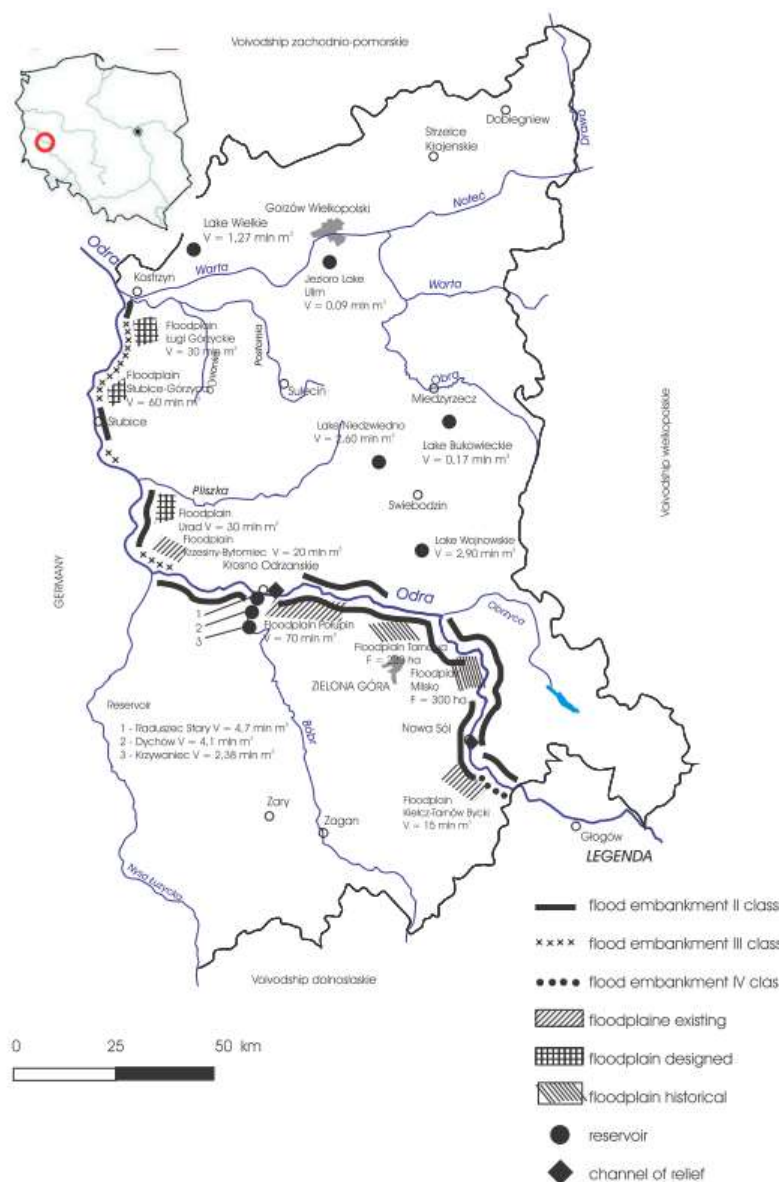
Fig. 1. Flood protection facilities in the Lubuskie Voivodship

Before the First World War, there were 12 polders on both sides of the Odra River with a total area of 12.7 thousand ha and a capacity of 104.6 million m³. At present, there are 10 polders on the Polish side of the Odra River with a total flood area of 6.4 thousand ha and a retention capacity of 75 million m³. During floods, they are flooded by inlet sluices or levee spillways [Rast, Obrdlik, Nieznański 2000]. There are three polders in the Lubuskie Voivodship (Fig. 1):

- Kielcz-Tarnów Bycki with a capacity of 15.0 million m³,
- Połupin with a capacity of 70.0 million m³,
- Krzesin-Bytomiec with a capacity of 20.0 million m³.

Połupin (4125 ha) and Krzesin-Bytomiec (1200 ha), and the following polders are planned to be constructed: Urad (30 million m³), Słubice Górzycza (60 million m³) and Ługi Górzyckie (30 million m³) - Fig.1.

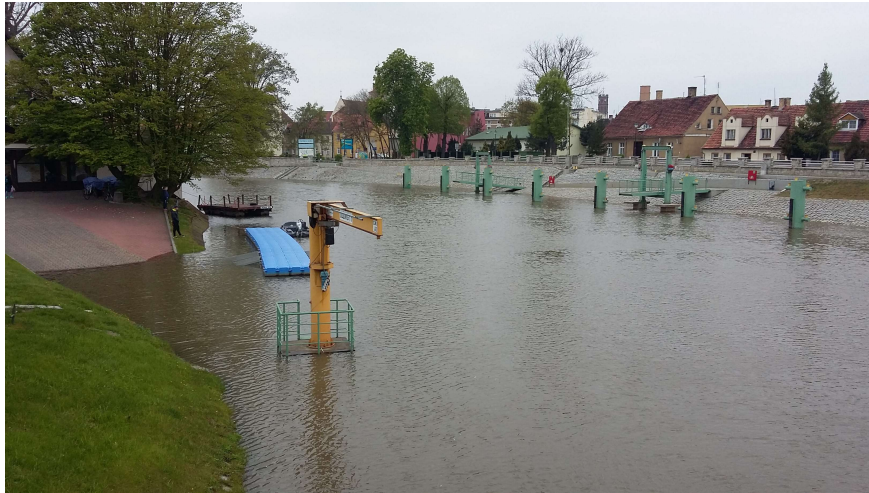
Photo. 1. The flood wall - the river port in Nowa Sól – May 2017 (Photo M. Hudak)

Another objective was to provide flood protection for the town of Nowa Sól. This was achieved by constructing a linear structure, consisting of a body of earth with a reinforced concrete wall on it in the form of a 955 m long ring levee beginning in the area of the intersection between Korzeniowski Street and Żwirko and Wigura Street at the entrance to the port basin, and ending on the high ground in the south-eastern corner of the port basin [Project 2004] - Photo 1. This protective structure contributes significantly to improving the protection of the historical part of the town with an area of about 27 hectares and protects this area against direct flooding by the Odra River, even when flow rates reach a level that can only occur once in a hundred years, i.e. with a probability of $p = 1\%$. Another measure taken to protect the town of Nowa Sól against flooding is reconstruction, extension, and demolition of the existing structures and construction of new structures in the district of Pleszówek (left bank of the valley of the Odra River and the Czarna Struga River) [<http://nowasol.pl>].

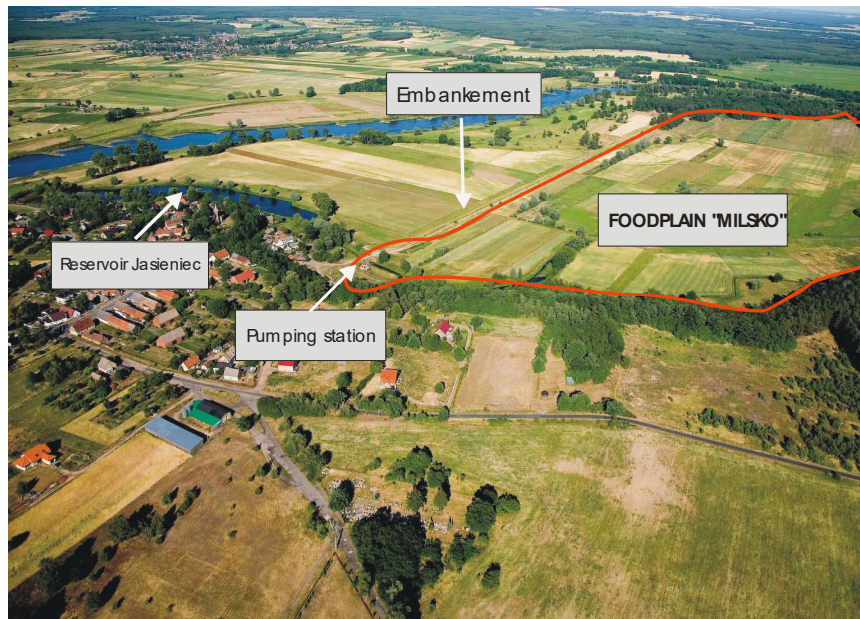
Photo. 2. Floodplain “Milsko” – April 2015 (Photo C. Karczmar)

From among the old polders, the Milsko polder is relatively easy to reactivate. The land, currently used for agriculture (Photo 2), is drained through the Jasieniec stream. At the mouth of the stream, there is a pumping station which directs the water to the canal, the Jasieniec reservoir, and then on to the Odra River. The

capacity of the existing pumping station is 0.30 m³/s (being 2 pumps with a capacity of 0.15 m³/s each) and the impact area is about 90 hectares. The Milsko polder will be a dry, controlled tank with an area of approximately 300 ha and an estimated capacity of 5 to 10 million m³. It will be reactivated according to the design specifications of the historical floodplain (Fig. 2), which was filled through a levee spillway. In order to reactivate the polder, it will be necessary to reconstruct the levee spillway, rebuild the pumping station, and clear the drainage canal.
