# Multivariate façade strengthening systems of textured layers in large slab panel buildings

This article presents the solutions of bonded anchors used to strengthen façade textured layers in the walls of three-layer large slab panel buildings in Poland. Large slab panel building systems that are found in Poland have been characterized. The use of new bonded anchors is preceded by diagnostics of the walls of three-layer large slab panel buildings. The author presents two-stage diagnostics: non-destructive methods, measurement of reinforcement parameters and its condition using a Profometer type device, and destructive methods by performing an opencast with a drilling rig. A review of previously used bonded anchorages in Poland was carried out. Proposals for the use of anchor groups in various configurations with different angles of inclination of the diagonal anchors were also presented in order to achieve the most durable effect possible.

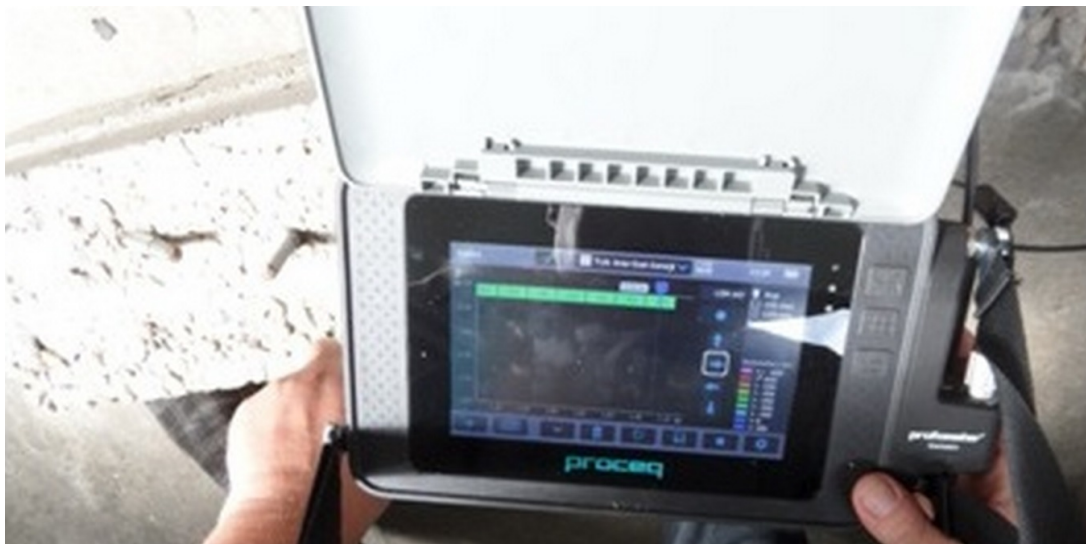
Figure 2. Preparation of the Profometer Corrosion for testing.

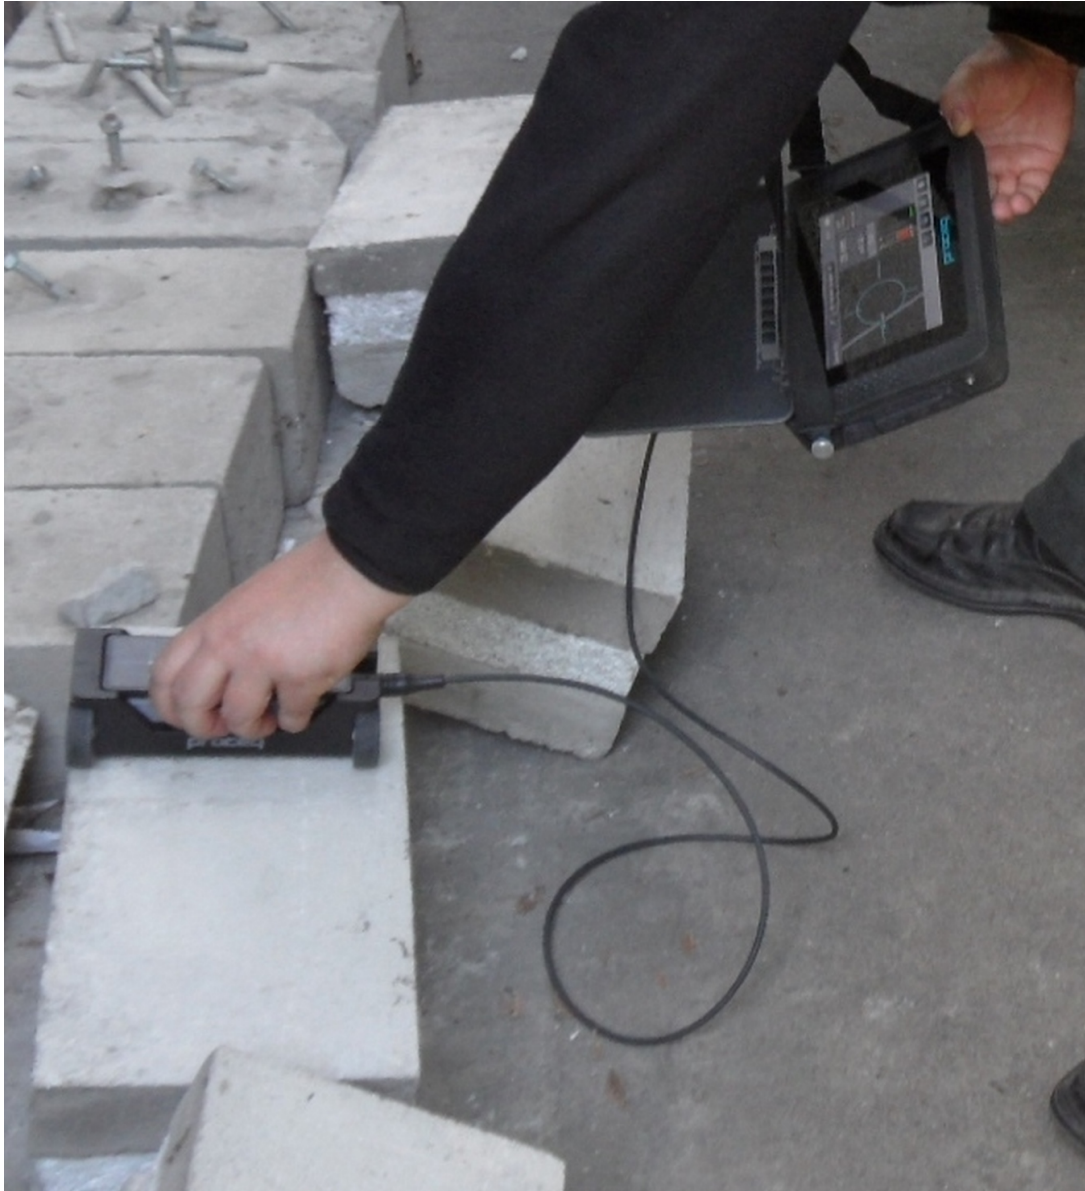
Figure 3. Preparation of the Profometer PM-650 for testing.

Typical reinforcement detectors are Profometer PM-600/PM-630 AI/PM-650 AI devices. During the pilot study, the author of the doctoral dissertation used Profometer Corrosion and Profometer PM-650 for research (Fig. 3).

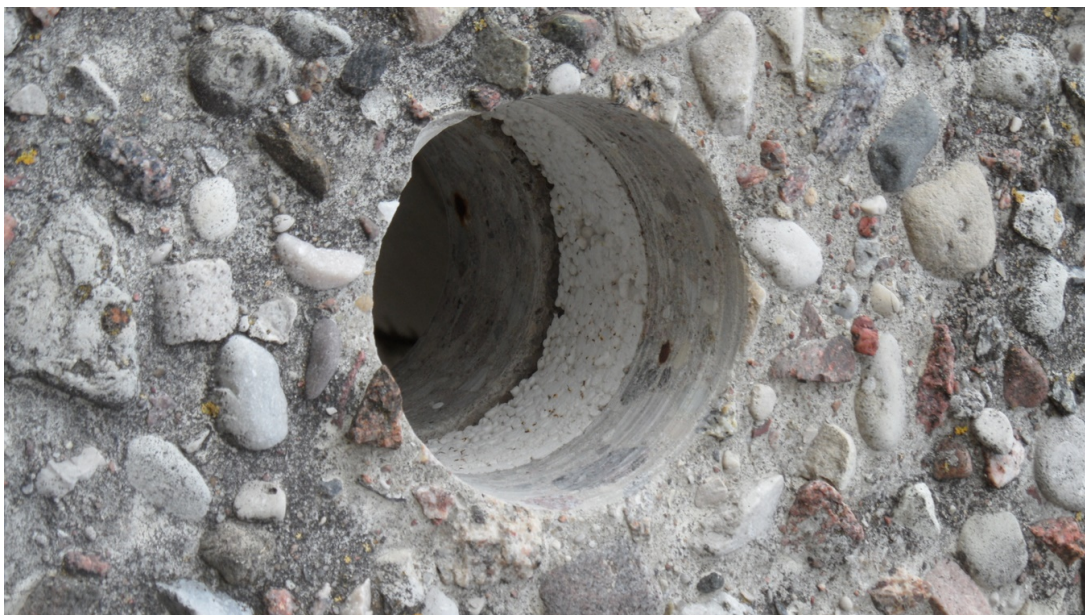
Figure 5. View of the hole made "through" using a drilling rig. [ref. own]

In the case of three-layer walls, you can also determine the actual thickness of the wall layers in a given place and check the cohesion of concrete layers with the inner layer of insulation. An example of checking the consistency of layers is shown in Figure 5.

This test was performed on a large slab panel building made in the Polish OWT-67/N system.

This object is called an empty apartment and is used to carry out various diagnostic tests. One borehole was made in the curtain wall and the gable wall. As can be seen in Figure 6, consistency of the external texture layer with the internal insulation layer has been observed at the hole locations.

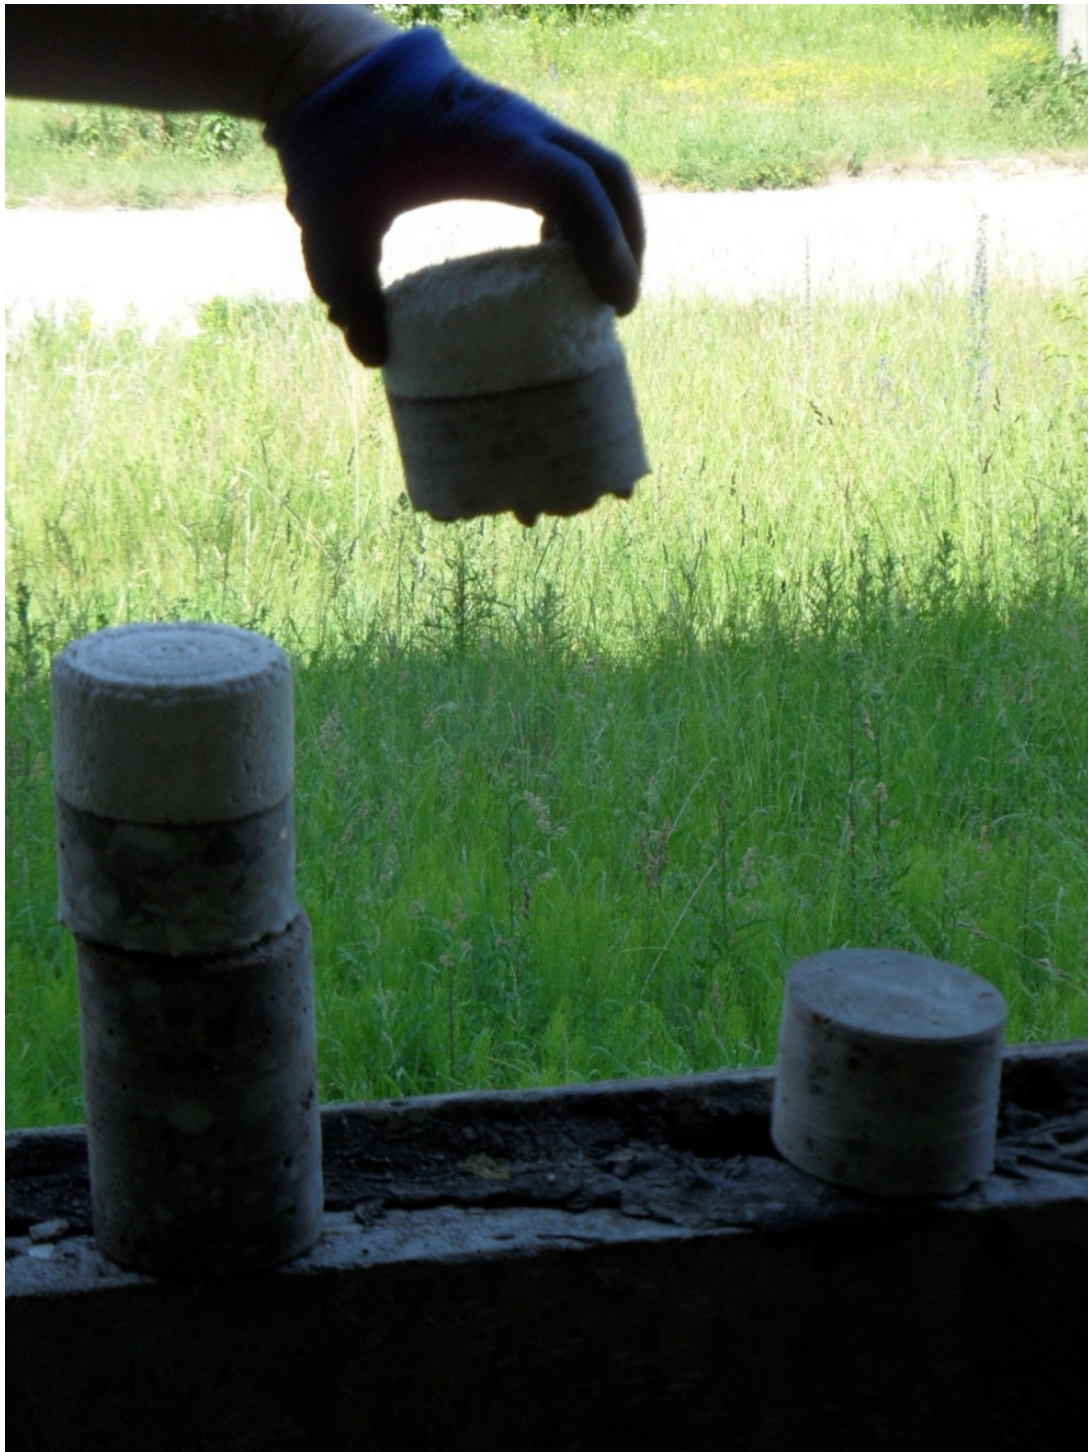
Figure 6. View of checking the cohesion of layers in the sample hole. [ref. own]

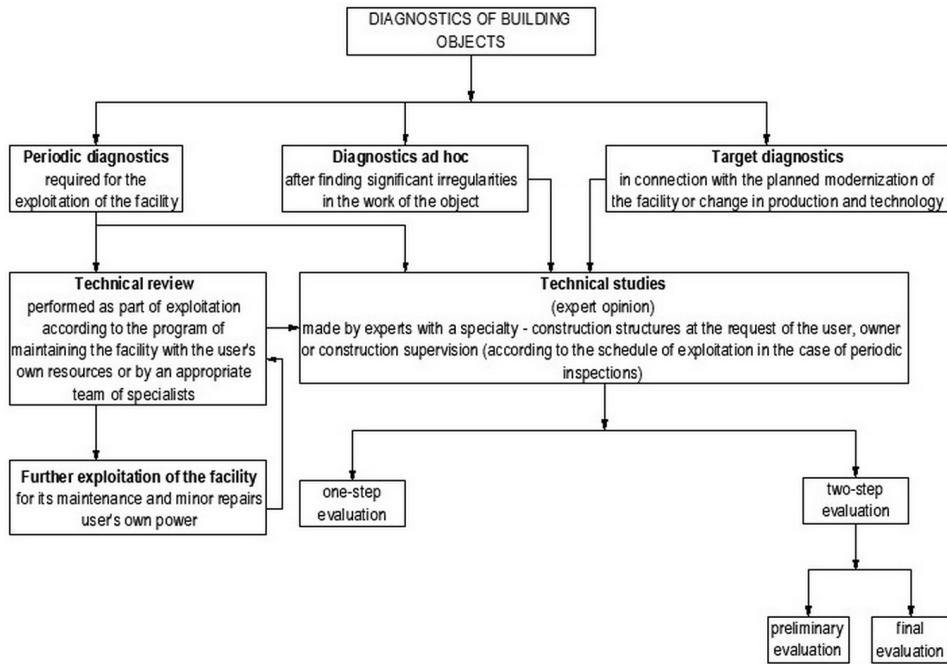
Figure 7. Diagnostic system for building objects [44].

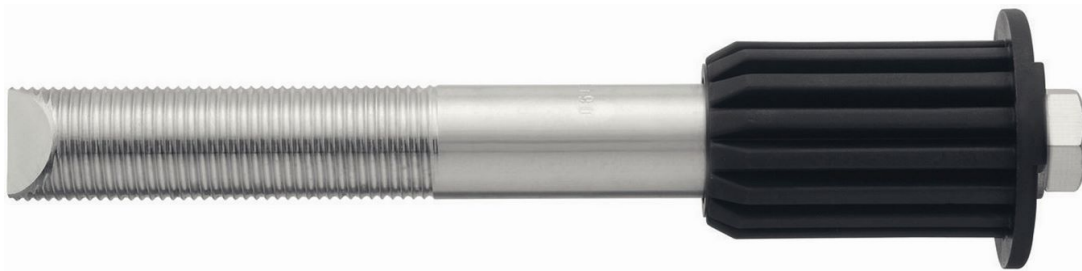
Figure 8. HWB-H bonded anchor  $\varnothing 22 \times 190$  mm for reinforcing external walls in large panel buildings (www.hilti.pl)

Some types of anchorages are only used for horizontal fixings (Fig. 8). This is the most popular solution used by most construction companies.

The HWB anchor for horizontal fastening is approved for use in all three-layer large panel slab systems such as W-70; Wk-70; OWT; WUF-T or the Szczecin System. It should be installed in concrete with a class not lower than B 15 (C 12/15) (www.hilti.pl). HWB bonded anchors have Technical Approval [4].

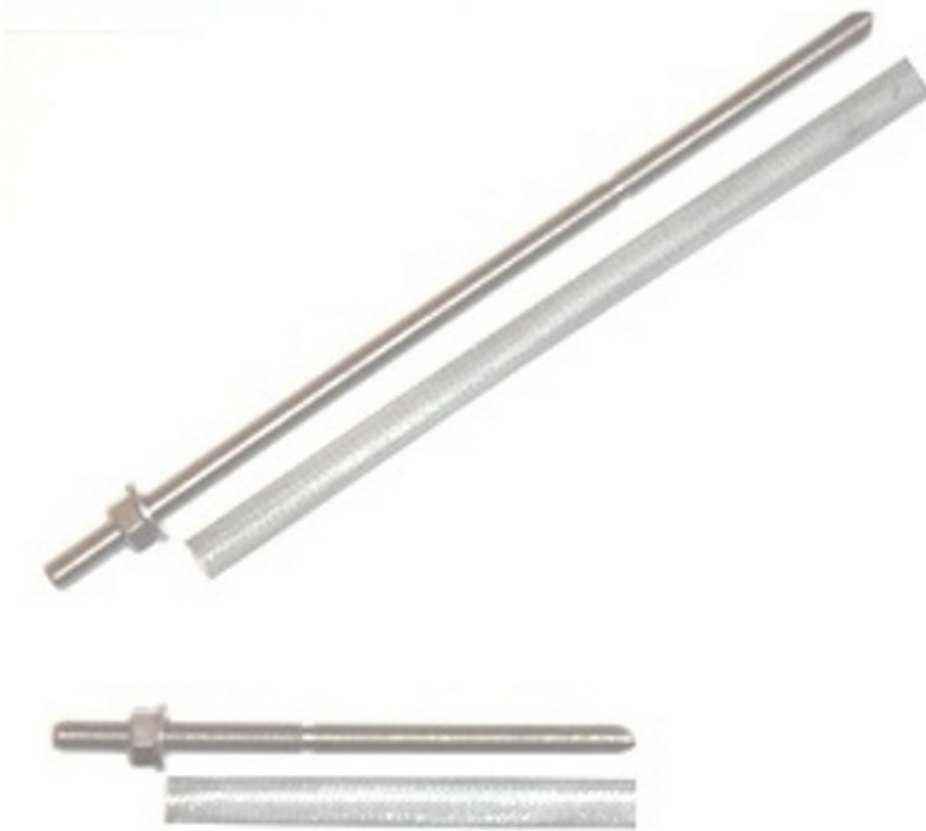
Figure 10. View of the COPY-ECO anchor system reinforcing the outer wall plates of large slab panel buildings: a) horizontal anchor M12 x 190 mm, b) oblique anchor M12 x 330 mm.

The COPY-ECO system [5] consists of two anchors: horizontal and diagonal. They reproduce the work of the hanger, and their design allows installation in walls whose construction layer is only 70 mm thick. The COPY-ECO solution can be used, among others, in buildings constructed in the systems in W-70 and OWT. The COPY-ECO large slab panel building wall reinforcement system has ITB Technical Approval AT-15-6916 / 2014. The view of COPY-ECO anchors for reinforcing balcony slabs as well as curtain and gable walls is shown in Figures 9 and 10.

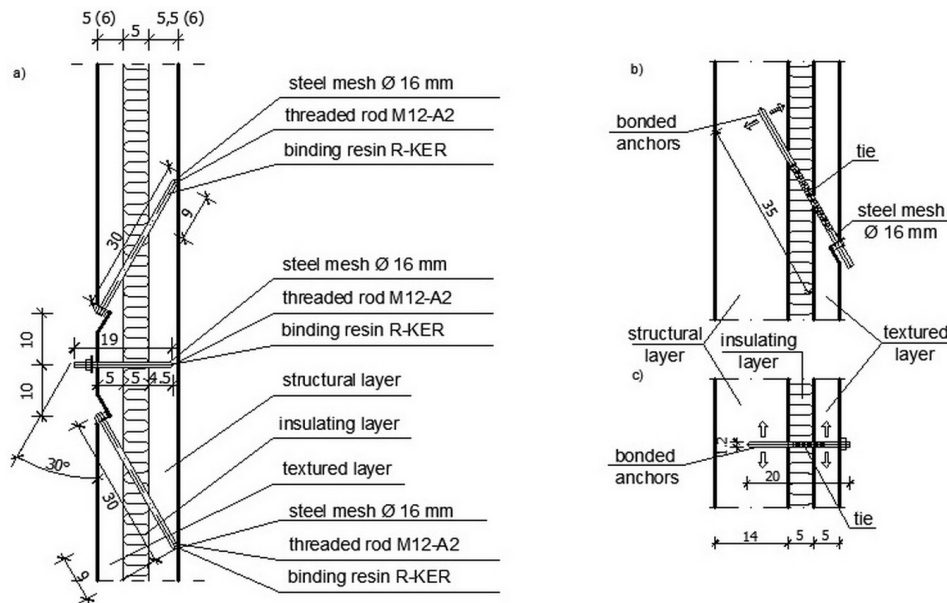
Figure 12. Wiring diagram with steel ties: a) solutions for staircase walls, b) solutions for gable wall panels.

Figure 12 presents the idea of using horizontal and diagonal anchors. The combination of both anchors creates the COPY-ECO system. The task of the diagonal tendon is to transfer tensile loads to the structural layer, derived from the own weight of the textured layer. On the other hand, the horizontal tendon can transfer the tensile loads that would occur if the textured layer detached [3, 27].

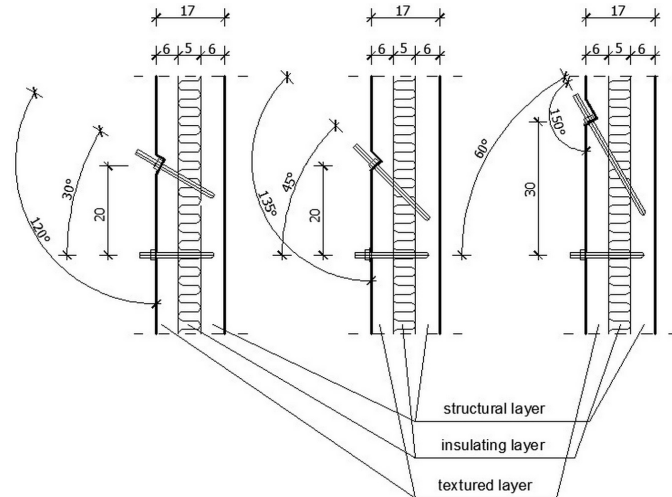
Figure 18. Alternative to two-anchor systems, inverted systems.

Alternative methods for anchoring three-layer walls is the manuscript author’s proposal in Figure 18. It is a mirror image of diagonal anchors in two-anchor systems.

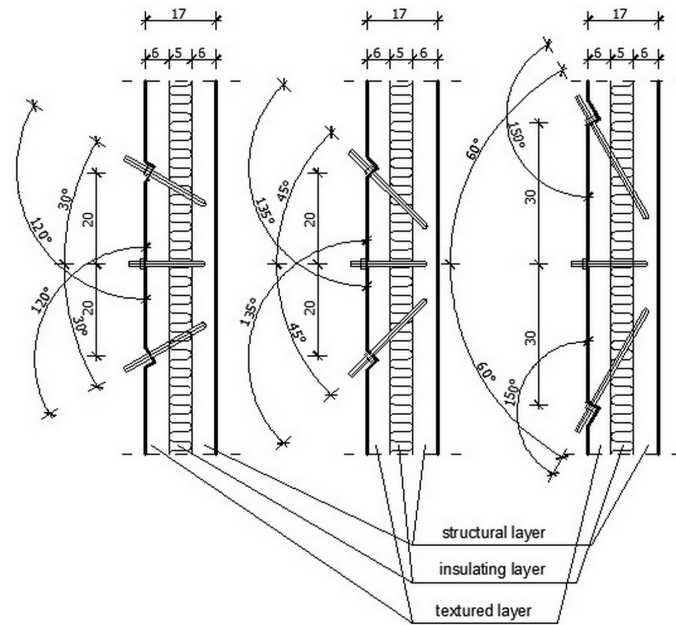
Figure 20. Alternative to three-anchor systems, inverted systems.
