FRICIONAL CHARACTERISTICS OF GEOSYNTHETIC–GEOSYNTHETIC AND GEOSYNTHETIC–SOIL INTERFACES DETERMINED BY THE INCLINED PLANE APPARATUS

DAMIAN RZEPECKI

JEAN-PIERRE GOURC

EUGENIUSZ DEMBICKI

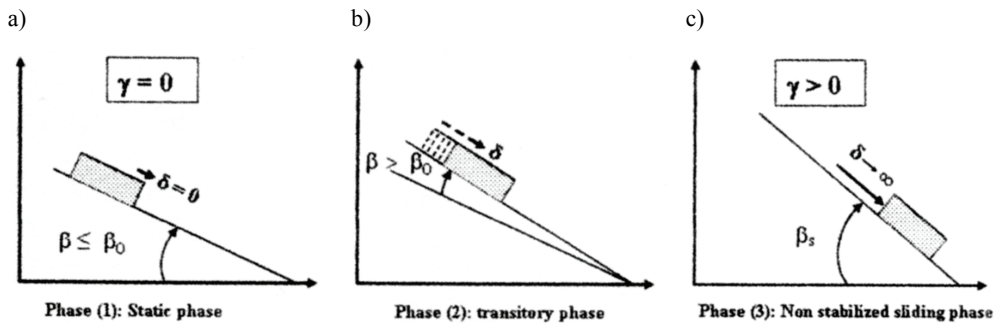
Fig. 7. Different phases of the upper plate movement, for an increasing inclination of the inclined plane; (a) Phase 1, static phase; (b) Phase 2, transitory phase; (c) Phase 3, non-stabilized sliding phase

The course of the IP test is not homogenous (Gourc, Pitanga et al. 2004), three phases with distinguished (Fig. 7).

- Phase 1 (static phase); the upper sample practically immobile ($\delta = 0$) until reaching an angle $\beta = \beta_0$;
- Phase 2 (transitory phase) for an increasing inclination ($\beta > \beta_0$), the upper sample moving gradually downwards;
- Phase 3 (non-stabilized sliding phase); the upper sample undergoes non-stabilized sliding at an increasing speed even if plane inclination is held constant ($\beta = \beta_s$).

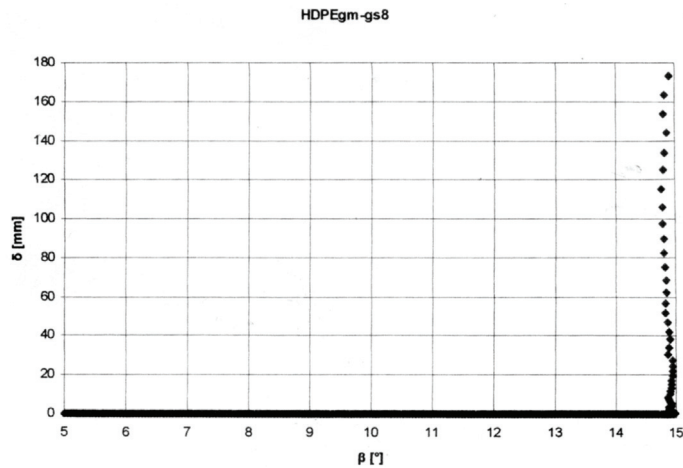
Fig. 15. HDPEgm–gs8 interface test

Test 2. HDPEgm-gs8 interface. As can be observed from the diagram in Fig. 15, changing the geospacer (gs6) for a bigger one (gs8) affects the friction angle. The course of the test remains similar to the previous one. Again, Phase 2 is practically non-existent. After reaching the inclination angle $\beta = \beta_s = 14.9^\circ$, the upper sample almost immediately begins the non-stabilized sliding.

The friction angle for HDPEgm-gs8 interface under the initial stress $\sigma'_o = 4.0$ kPa is $\phi_{gg} = 14.9^\circ$.

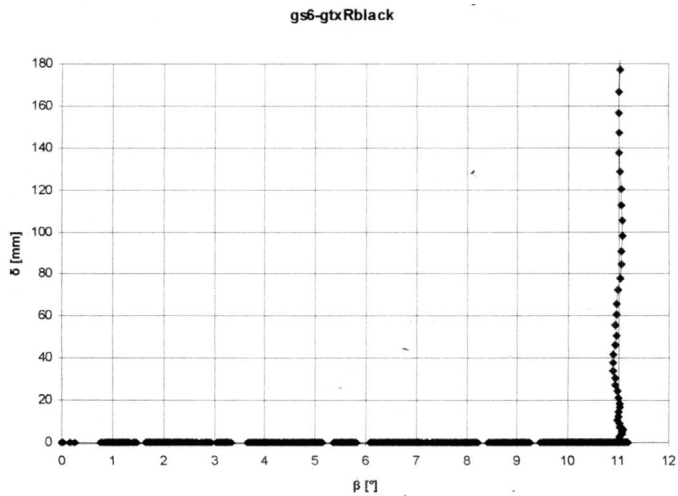
Fig. 18. gs6-gtxRblack interface test

The upper sample in this test is woven geotextile, reinforced with polyester fiber. The non-stabilized sliding begins when the inclination reaches the angle $\beta = \beta_s = 11.1^\circ$ (Fig. 18). The friction angle for gs6R block interface under the initial stress $\sigma'_o = 4.0$ kPa is $\phi_{gg} = 11.1^\circ$.

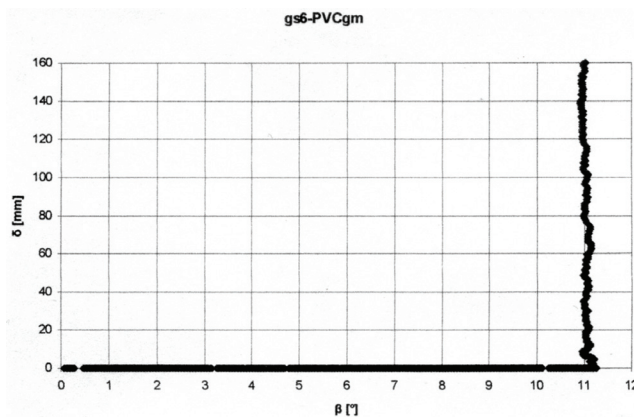
Fig. 20. gs6–PVCgm interface test

In this test, the upper sample is polyvinyl chloride geomembrane. We can see on the diagram (Fig. 20) that Phase 3 of the movement starts when the inclined plane reaches the angle $\beta = \beta_s = 11.0^\circ$. The friction angle for gs6–PVCgm interface under the initial stress $\sigma'_o = 4.0$ kPa is $\phi_{gg} = 11.0^\circ$.

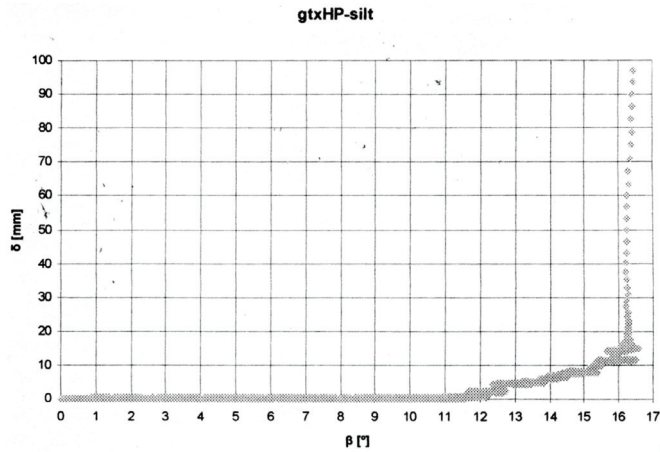
Fig. 25. gtxHP–silt interface test (2.0 kPa)

GtxHP is very similar to gtxLF. The difference lies in the addition of a reinforcing geomat. As expected, this reinforcement resulted in a large increase in the friction angle. The

movement starts at the angle $\beta = 11.7^\circ$. Phase 2 is very long in this test. When the inclination reaches the angle $\beta = 16.2^\circ$, the sample starts non-stabilized sliding. The friction angle for gtxHP–silt interface under the initial stress $\sigma'_o = 2.0$ kPa is $\phi_{gs} = 16.2^\circ$ (Fig. 25).

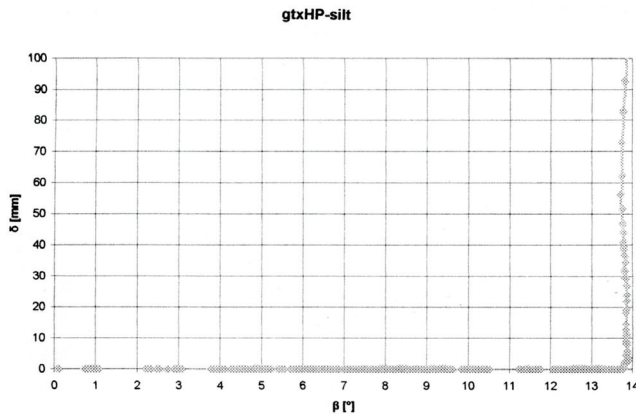
Fig. 28. gtxHP–silt interface test (2.2 kPa)

GtxHP was utilized in the fifth test. Just like in the previous test the lack of Phase 2 is visible from the diagram (Fig. 28). The non-stabilized movement begins when the inclination reaches the angle $\beta = 13.9^\circ$. The friction angle for gtxHP–silt interface under the initial stress $\sigma'_o = 2.2$ kPa is $\phi_{gs} = 13.9^\circ$.

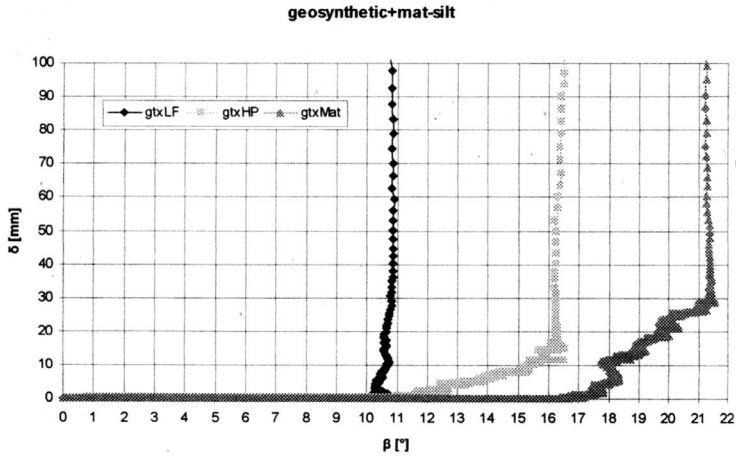
Fig. 30. Geosynthetic+mat–silt interface test (2.0 kPa)

The results of the tests on geosynthetic–silt interfaces under the initial stress $\sigma'_o = 2.0$ kPa are illustrated in the diagram in Fig. 30. As presumed the product without the reinforcement of geomat has a significantly lower friction angle than the other two. The friction angle for gtxLF–silt interface is $\phi_{gs} = 10.9^\circ$. Addition of a geomat to this geosynthetic resulted in the friction angle $\phi_{gs} = 16.2^\circ$. The last geosynthetic tested reached the friction $\phi_{gs} = 21.3^\circ$. It is safe to say that adding geomat to geosynthetic results in a significant increase in its soil-retaining properties. However, the first movement starts long before the actual friction angle, which is calculated for a 50 mm displacement. This means that what actually assures higher friction angles is the presence of a long Phase 2. The gradual sliding prolongs the time before the inevitable non-stabilized sliding.

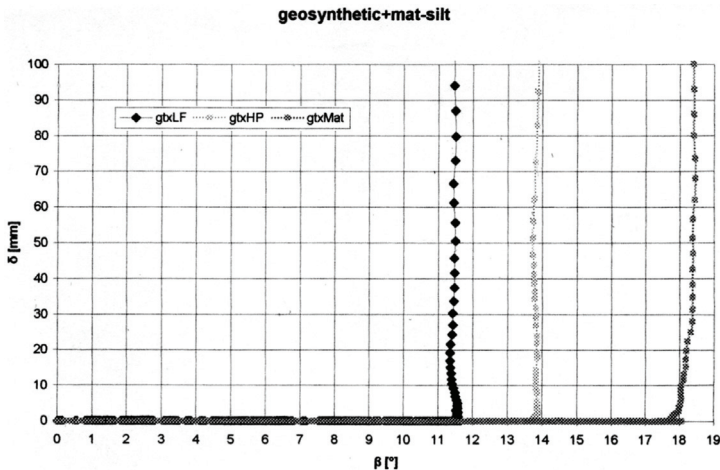
Fig. 31. Geosynthetic+mat–silt interface test (2.2 kPa)

The diagram in Fig. 31 illustrates the results of the tests on geosynthetic–silt interfaces under the initial stress $\sigma'_o = 2.2$ kPa. Previous research indicated that the friction angle decreases, with increasing normal stress applied to the interface (Gourc and Pitanga, 2007). During our tests, we observed that even a small change in the value of the normal stress (0.2 kPa increase in this case) influences the results. But the value of the friction angle is not the only thing that was affected. In the first two tests, the behaviour of the sample changes as well: Phase 2 is no more present in these tests and the non-stabilized sliding begins immediately after Phase 1.

The performance of the different geosynthetics remained adequate to the performance under the lower normal stress: $\phi_{gs} = 11.6^\circ$ for gtxLF–silt interface $\phi_{gs} = 13.9^\circ$ for gtxHP – silt interface and $\phi_{gs} = 18.4^\circ$ for the interface between silt and gtxMat. The last material tested once again seems to be most suitable for a landfill capping application.
