Historical Railway Stations on Former Prussian Eastern Railway Lines. Example of Toruń and Łława

Marta KOPERSKA-KOŚMICKA¹

Keywords: railway stations, historical sites, revival

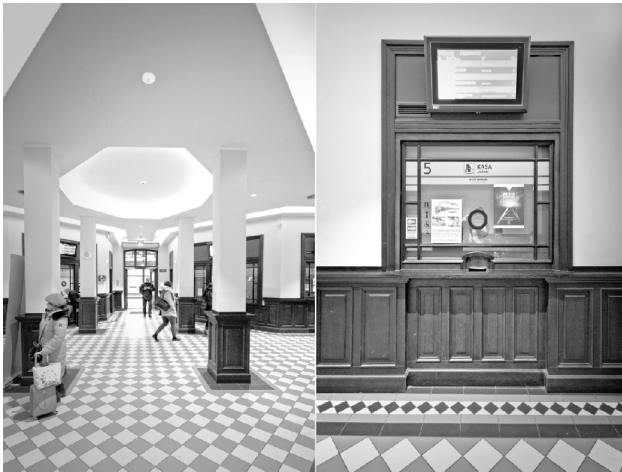
Fig. 1. Toruń Główny railway station, ground floor, interior, 2011; [photo autor]

The insular location of railway station buildings and the related arrangement of platforms are typical of large Prussian interchange stations, rare in other regions of Poland. It was similar to the railway stations in Bydgoszcz, Chojnice, Kamień Żąbkowicki, Kłodzko, Krzyż, Leszno, Piła and Poznań. The first half-timbered railway station building was soon, as early as in 1874, replaced with a new brick-structure unit. At the outset of the 20th century, in 1903, it was thoroughly modernized, the result was a spacious arrangement with a corridor along a longitudinal axis, in the center of which was an octagonal two-story room with a skylight. Unfortunately, the location of this plan is now vague on the ground floor (Fig. 1) only walls in the cellar are left. Due to numerous alterations, the nature of the front side changed as well – initially it was not a single space but divided into a series of custom handling rooms. The opposite side of the building accommodated waiting rooms for passengers of 1–4 class, as well as a restaurant. Smooth and quick communication between platforms was possible thanks to crosswise corridors. During World War II, the railway station was burnt. It was reconstructed to restore the pre-war arrangement in 1949, while in the 1960s it was modernized, but with serious mistakes – the facade was painted with emulsion paints, the joinery was replaced and large parts of the decorations were destroyed.

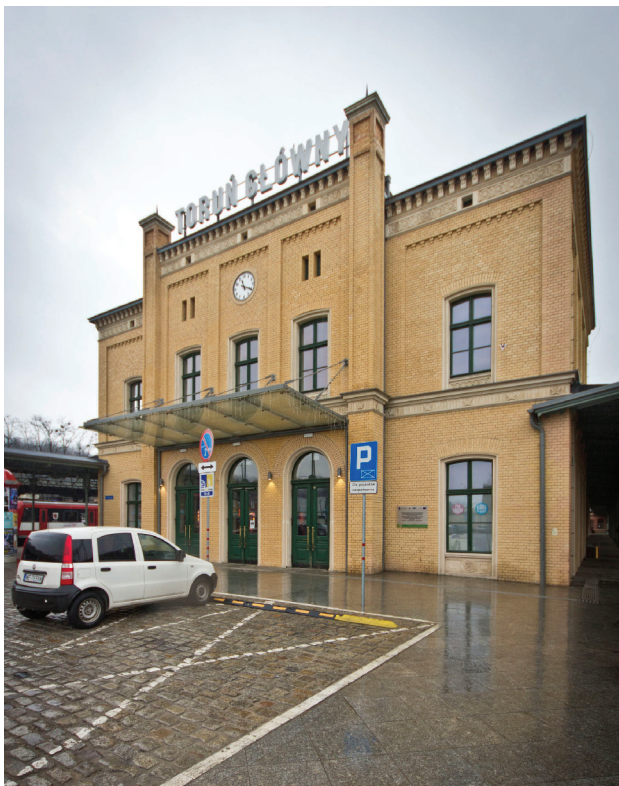
Fig. 2. Toruń Główny railway station after revival, 2019 [photo autor]

The railway station complex is composed of three uniform buildings – the former post office building (administration), a public toilet building combined with the former telegraph building, as well as the main railway station building (Fig. 2). The element that integrated them all is the facade materials – a face brick combined with a concrete and ceramic detail of decorative friezes, window trims and cornices (Fig. 3).

The facade composition demonstrates the strong impact of Mannerism, which was fashionable at that time. The main railway station building intended to serve passengers consists of a two-floor mass which was extended to include a two-level wing from the front. The triaxial main entrance was emphasized on the face of the wall with a small projection. The entire element is decorated with horizontal cornices around

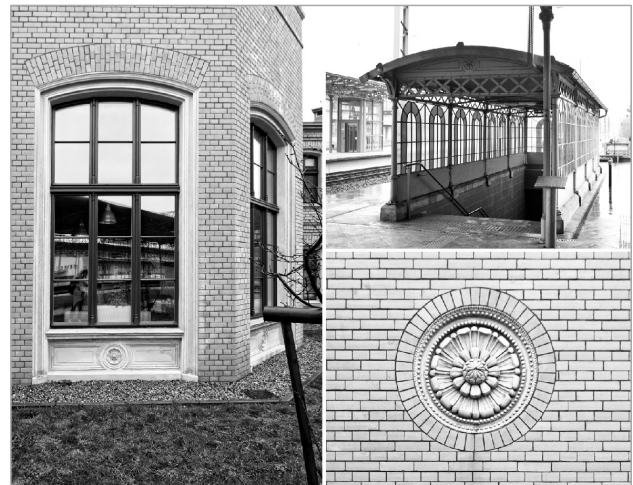
Fig. 3. Toruń Główny, exterior details, 2011; [photo autor]

Restoration works started from drying walls and reinforcing the structure, as well as eliminating the causes of wall dampness: rainwater was carried away properly and the facade was cleansed from dirt and paint which accumulated excess damp. The aforesaid removal was a serious challenge as there was no effective method of exposing brick surfaces safely and without secondary damage. In this case, a combined solution was adopted: chemical – with the use of specialist pastes, and mechanical – blasting method (so-called erasing). Unused elements (industrial systems, advertisements, secondary grates, sheds and roofing) were dismantled, while ceramic details were demolished. To prevent dampness

coming from the ground, vertical and horizontal water insulation was installed. Next, the missing elements of the facade face and architectural details were filled, and brick surfaces were blended in terms of colors with the use of glazing coatings based on semi-transparent paints using natural minerals.

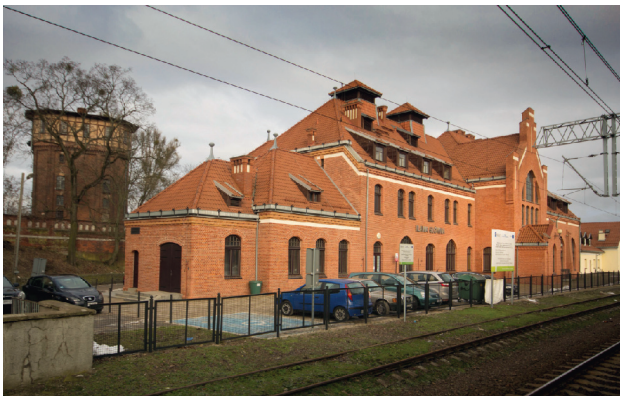
Fig. 5. Iława Główna railway station, 2019 [photo autor]

Iława played a crucial role in the railway link system when the Malbork-Mława railway was commissioned (1876-77) to cross the Toruń-Wystruć railway track. The first railway station located in the north-eastern part of the city was opened on 1 July 1872 along with the line to Toruń. The current shape of the building is related to the reconstruction of the station complex in 1905, which was required due to the growth in passenger and freight carriages at the outset of the 20th century and the location of barracks for the artillery unit. By 1916, there were two large barracks in Iława, where nearly three thousand soldiers served. The little old building was demolished and a new railway station took over its function (Fig. 5). This concept is attributed to Paul Thoemer, an architect from the Ministry of Public Roads in Berlin, who designed similar buildings in Grudziądz and Kwidzyn, as well as large railway buildings in Gdańsk and Opole [11].

The set of developments of the station in Iława consisted of the following: a railway station building, water towers located nearby, locomotive bay, post office, free-standing toilet as well as residential and storage buildings. The railway station was designed in a neo-Gothic style, on an elongated rectangle, with a considerably developed shape with a steep gable roof. The facade was finished with a face brick with plastered cornice details and gable decorations. The monolith of the main shape was dissected by a central projection, as it accommodated an imposing main hall which divided the facility into two sections: north – intended for passengers (with a spacious waiting room and restaurant) and south – intended for the ticket office hall and railway service rooms (Fig. 6).

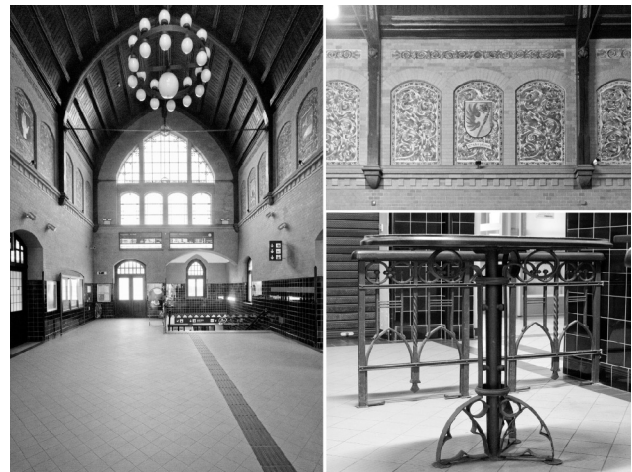
Fig. 6. Iława Główna, main hall details, 201; [photo autor]

The beautiful spacious railway hall is the central point. On both sides it is enclosed with the tops of stairs in which a group of ogival windows decorated

with stained glass were embedded. At the top, from the side of the city, there is an emblem of Iława presenting the Mother of God with the Baby in her hands, sitting on the throne in the center of the city gate. A 12-m high space is enclosed with an exposed hanging roof construction supported on corbels. The fields between beams were decorated with alcoves decorated with polychromes in the form of plant twigs in which city emblems related to the Królewsko-Pruska Eastern Railway were integrated. Eight central fields were decorated with the emblem shields of Brodnica, Działdowo, Gdańsk, Kowalewo, Malbork, Prabuty, Toruń and Wąbrzeźno, designed by a famous German heraldist – Otto Hupp. Painted friezes go around the waiting room and ticket offices (plant motifs) and former restaurant (geometrical forms).

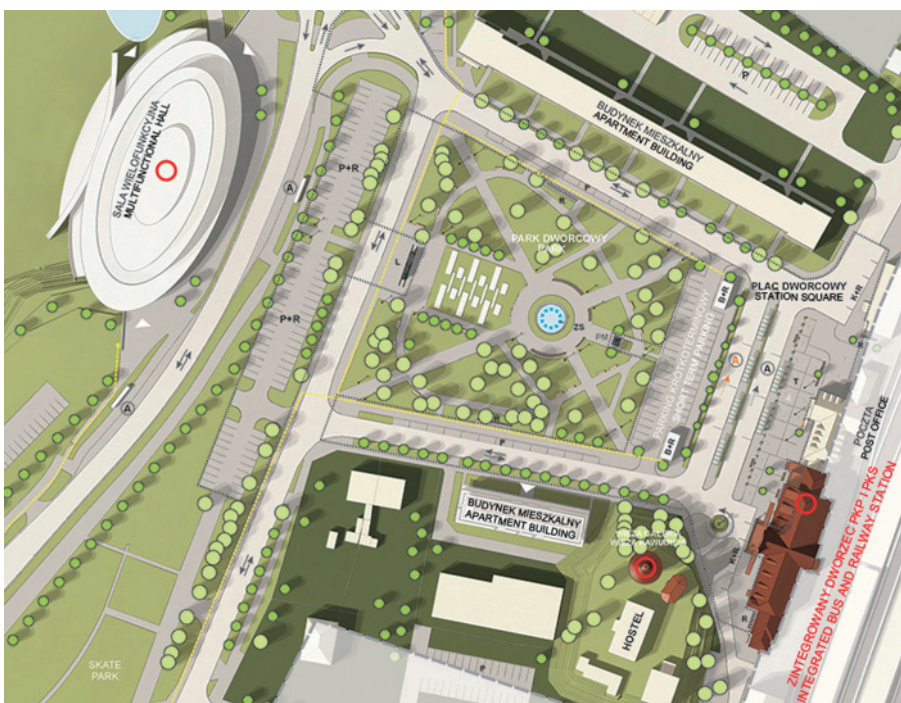
Fig. 7. Iława Główna, transportation hub design, competition project; Spatial Planning KONTRA, [see:] http://www.a-ronet.pl/index.php?mod=nagroda&n_id=4406

On 14 November 2017, the Marshal's Office in Olsztyn provided Iława with funds for the task: "Creation of the transportation hub in the south of the city – public space management by the PKP railway station" (Fig. 7). It will be fulfilled on the basis of a competition project (commencement of works in 2019) which assumed the clear connection of the railway station complex with a modernized road system, as well as introduction of the following in the immediate vicinity of the railway station (from the front side): public transport stops and long-distance bus stops as well as short- and long-term car parks and bicycle in-

frastructure (roofed sheds and bicycle parks) [19]. It is necessary to note that a holistic approach to public transport, combining various means of transport in one place and improving moving conditions without the use of private cars, is likely to result in the successful revival of railway sites.
