Detectability of Defect and its Beginning on the Formed Cast-iron Cast

The article describes the detection of a defect in a cast iron casting. It analyzes the cause of the crack in the Turbine Component casting. In this article, we are focusing on a particular turbine casting that is commonly used in automobiles as one of the components for turbochargers. The turbine is a casting made of ductile cast iron with a visible crack on the naked eye. The formation of cracks in castings is a common but undesirable phenomenon in the foundry practice. It is important to identify the errors, but also to know the cause of defects in castings. The solution is a detailed error analysis. In this paper I used metallographic analysis and magnetic powder method. The crack formation is due to tension in the casting, which results in tensile, shear, or shear forces. The crack formation kinetics is difficult because it is still very low during hardening and shortly after the casting is overloaded. The crack is most often due to core resistance or shrinkage molds that begin after the surface layer is tightened when the strength of the material is negligible to the end of the crystallisation.

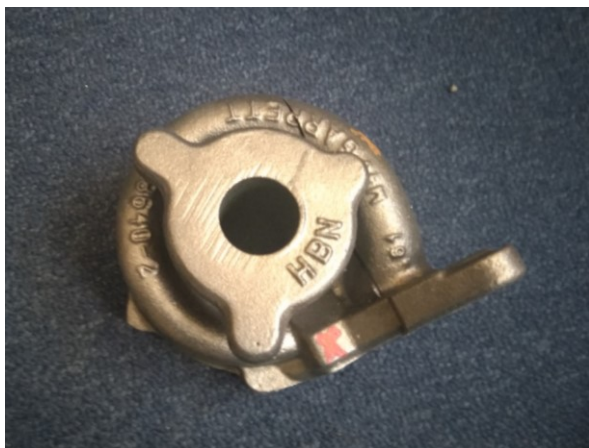
Fig. 1. The turbine HBN

In this article, we are focusing on a turbine (fig. 1) casting that is commonly used in automobiles as one of the components for turbochargers. The turbine is a casting made of ductile cast iron with a visible crack on the naked eye.
