Problems of Practical Diagnostics of Induction Machines in Industry

Summary: There are many problems in practical diagnostics of high-power, squirrel-cage induction machines, operated in industrial conditions. These problems make the diagnostics a difficult matter. The problems appear already at the stage of gathering diagnostic signals. The only practically accessible signals are the currents on secondary sides of current transformers monitoring supply currents of separate machines. Due to the proximity of other conductors, carrying high currents, these signals are sometimes accompanied by heavy background noise. The next stage of the diagnostic procedure is off-line analysis of registered signals referring to investigated objects. The main problem at this stage is proper interpretation of gotten results, especially in the cases where determination of the cage state, of investigated machines, is difficult due to ambiguity of diagnostic signals. The ambiguities and doubts by taking diagnostic decision result from that the diagnostic-like signal could be generated not only by cage damage but also by slightly asymmetrically manufactured rotor cage. In such difficult cases, the many-

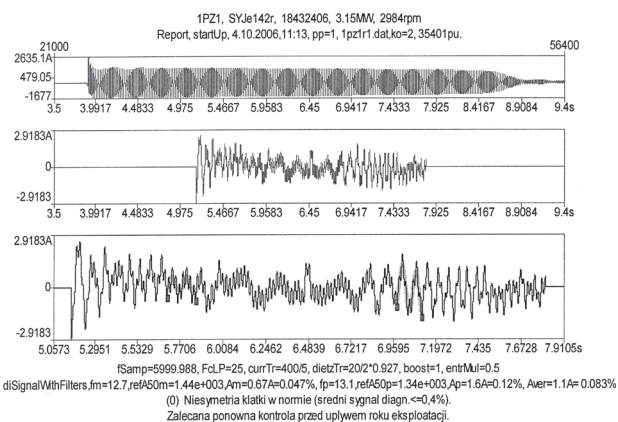
Fig. 1. Diagnostic report for induction motor without damages – start-up

Two diagnostic reports for two similar induction machines have been presented in Figures 1 and 2. Figure 1 refers to diagnosis based on start up current, whereas figure 2 to the one based on steady state current. The only restriction for the usability of the start up current for diagnostic purposes is its length of minimum half a second. That is due to the fact that right after switching on the diagnostic signal is corrupted by transient current components. It follows from the experience that the start up time higher than half a second secures damping of these corrupting components. Though, in some critical cases, only the second half of the diagnostic signal is valuable, that is the half referring to the rotor speed higher

than 50% of the synchronous speed. In Figure 1 the start up time of about six seconds fulfills in excess this requirement. It follows from the Figure 1 that the level of diagnostic signal reaches 0.083%. It is well below 0.5%, being the threshold for damaged/non-damaged cage. This threshold was established through experience gathered from numerous diagnoses of both the real industrial machines and laboratory experiments on machines with purposefully cut-through cage bars.

Summing up, the magnitude of the diagnostic signal at a startup is 0.083% and at steady-state 0.2%. As these magnitudes are smaller than 0.5% the machines are diagnosed as not damaged.

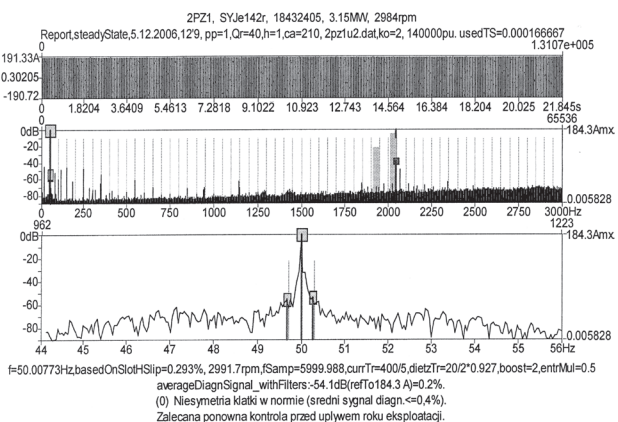
Fig. 2. Diagnostic report for induction motor without damages – steady state

The condition for the diagnostic value of the steady state currents is that they refer to the loaded machine, minimum 50% of the rated power. This secures sufficiently high currents flowing though the cage elements. Broken bars do not allow the currents to flow, to their full extents, through the damaged bars. This provokes air gap flux disturbances, as compared to the healthy case, resulting finally in diagnostic components in stator currents. Too small loading would provoke too small rotor currents and hence too small flux disturbance to induce discernible diagnostic signals in stator currents. However, there is one more, not less important, reason for the requirement of minimum 50% load. The diagnostic components in normal steady state are close to the 50Hz fundamental component. The smaller the slip the closer these components are to the fundamental or 50Hz component. Of course, the vicinity of the 50Hz fundamental component corrupts the diagnostic components, resulting in overestimation their amplitudes. Only big enough slip, following big enough loading, secures big enough separation of diagnostic components from the 50Hz component, thus preventing false assessment of their amplitudes. Hereby, it should be remembered that the bigger the machine the smaller the rated slip. In consequence, the just mentioned problem of identification of the amplitudes of the diagnostic components becomes extremely serious in case of big machines. And, in practice, exclusively the big machines are commissioned for diagnostics. In figure 2 the slip of 0.293% secured big enough distance of diagnostic components from the 50Hz one. The diagnostic signal amplitude of 0.2% falls well below the 0.5% threshold. Hence, the diagnostic verdict is that the rotor cage remains healthy.

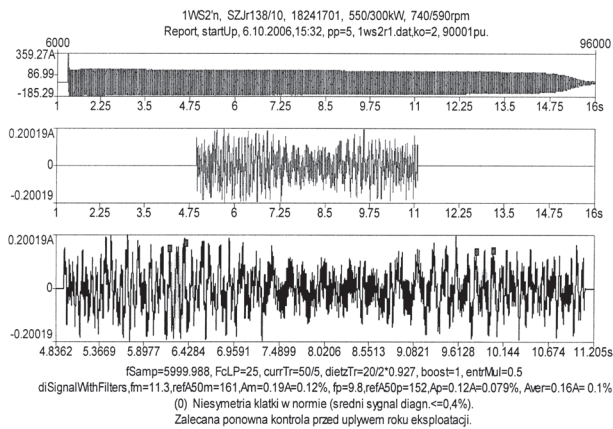
Fig. 3. Diagnostic report for induction motor with damage symptoms – start-up

The reports presented in Figures 3 and 4 refer to one and the same machine. Figure 3 refers to the current registered on October 6th, 2006 and figure 4 on October 4th, 2006. As the dates of start up and steady state measurements are close to each other, it could be assumed that the cage state did not change. However, the amplitude of the diagnostic signal in Figure 3 amounts to 0.1% whereas that in figure 4 to 0.51%. The explanation for this discrepancy is that the results in Figures 3 and 4 refer to different regimes of operation. In Figure 3 the frequencies at which the amplitudes of the diagnostic component were identified were 11.3Hz and 9.8Hz. The frequency of the rotor currents, when these frequencies were identified, was around 25 Hz. Current distribution over separate cage bars depends on both the bar resistance and bar leakage reactance. Damaged cage bar only effects increase of bar resistance, and not bar reactance. The higher

the rotor currents' frequency the higher the bar's reactance, and hence the lower the effect of increased bar's resistance on the result bar's impedance. In consequence, the disturbance in current distribution, followed by the disturbance in air gap flux, is small. Thus, small is also the diagnostic signal in Figure 3. To the contrary, by full speed the frequency of the rotor currents is very low. Low in then also the bar's reactance. In consequence, the bar's impedance is determined practically by bar's resistance. Hence, the disturbance in bar resistances carries to comparatively high disturbances of the air gap flux and thus to higher diagnostic signal. This explains the elevated (up to 0.51%) magnitude of the diagnostic signal in steady state. All this reasoning is valid only if the cage bar is not totally broken. Thus the ultimate diagnosis, resulting jointly from the Figure 3 and 4 is that the cage damage still remains in the incipient stage. It is expressed in diagnostic report as "symptoms of damaged cage".

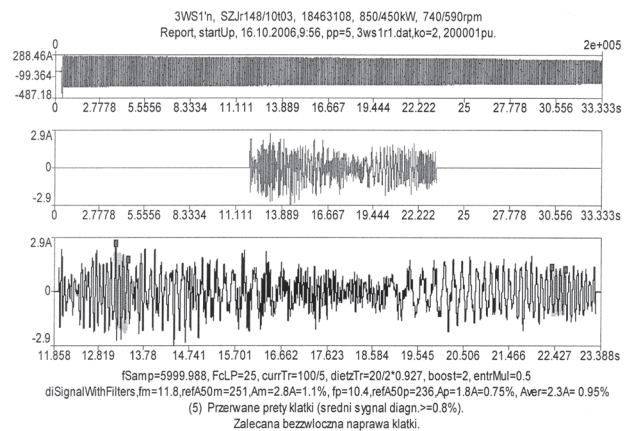
Fig. 5. Diagnostic report for induction motor with stable cage asymmetry – start-up

Figures 5 and 6 refer to one and the same machine. The amplitude of the diagnostic signal in Figure 5 amounts to 0.95%, thus well trespassing the half percent threshold for the

cage to be diagnosed as damaged. The amplitude of the steady state signal in Figure 6, amounting to 0.5%, also confirms cage asymmetry. However, the diagnostic measurements performed in three previous years delivered practically exactly the same values. This allows to conclude that the cage asymmetry, though not rising any doubts, is stable and does not show up the tendency to magnify. One of the possible explanations for elevated, though stable, asymmetry could be that the end rings are of bended slabs of copper, welded together. The welding seam would surely introduce some magnified resistance of one end ring segment, resulting in overall cage asymmetry. The ultimate diagnosis, accounting also for three years old history, was that the cage, though asymmetric, was healthy.

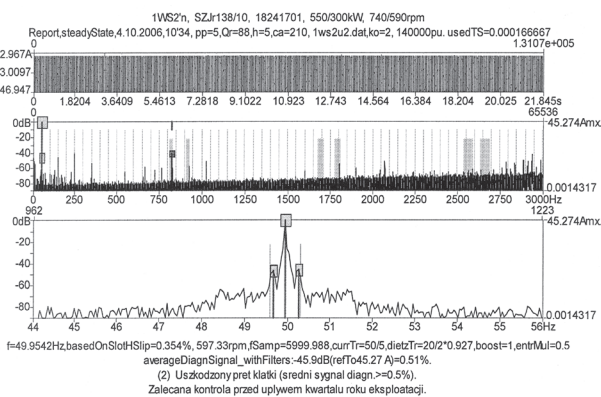
Fig. 4. Diagnostic report for induction motor with damage symptoms – steady state

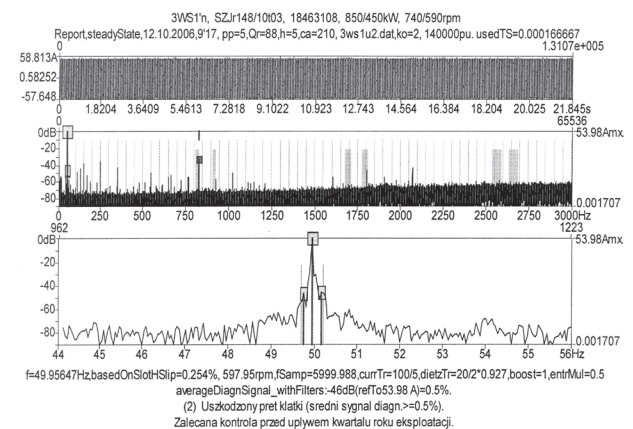
Fig. 6. Diagnostic report for induction motor with stable cage asymmetry – steady state

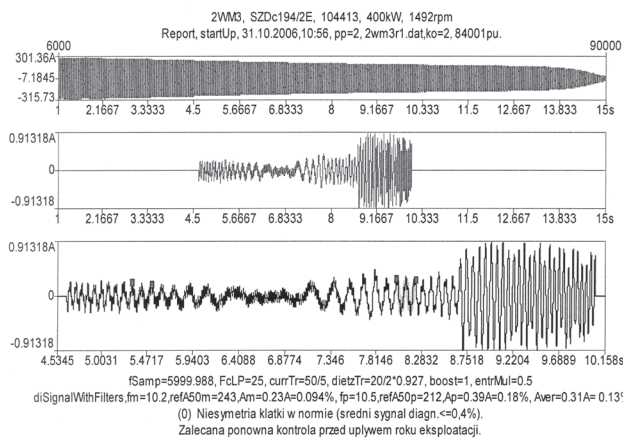
Fig. 7. Diagnostic report for induction motor with interrupted bar after certain heating – start-up

Figure 7 presents the diagnostic signal during starting up. The peculiarity of this signal lies in that after about 8 seconds from switching on, its amplitude magnifies in a step wise manner. The waveform shown in Figure 7 refers to measurements performed on October 31, 2006. Exactly the same signal envelope behavior was registered one year earlier. This seems to justify the supposition that after heavy heating of the cage, resulting from heat development during 8 seconds of start up, one of the cage bars loses its contact with one of the end rings. However, in steady state, that is when the cage cools down again to normal operating

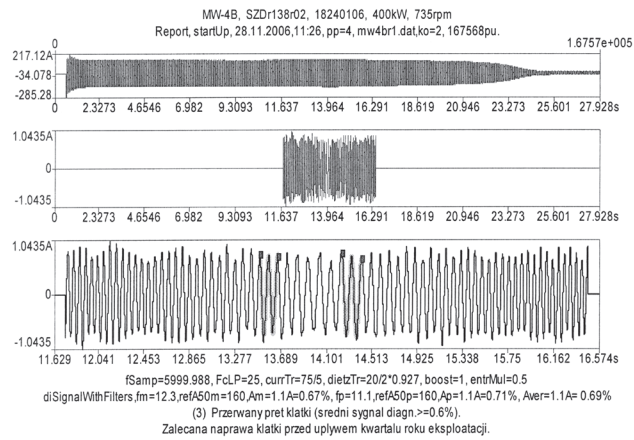
Fig. 9. Diagnostic report for induction motor with non-diagnostic signal – start-up

Figure 9 contains the waveform of the diagnostic-like signal. When the speed approaches half of the synchronous one, the frequency of the signal diminishes. Then, above half of the synchronous speed, the frequency of the signal magnifies. These are features characteristic for diagnostic signal. However, for the signal to be recognized as diagnostic one, its amplitude by half of the synchronous speed had to fell down to zero. This is but not the case in Figure 9. Hence the only conclusion must be that this is not the diagnostic signal. The explanation of the nature and origin of this signal still remains unknown. The level of the diagnostic signal in figure 10 is 0.28%, confirming that the cage is healthy.

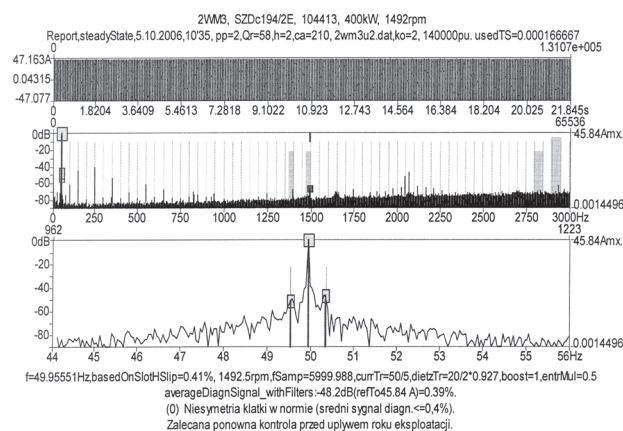
Fig. 8. Diagnostic report for induction motor with interrupted bar after certain heating – steady state

temperature of the cage, the bar regains its contact with the end ring, as the amplitude of the diagnostic signal in figure 8 amounts to 0.39%, that is, it does not trespasses the half percent threshold.

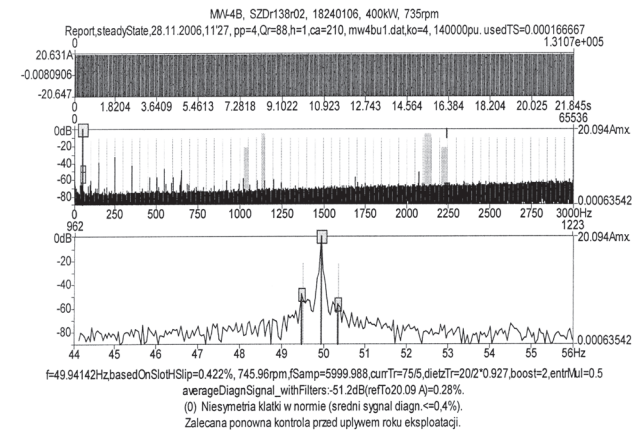
Fig. 10. Diagnostic report for induction motor with non-diagnostic signal – steady state

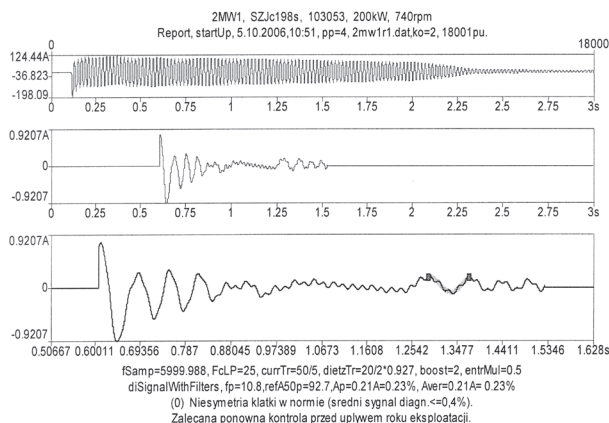
Fig. 11. Diagnostic report for induction motor with high background signal of measurements – start-up

Figures 11 and 12 refer to one and the same machine. Figure 11 refers to start up current. The start up time is rather short. The first half of the start up time is useless for the diagnostic purposes as the diagnostic signal is corrupted by the transient current components. But the second half of the start up current delivers clear diagnostic signal, amounting 0.23%. Thus, the cage is diagnosed as healthy.

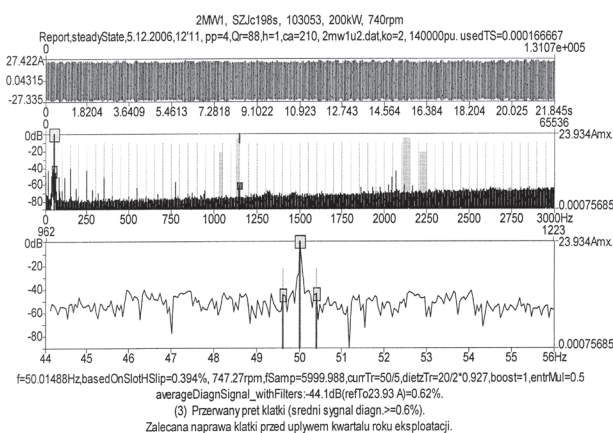
Fig. 12. Diagnostic report for induction motor with high background signal of measurements – steady state

Figure 12 shows the spectrum referring to the steady state current. It contains heavy background, hardly allowing for sturdy identification of diagnostic components. In fact, the placements of these components was identified on the basis of current signal after notch-filter suppression of the 50Hz component. This technique of current registration, to be presented in a separate paper, proved to be priceless in cases like the one of Figure 12. The reason for heavy background is that the machine in Figure 12 drives the coal mill, accompanied by stochastic loading torque.
