IN-DEPTH INVESTIGATION ON SCENE OF AN ACCIDENT – PILOT STUDY OF DaCoTA (ROAD SAFETY DATA, COLLECTION TRANSFER AND ANALYSIS) PROJECT

Summary. The article presents the procedure of in-depth investigation on-site of an accident data collection developed within the project DaCoTA (7th EU Framework Programme). Motor Transport Institute (MTI) participated in a pilot study to test practical usage of proposed methodology. The paper presents procedure, scope of collected data, analysis and the results of research carried out in Poland. After the end of DaCoTA, MTI continues in-depth data collection & analysis of Two Powered Wheel's accidents (with motorcyclists) as EU project named SaferWheels.

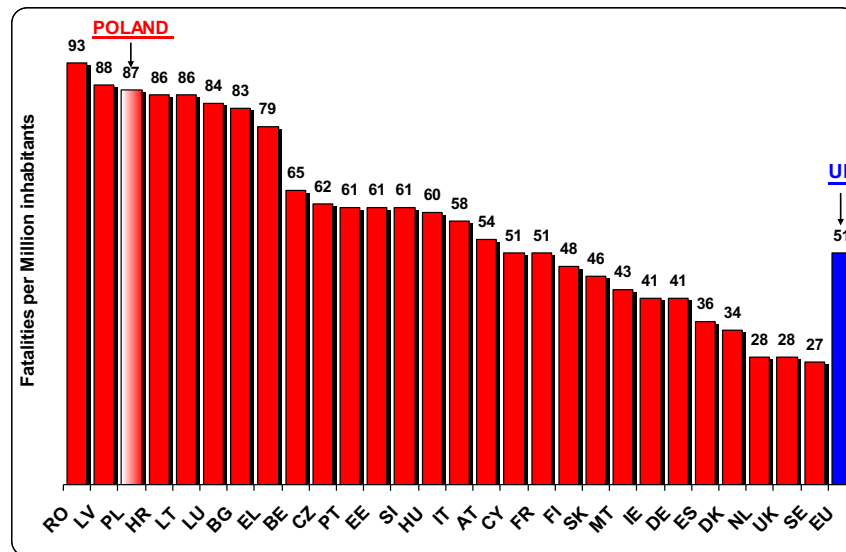
The threat of road accidents in Poland is for years very high. Fatalities per million inhabitants in Poland despite the downward trend compared to other European Union countries is one of the highest (Fig. 1). There were 87 fatalities per million inhabitants in Poland in 2013. The average risk for European Union countries were 51 fatalities per 1 million inhabitants (Fig. 1) [2, 3].

Fig. 1. Fatalities per million inhabitants by country in EU in 2013 [3]

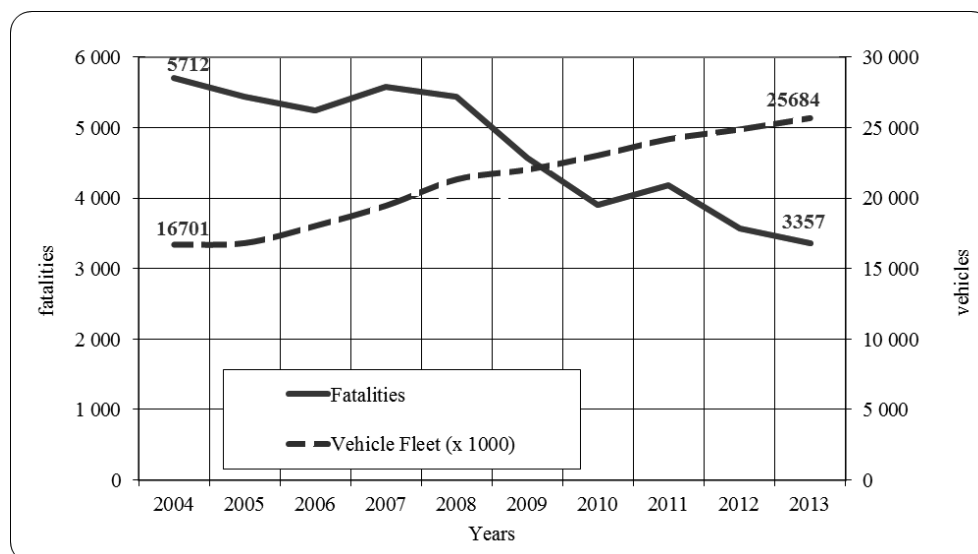
Within the past 10 years, i.e. since 2004 (Fig. 2) has decreased:

- the number of accidents by 30%,
- the number of fatalities by 40%,
- the number of injured by 31%, including the decrease among seriously injured by 33%.

Fig. 2. Road fatalities in Poland 2004 - 2013 [5]

With the exception of a slight increase in the number of victims in 2011, downward trend has maintained since 2008. Despite being optimistic, these changes have not met the objectives of the National Road Safety Programme, which assumed that in the period from 2010 to 2020 number of fatalities would drop by 50% and the number of seriously injured by 40%. This means that in the course of the implementation of the assumptions of the National Road Safety Programme 2020 (NRSP 2020) on Polish roads in 2020 should not be more than 2 000 fatalities and no more than 6 900 seriously injured people [6]. If this objective is to be achieved, each year should be followed by an average drop of 6.7% among fatalities. It means that there should not have been more than 3 193 fatalities in 2013 and no more than 9 861 seriously injured people (annual drop of 5 %).

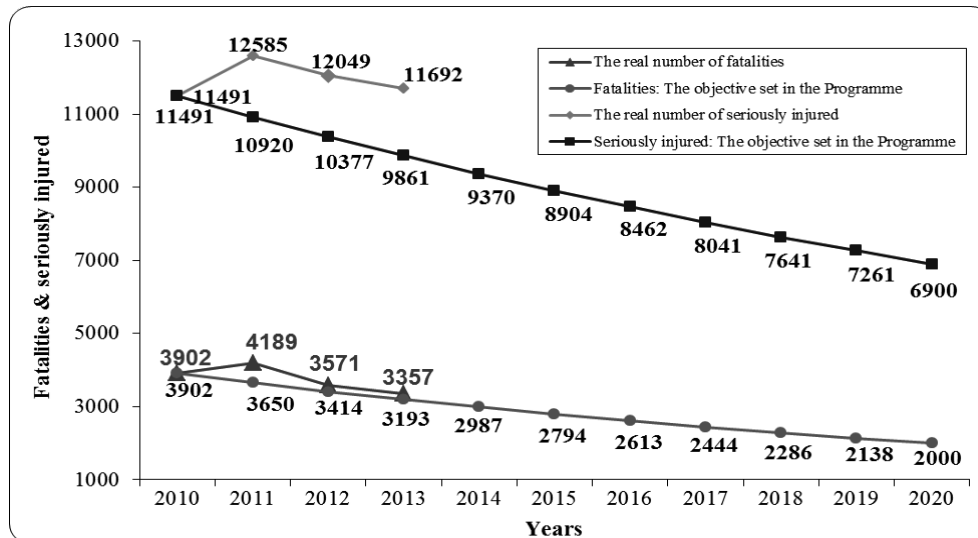
Fig. 3. The objectives set in National Road Safety Programme for 2010 - 2020 [6]

Poland significantly approach achieving this objective in 2013 because there were 164 fatalities on roads more compared to the assumptions previously made (decrease by 14% as compared to 2010). In relation to set objectives, there is unfortunately small decrease in the number of seriously injured. There were too many of them by 1 811 (increase by 1.8% as compared to 2010) (Fig. 3).

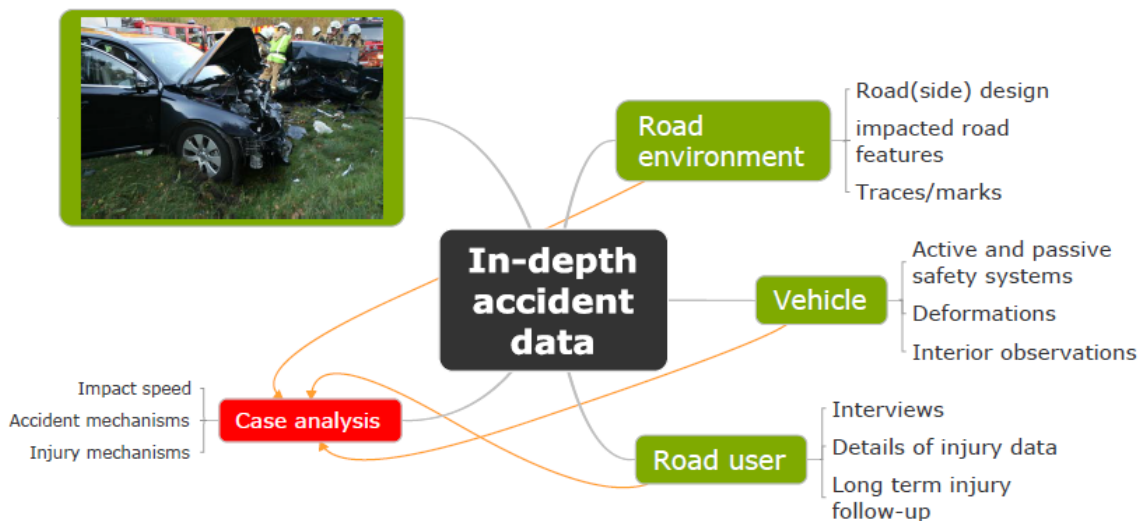
The purpose of in-depth research was to collect a set of core data describing accident to make case analysis and established cause of incident. The DaCoTA on-line manual for in-depth road accident investigators was prepared to indicate the scope, characteristics and practical requirements of the methodology as well as detailed information on all variables in the database. The system provided approximately 1500 variables (or fields) possible to collect in a case. Normally around 200 variables were needed to be collected to describe the overall accident and road characteristics [9]. The board range of data collected according to the instructions (on-line manual) and selection of accident investigation tools (forms, lists and diagrams) were store in crash investigation cases on - line application. The on-line application stored data in a structured and organized manner in a database. Finally the database allows the results of the case analysis for each accident to be stored (Fig. 5).

Fig. 5. In-depth accident data uses [8]
