Miloslav Kopecký*

EXPECTED GEOTECHNICAL PROBLEMS ON EXPRESSWAY R4 IN EAST SLOVAKIA**

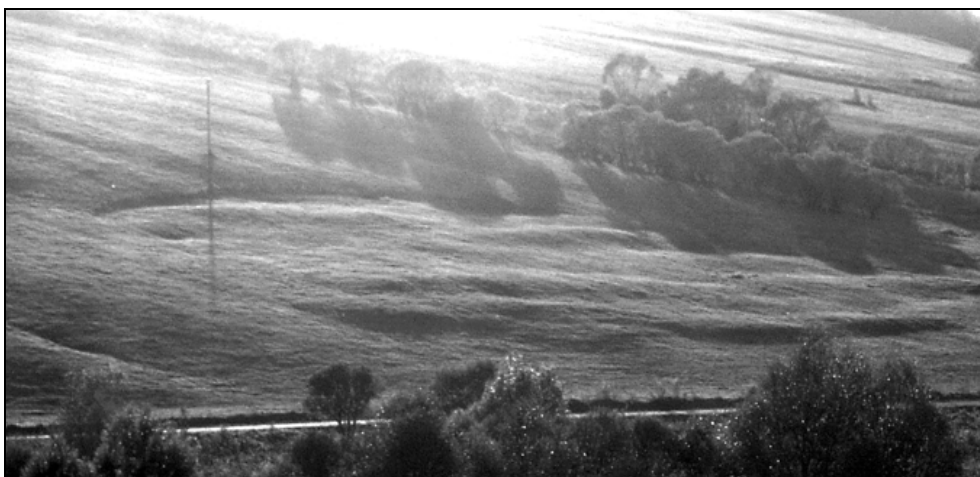
Fig. 5. Typical landslide in the area

Among the more frequent geodynamic phenomena present along the routes of the assessed variants we rank first of all sheet erosion and vertical (gully) erosion. On the slopes with suitable geological and hydrogeological conditions there occur slope movements [2] dominantly landslides and earthflows (Figs. 4 and 5).
