MODULAR MONITORING SYSTEM FOR PILGER MILL DRIVE

SUMMARY

Keywords: pilger mill, dynamic load, monitoring

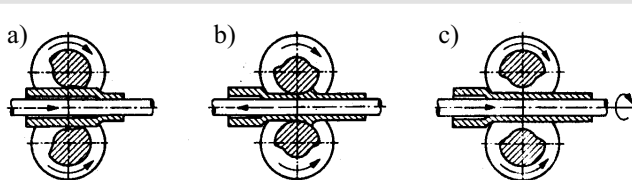
Fig. 1. Operating principle of a pilger mill (schematic diagram)
a) reduction of wall thickness; b) wall calibration;
c) tube release

The pilger hot rolling process involves the periodic forging of the tube walls with rollers of variable roll face profile (Fig. 1).

With deformation of subsequent portions of the tube blank under the pressure of rolls (Fig. 1), the moment M applied to the roll mill is equal to:

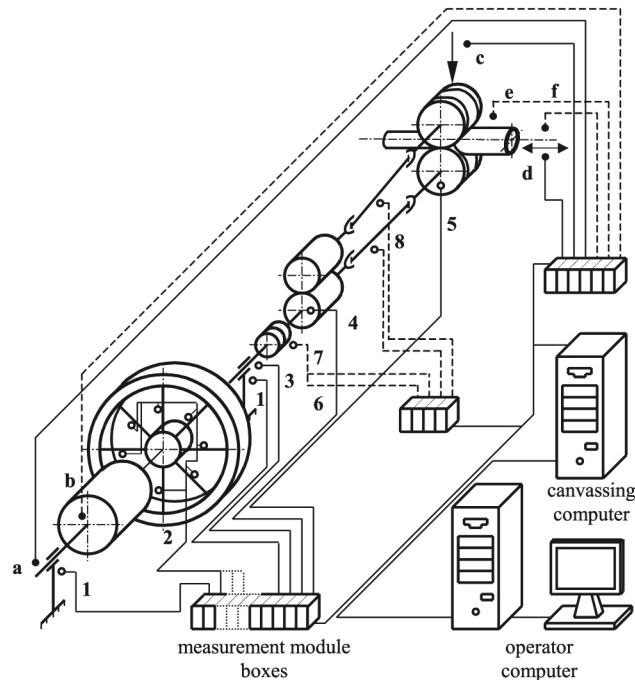
Step I	Step II
Vibration signals	
1. accelerometers on the main shaft bearing housing 2. systems of strain gauges on the flywheel arms 3. systems of strain gauges on the main shaft 4. accelerometers on bearing housings in the pinion stand 5. accelerometers on bearing housings in working rolls	6. accelerometers on the main coupling's housing 7. system of strain gauges on the main coupling components 8. system of strain gauges on spindle shafts and heads
Variable parameters of the process	
a) main shaft rpm b) current in the motor c) roll separating force	d) tube blank feeding frequency e) tube blank temperature f) loading of the feeding apparatus

Fig. 2. Schematic diagram of the system for monitoring of the mill condition and of the pilger hot rolling process

Engineering of a system for monitoring the mill condition and the pilger rolling processes for producing seamless tubes (Fig. 2) shall proceed in two steps.

In accordance with the procedures currently in force (Radkowski 2002), the system for monitoring the bearing condition in a roll mill (Fig. 2), both in the drive shaft (I step of system implementation) and the rollers in the stand (designed for step II) uses acceleration signals for vibration measurements. Piezoelectric vibration sensors fixed to the bearing housing enable the measurements in three directions in the rectangular coordinate system – horizontal H, vertical V, axial A.

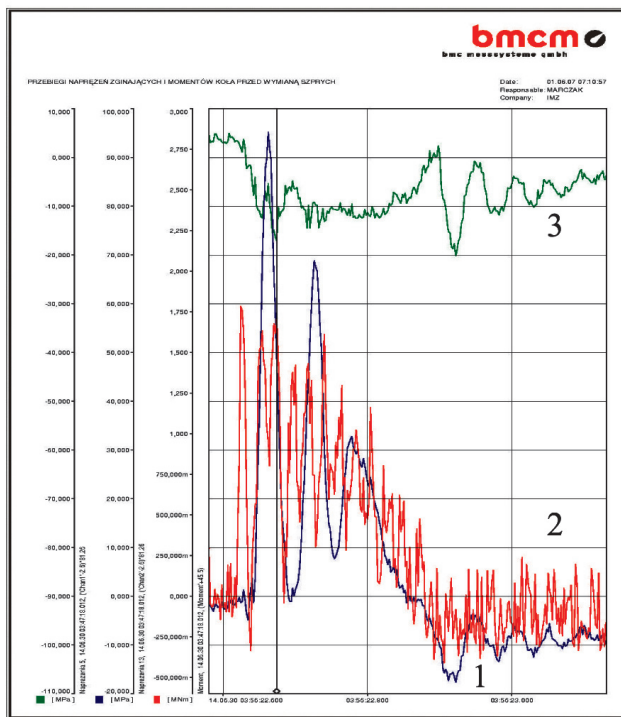
Fig. 3. Oscillograms of bending stress in the spokes 5 and 13 (1, 2) of the flywheel arms and torsion moment in the main shaft (3) of the pilger mill (IMŻ 2007)

Pilger processes are used in production of tubes ranging in diameter and tube thickness, made of various steel grades, hence the wide range of operating loads and their variability throughout the process (Kazanecki 2003). As a consequence, mere recording of stresses in particular rims and arms (Fig. 3), though useful in assessing the deterioration of the quality of its coupling to the wheel hub – increased clearance levels (Świątoniowski and Marczak 2007) – fails to reliably alert us to the upcoming critical condition²⁾.

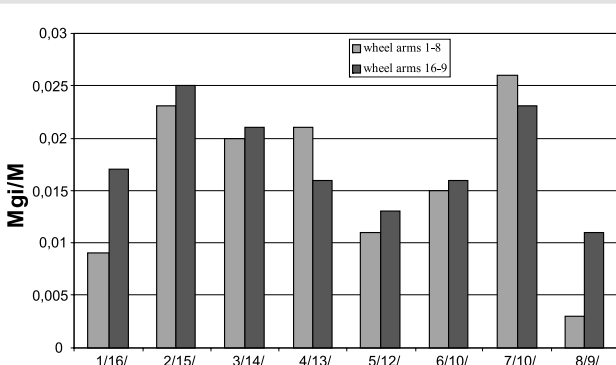
A much better picture is obtained when we analyse how each individual flywheel arms should contribute to the overall load transmission (Fig. 4). This proportion is expressed as the quotient of effective bending moment of the arms in its most stressed cross-section to such value of the total moment of inertia forces applied to the wheel rim whilst its speed is varied (i.e. when accumulated energy is imparted) during the subsequent forging cycles.

Fig. 4. Contributions of individual wheel arms to the transmission of inertia force moment. Condition after one year of service

It is readily apparent that after one-year service (see Fig. 4) of the rolling mill following its repair, the distribution of loads carried by individual flywheel arms are non-uniform. Stress amplitudes in spokes on the motor-end are lower on the average than in the neighbouring pair, located on the mill stand end. That implies that the flywheel system does not display the properties of a rigid solid, instead it behaves like a feeble frame, easily deformable under the

applied loads. The resultant overloading of wheel arms on the mill stand end leads to their breaking, which further enhances the difference between the loads transmitted onto particular wheel sections.

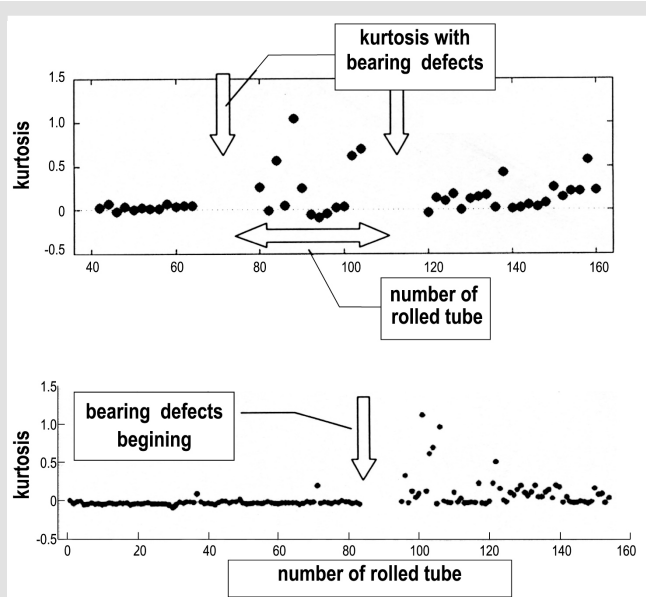
Fig. 5. Kurtosis of a vibration signal from a bearing in a pilger mill when the bearing track gets damaged

Increase of the kurtosis value is suggestive of the damage of the internal bearing ring in the working roll. That is most typical kind of damage, widely encountered in those roll mills.

Applications of the kurtosis to the assessment of the bearing condition in the working rolls of a pilger roll mill are illustrated in Figure 5.

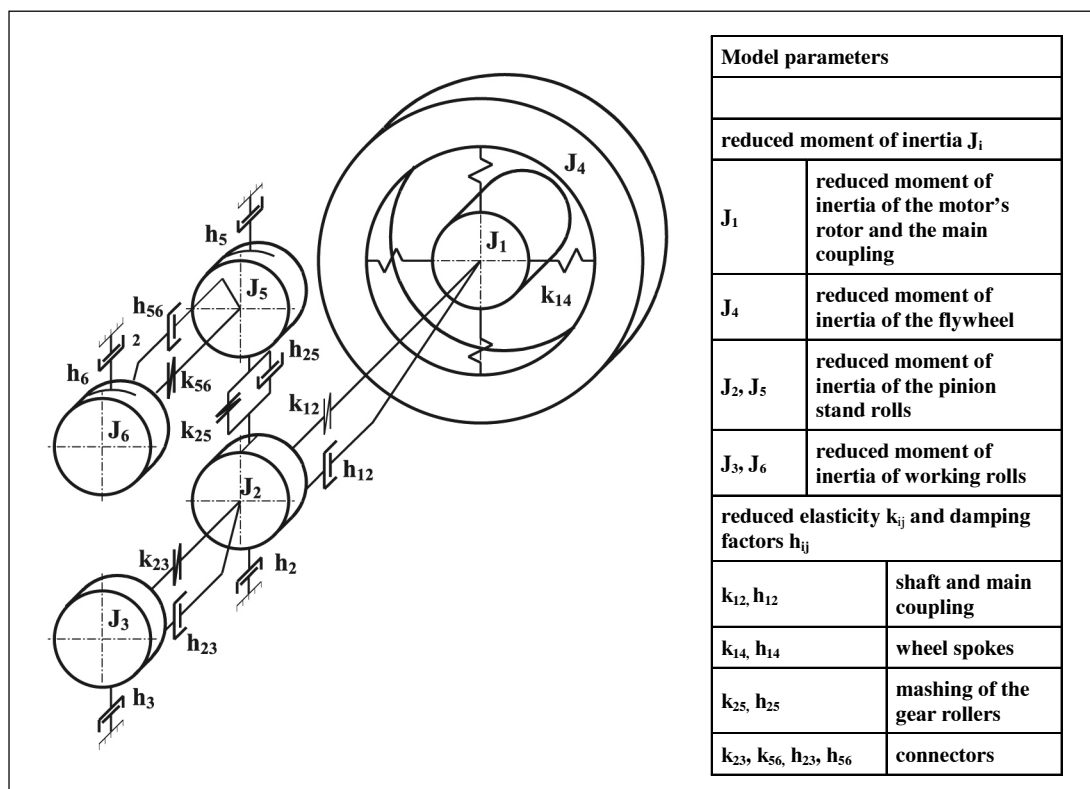
A structural discrete model of a pilger roll mill, that would fully meet those objectives, is shown in Figure 6.

Fig. 6. Mass spring model of a pilger mill's drive reduced to a 6-DOF system

The equations of motion (Fig. 6) are written as:

$$\mathbf{J} * \Phi'' + \mathbf{H} * \Phi' + \mathbf{K} * \Phi = \mathbf{M} \quad (6)$$
