Exploitation Research of Tram's Head Lighting – Low Beam Lights

Abstract

Keywords: tram's head lighting, low beam lights, CCD camera, luminance

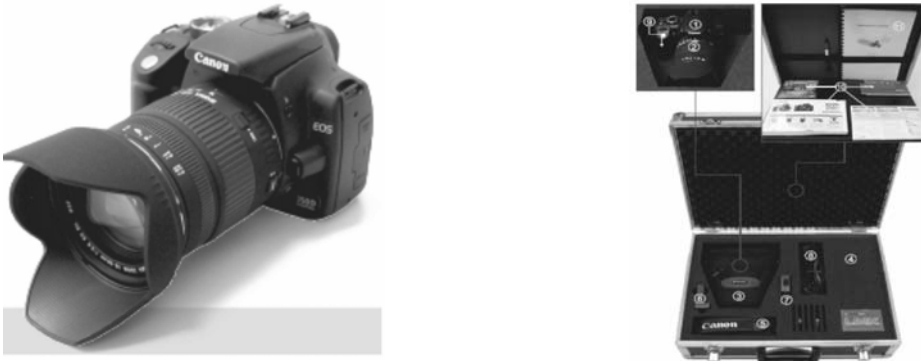
Fig. 1. The view of LMK camera for luminance measurement together with indispensable equipment [3]

The measurements of luminance were conducted by means of specialist portable camera LMK MOBILE ADVANCED made by the company Techno Team Bildverarbeitung GmbH [3] (Fig. 1).

The tool used allows taking a photo of a light spot image scaled in luminance units cd/m^2 . Additionally, it is equipped with specialist software LMK 2000 making it possible to process and scale obtained luminance images for the purpose of assessment and comparison of obtained results.

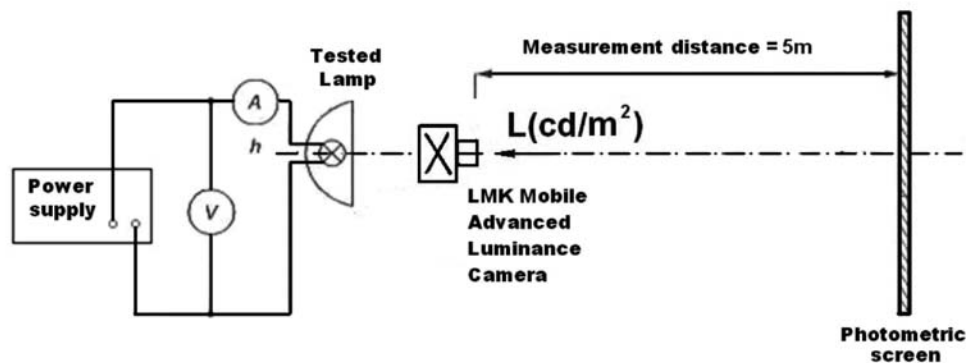
Fig. 2. Measurement station diagram

Luminance measurements were conducted for seven light beams of low beam lights on measurement screen placed at a distance of 5 m perpendicularly to the tested lighting device (Fig. 2). The measurements of the screen equal 3.6 m within horizontal plane and 2m within vertical plane. Measurement photometric screen is produced from material characterized by Lambertian reflectance.

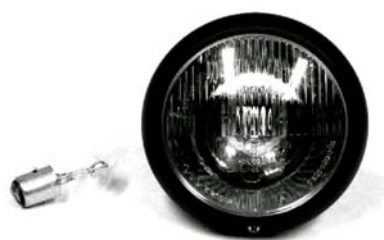
Fig. 5. Main light and low beam light reflector of 0-300-181-003 type with BA20D light bulb

Lighting equipment of disadvantageous lighting parameters is reflector of 0-300-181-003 type with BA20D light bulb. This reflector in all measurement points and areas presents significantly understated luminance values.

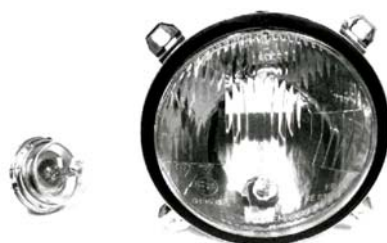
Fig. 7. Main light and low beam light reflector of RE09237 type with R2 light bulb

Lamps exploited in tram vehicles in most cases are obsolete constructions [9]. Traditional paraboloidal reflectors are mainly used with classic (R2 or BA20 bulb) (Fig. 5, Fig. 7, Fig. 9) or halogen (H4 bulb) (Fig. 11, Fig. 13 and Fig. 15) sources of light. In the latest constructions of optical-luminous lamps, more modern solutions for creating luminous flux are used by means of application of ellipsoidal reflectors (Fig. 3) with halogen H7 light bulbs.

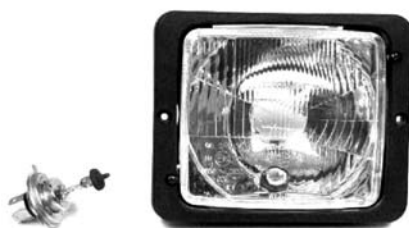
Fig. 11. Main light and low beam light reflector of RE22879 type with H4 light bulb

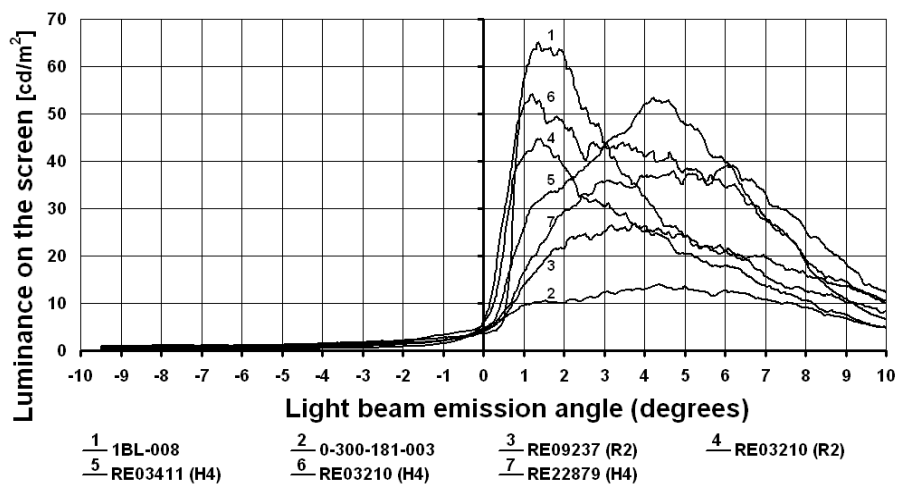
From the point of view of the quality of obtained light spot in the vehicle's foreground. An essential parameter of a light beam is the shape of borderline of light and shade observed from above and below the horizontal axis of photometric screen (H-H). Figure 32 presents the shapes of borderlines of particular projectors and reflectors by means of cross sections of light beams within axis V-V.

Fig. 32. Section within vertical axis V-V of light beam – borderline of light and shade

The analysis of borderline of light and shade confirms the results obtained in measurement points and areas. Projector 1BL-008 (Fig. 32) has borderline of the highest luminance contrast. Whereas, in the case of the light beam of 0-300-181-003 reflector it is difficult to talk about the existence of clear borderline. In reflectors RE 03411 H4 (Fig. 14), RE 22879 H4 (Fig. 11), RE 09237 R2 (Fig. 8), luminance maximum is significantly deflected (for about -5°) from the horizontal axis H-H of measurement screen. These reflectors are characterized by blurred borderline of light and shade, which is advantageous from the point of view of jump luminance changes created on the surface of eyes as a result of sudden changes of direction of light beam emission within vertical plane.
