ANALYSIS OF FACTORS AFFECTING FRACTURES OF RAILS WELDED BY ALUMINO-THERMIC WELDING

Summary. On Latvian Railway the use of the alumino-thermic welding is widespread using the Elektro-Thermit Company technology. Today it is a basic method for rail joints on railway switches. The analysis of the metal structure in the thermic welding and in the thermic welded zone of rails showed that the weld metal had inclusions small pores and nonmetallics. Pores and nonmetallics are not reduce hardness but it is concentrators of stresses and sources of cracks development.

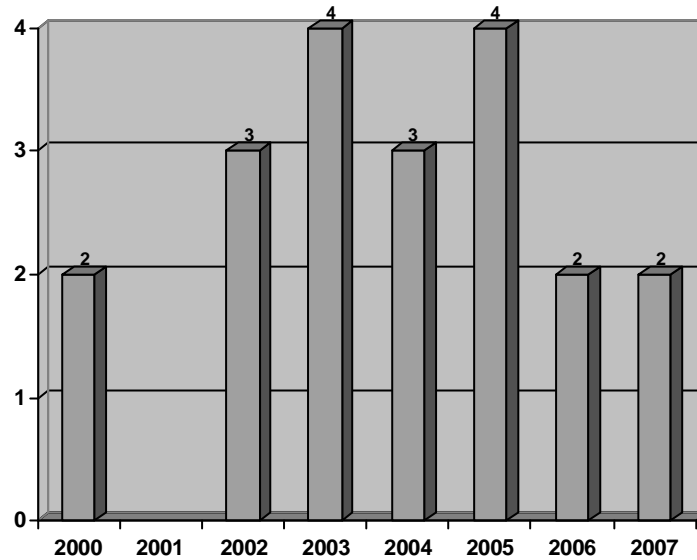
Fig. 1. Thermic weld fracture on Latvian Railway

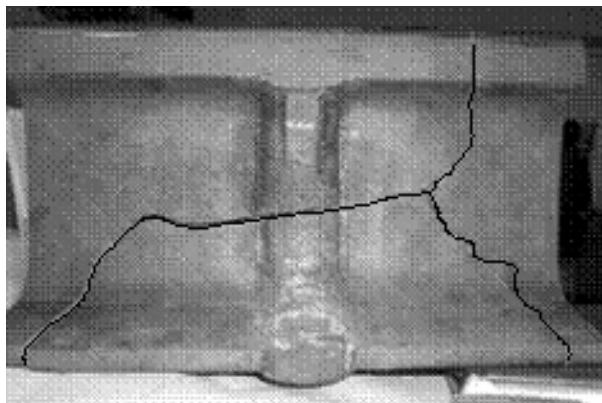
Experience of the operation of rails welded by the thermic welding showed that every year occur from 2 to 3 fractures of thermic joints on the main tracks between stations of Latvian Railway. In more cases these fractures of thermic joints are as shown in fig. 2.

Fig. 2. View of a thermic weld fracture

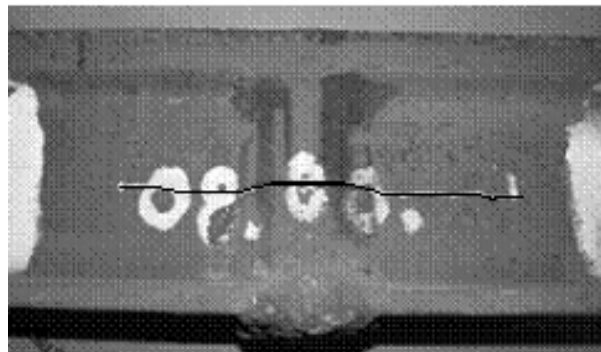
Fig. 3. View of a thermic weld score and cracks revealed
Рис. 3. Вид надпила термитного шва и появившейся трещины

Rails for test were removed from the main railway network in service for more than 1 year. Continuous welded rails were welded using volumetric tempered rails P65 and UIC60 type with unhardened foot. All 6 rail joints welded by the thermic welding had through cracks of 200-300 mm of length on both sides of the weld joint alongside a score (see Fig. 3). No load was applied to the rails with scores made on the lugs of the weld joint.

Such emergence of cracks in the weld joint alongside the scores indicates of great residual stresses in the weld joints made by the thermic welding.

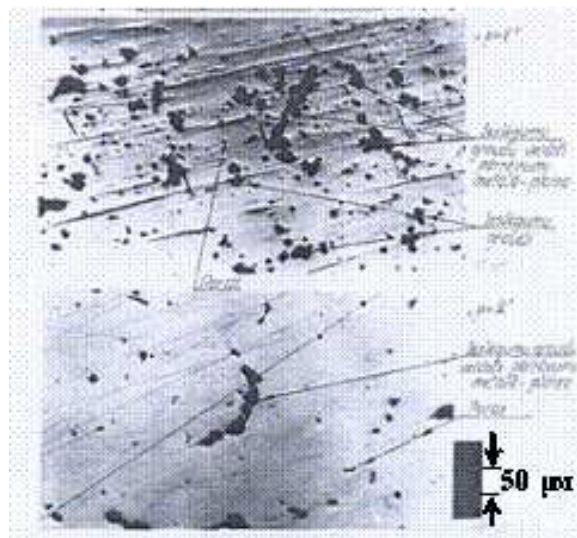
Fig. 4. Structure of the thermic weld metal in the rail head
Рис. 4. Структура металла термитного шва в головке рельса

The analysis of the metal structure in the thermic welded zone of rails showed that the weld metal had inclusions of iron oxides infused (FeO , Fe_2O_3 , and Fe_3O_4) and small pores (see Fig. 4). The emergence of pores was caused by ingress of moisture into the thermite during the welding process on rails. Pores and infused oxides are concentrators of stresses and sources of cracks development. Pores and infused oxides reduce hardness of the weld joint under the action of tensile forces.

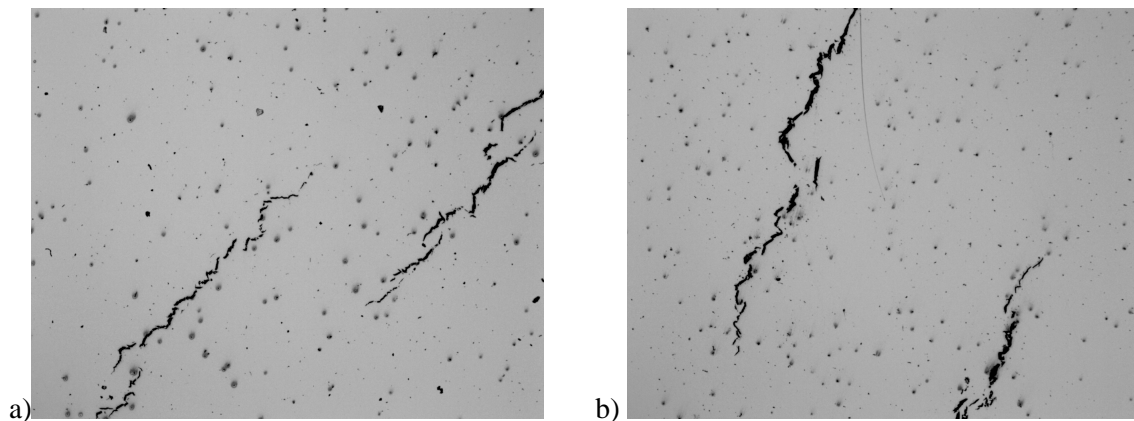
Fig. 5. Cracks in the structure of the rail, 5x
 Рис. 5. Трещины в металле основного рельса, 5x

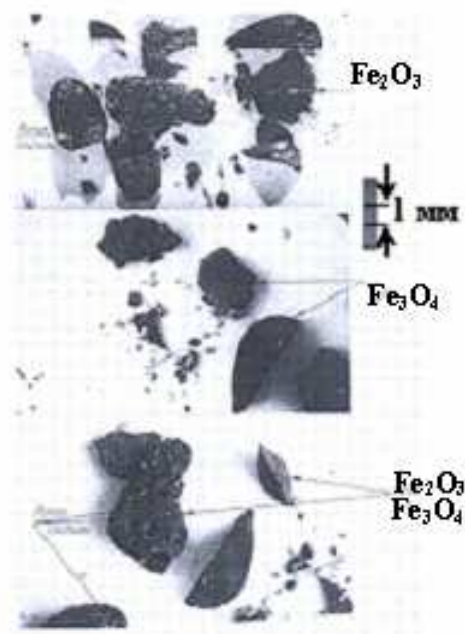
The analysis of the thermite structure showed that some elements of iron scale Fe_3O_4 and Fe_2O_3 have dimensions of 5-6 mm (Fig. 6), while, according to the standard, their dimensions should not exceed 1-2 mm.

Fig. 6. Structure of the thermite
 Рис. 6. Структура термита

Only at such conditions iron oxides have time to fuse at the temperature of 2600°C . Just iron oxides remaining in the weld joint originate cracks formation in the weld metal and reduce its strength.
