SURFACE TOPOGRAPHY OF OPERATED SLIDE JOURNAL MICRO-BEARINGS USED IN COMPUTER FANS

Abstract

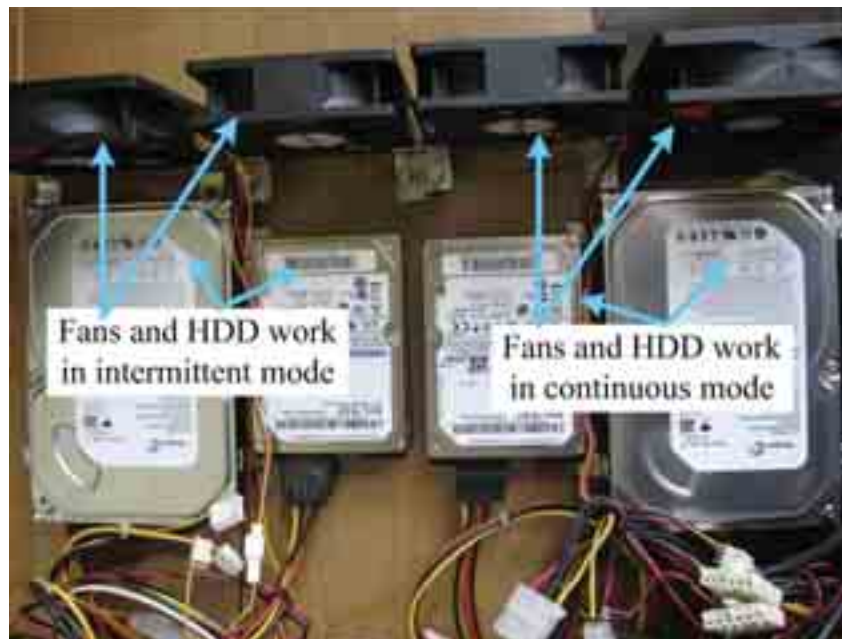
Figure 1 shows the working sets (first set - continuously, second set - intermittently) of computer hard disk drives and cooling fans.

Fig. 1. Working sets of computers hard disk drives and fans

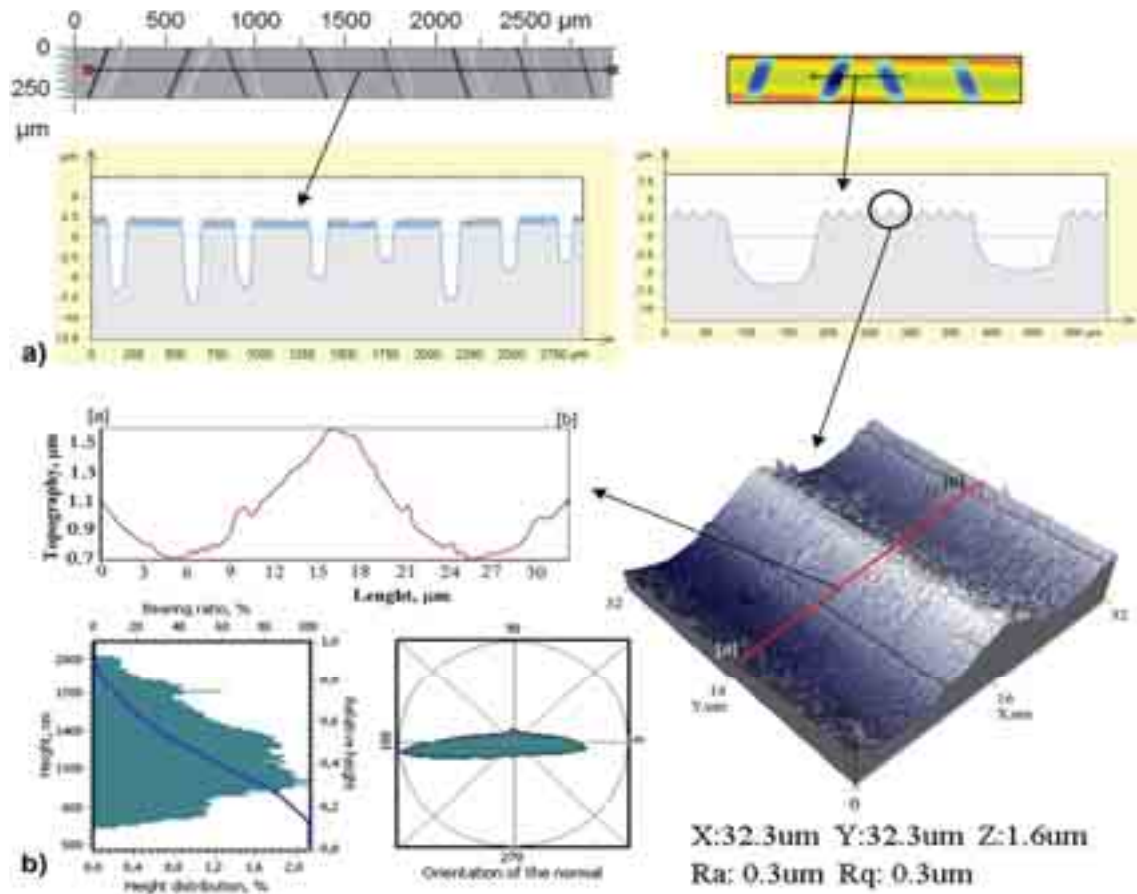
In Fig. 2, besides microgrooves, it can be observed the traces after turning as regular grooves with a width of about 19 μm and depth of 1 μm . The width of the fabricated microgrooves is around 100 μm , depth 5-10 μm and the distance between the grooves is about 300 μm . Treatment traces of surface, presented in Fig. 3, is less evident. It proves the wear of bearing sleeve surface, which was operated in intermittent mode, to be greater.

Fig. 2. Bearing sleeve surface with microgrooves - bearing from Kama Flow SP0825FDB12H – continuous mode

The results of surface topography measurements of Kama Flow SP0825FDB12H fan micro-bearing *sleeve*, which was operated in continuous mode, are illustrated in Fig. 2. Fig. 3 shows the surface topography of Kama Flow SP0825FDB12H fan micro-bearing sleeve, which was operated in intermittent mode. Fig. 2a and 3a present the topographies of investigated surfaces, acquired with the profilometer, while Fig. 2b and 3b show results gained with the atomic force microscope. The surface topography is presented in two and three-dimensional graphs. Furthermore, some selected cross-sections, roughness height distribution and orientation are introduced as well.

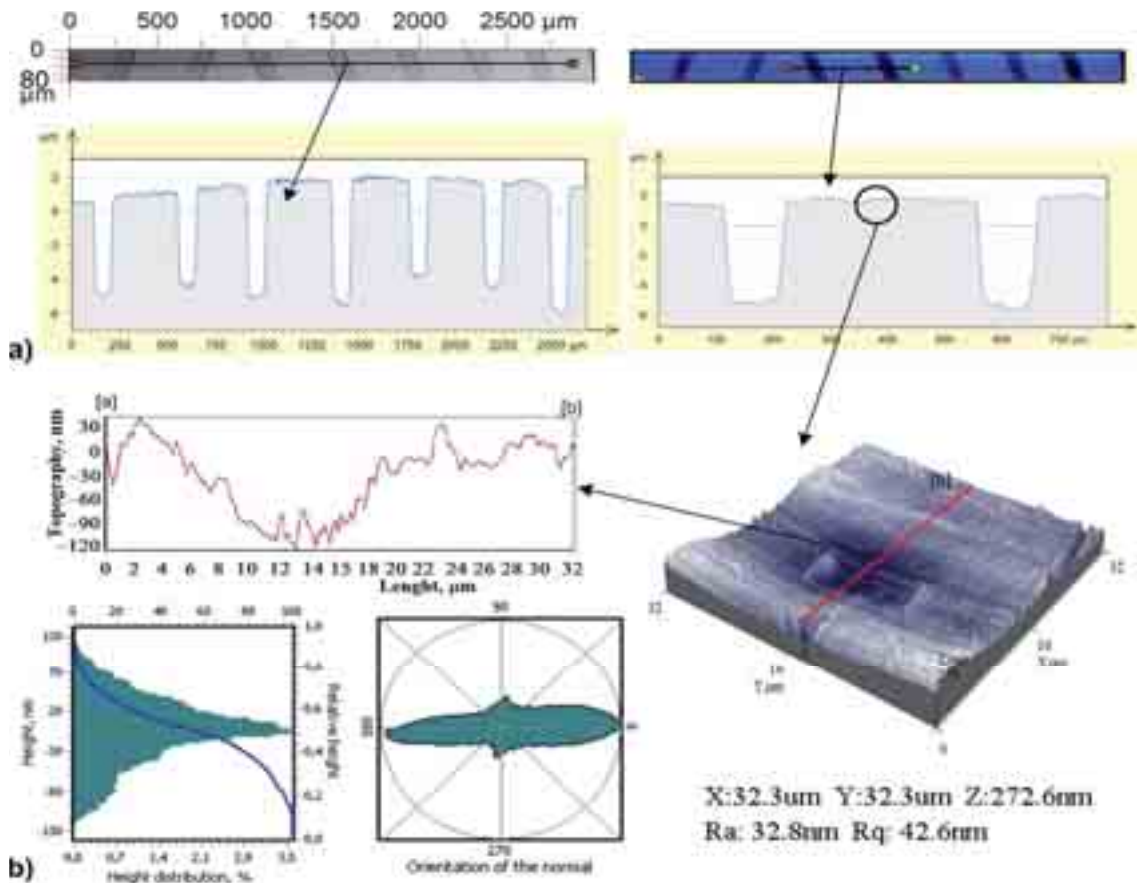
Fig. 3. Bearing sleeve surface with microgrooves - bearing from Kama Flow SP0825FDB12H – intermittent mode

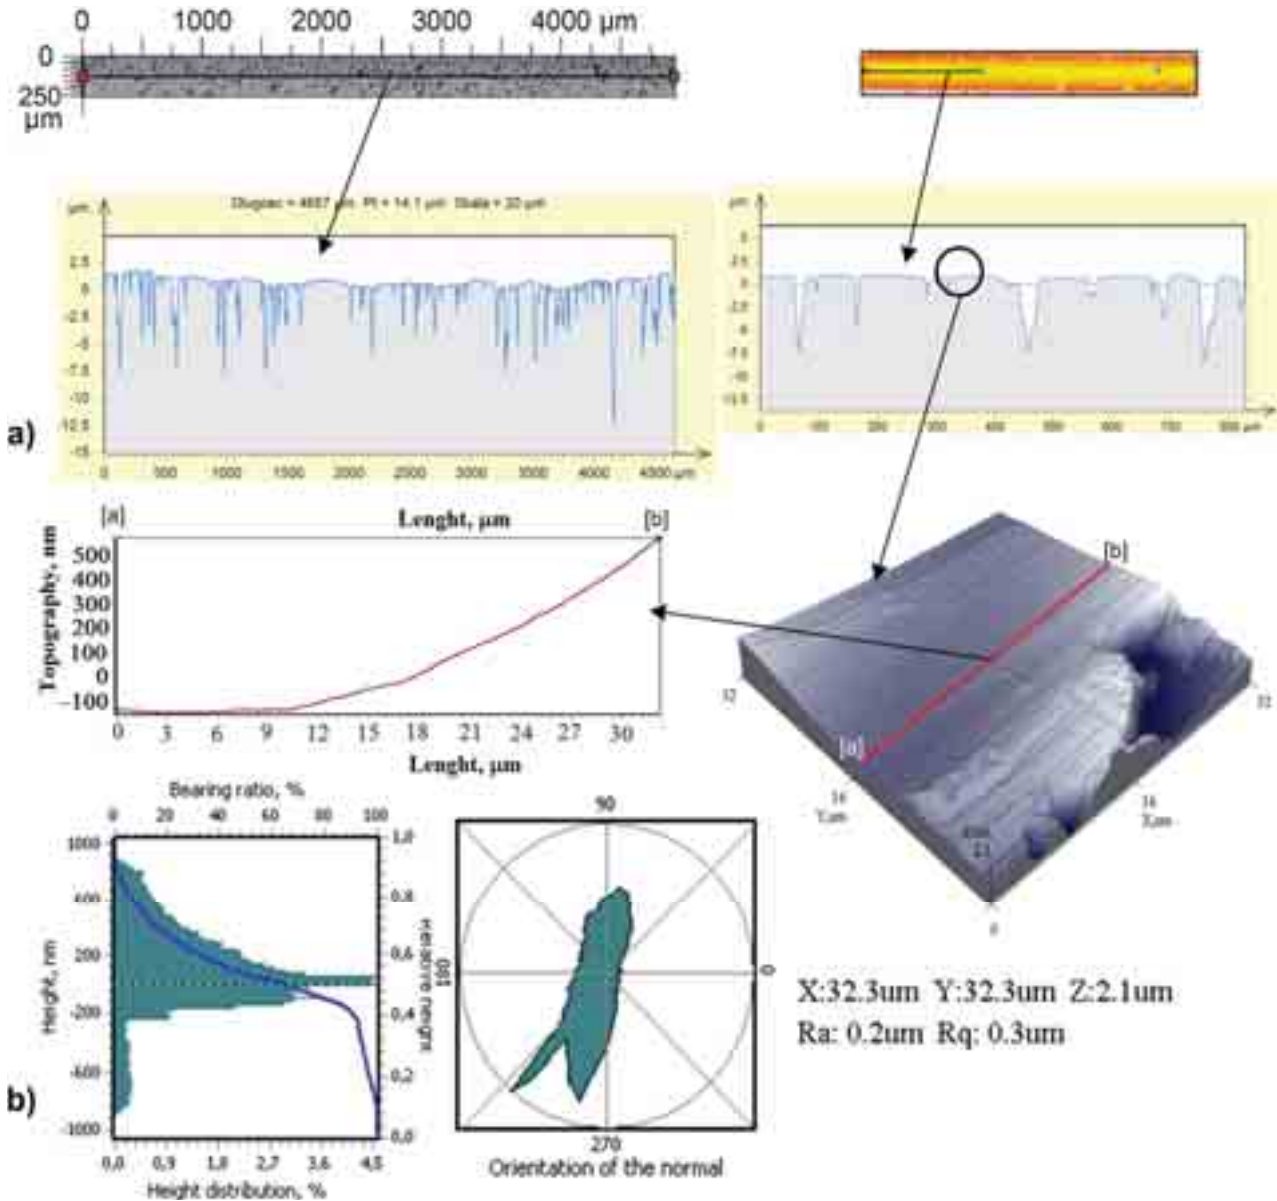
Xilence Case fan bearing sleeve is made of porous and sintered material. It can be seen in Fig. 4b and Fig. 5b as significant irregular cavities on bearing surface.

Fig. 4. Bearing sleeve surface without microgrooves - bearing from Xilence Case – continuous mode

The results of surface topography measurements of classical slide micro-bearing, used in Xilence Case computer cooling fan, which worked in continuous mode, are presented in Fig. 4. Surface topography of the same bearing, but used in intermittent mode, is presented in Fig. 5. Fig. 4a and 5a present the topographies of investigated surfaces, achieved with the profilometer, Fig. 4b and 5b with the atomic force microscope.

The roughness values of surfaces presented in Fig. 4b and 5b are much higher, in comparison with roughness of other investigated surfaces. It is due to the fact that sleeve material is porous.

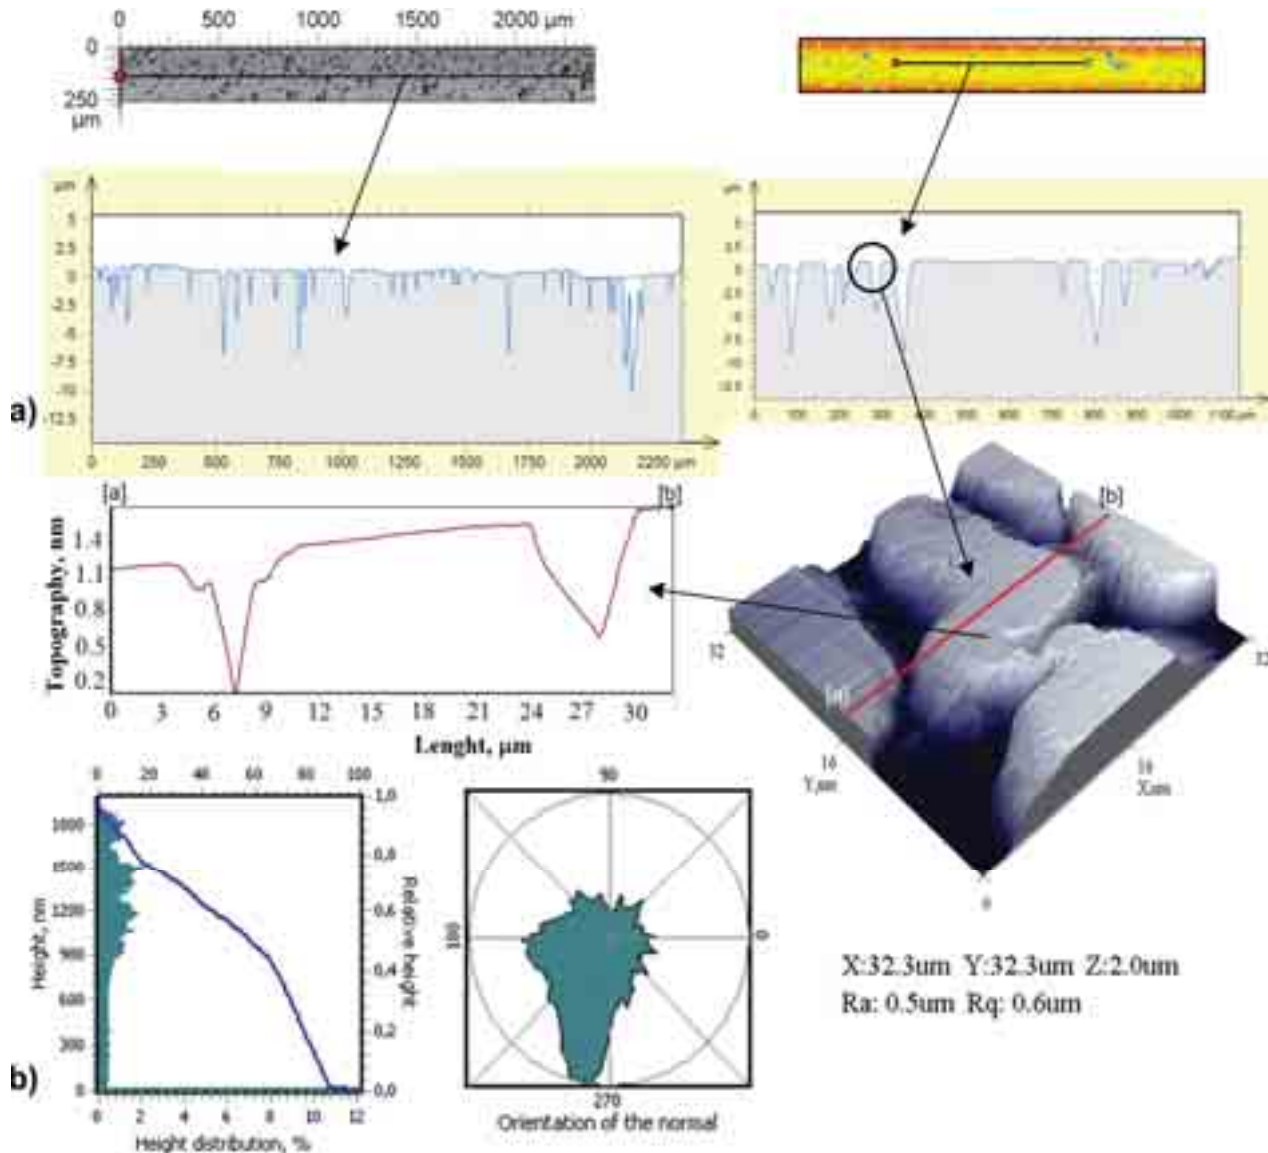
Fig. 5. Bearing sleeve surface without microgrooves - bearing from Xilence Case – intermittent mode

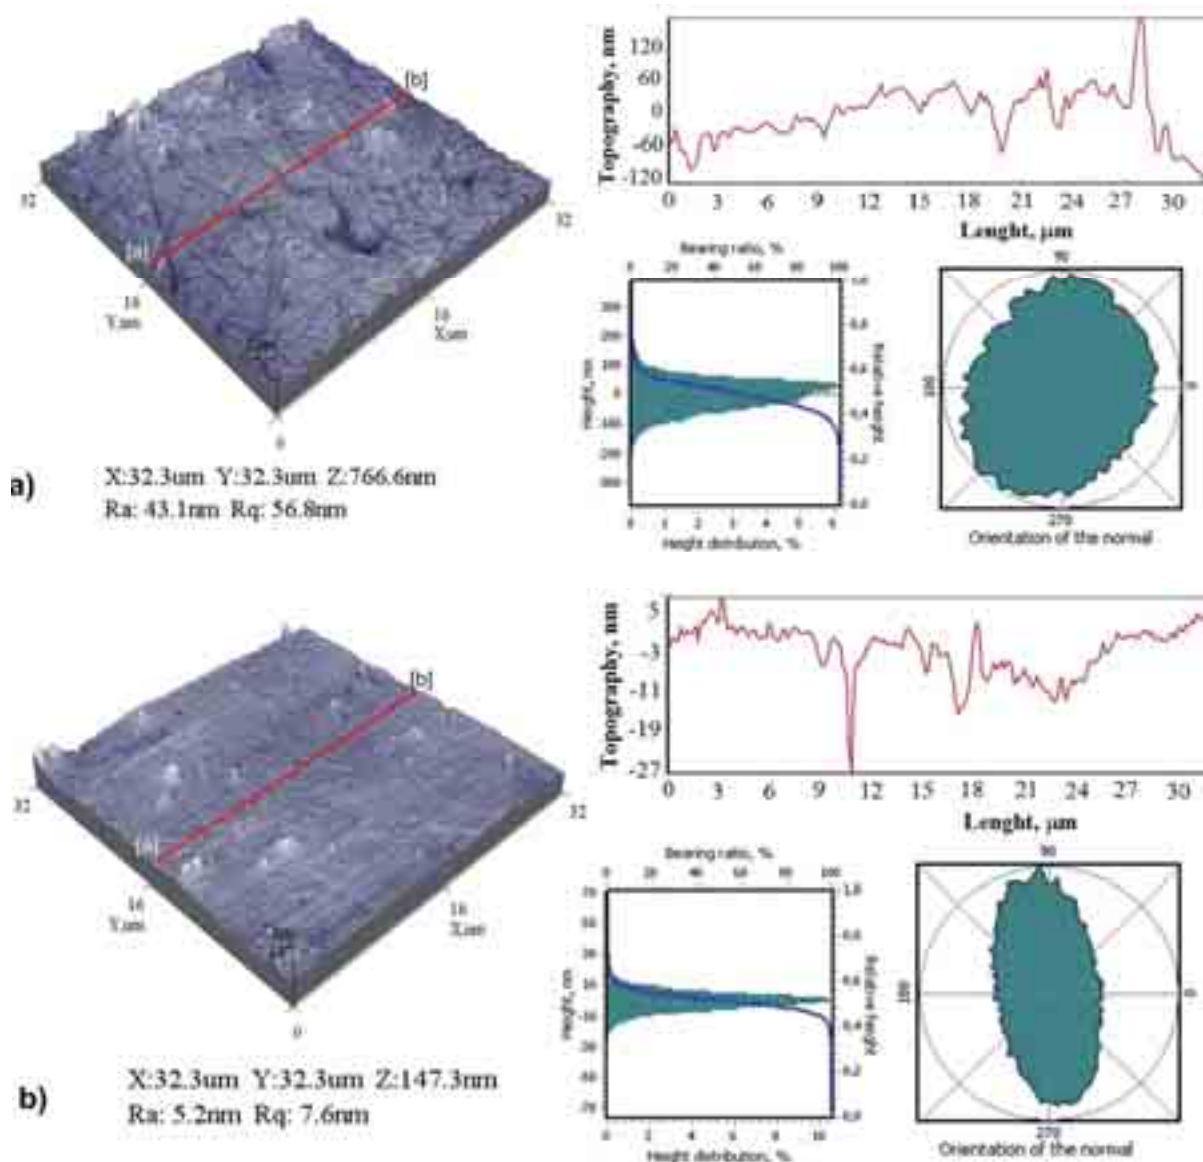
In Fig. 6a, 7a and 7b visible signs of wear of bearing journal (in the form of material loss or scratching) occur. It can be caused by hard inclusions that exist in slide bearing lubricating gap or may be a result of boundary friction between cooperating surfaces of slide micro-bearing.

Fig. 6. Bearing journal surface topography - bearing from Kama Flow SP0825FDB12H: a) continuous mode, b) intermittent mode

Surface topographies of investigated micro-bearings journals are presented in Fig. 6 and 7. Fig. 6 shows results received for Kama Flow SP0825FDB12H fan bearing journal, Fig. 7 presents results for Xilence Case fan bearing journal.

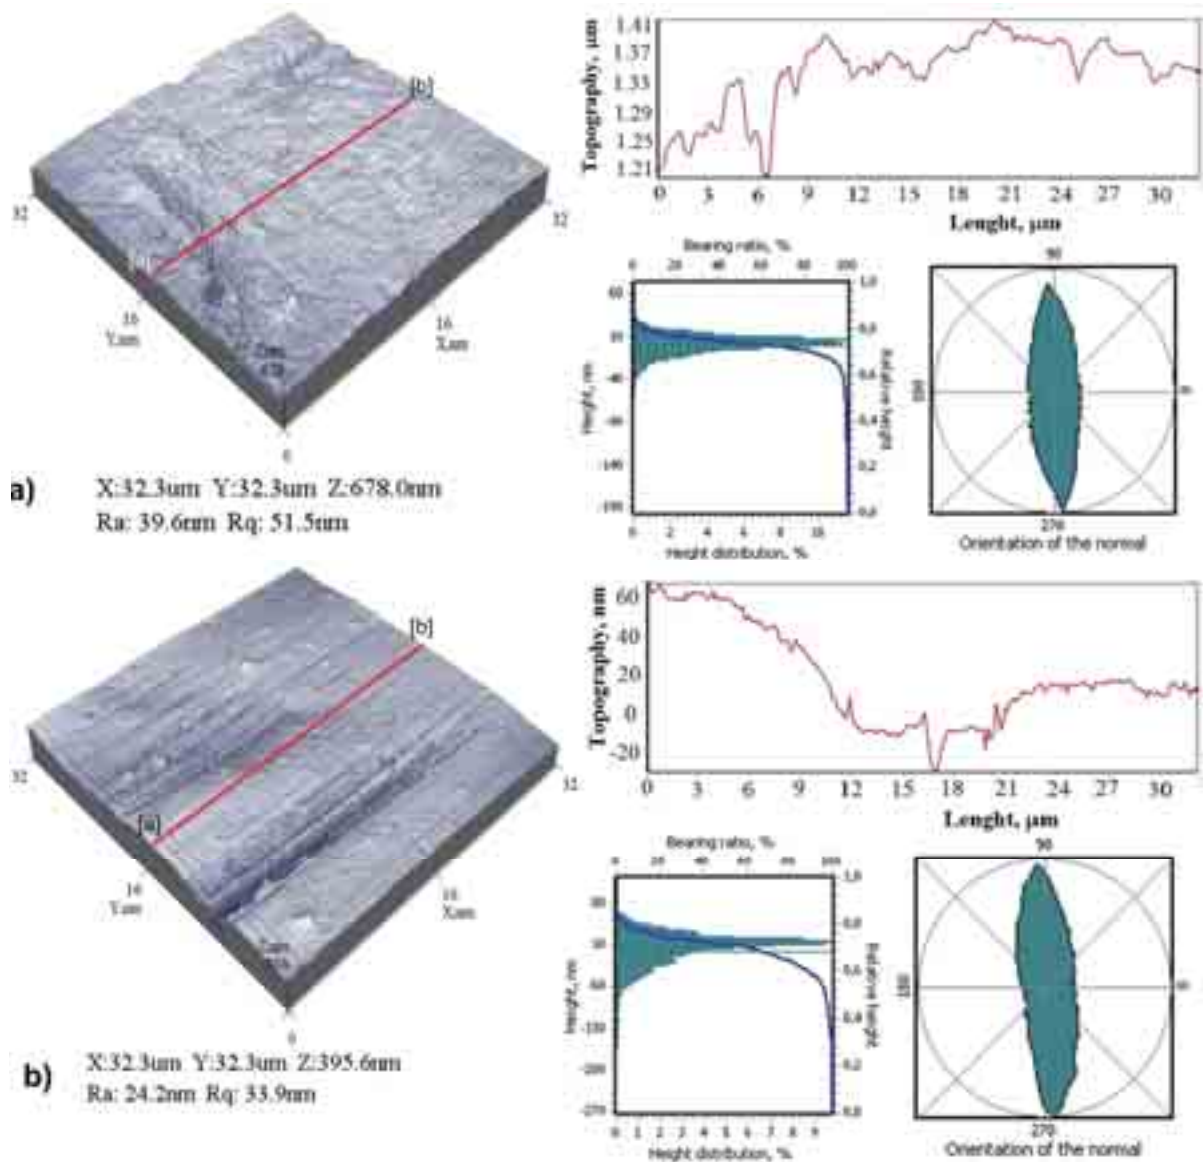
Fig. 7. Bearing journal surface topography - bearing from Xilence Case Fan – continuous mode, a) continuous mode, b) intermittent mode
