MINEWATER REMEDIATION IN THE UNITED KINGDOM

Keith D. PHILPOTT¹

Key words: minewaters, discharge, environmental, United Kingdom.

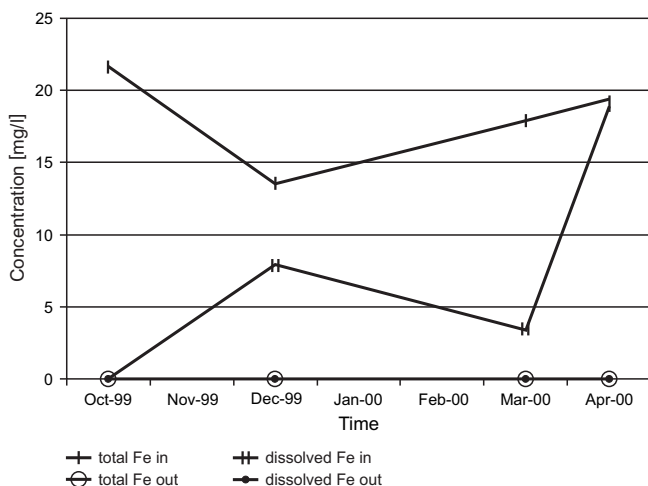
Fig. 2. Edmondsley Minewater, iron content

ochre on the bed of the receiving watercourse for a distance of at least 0.5 km downstream. The discharge is net alkaline with total levels of iron and manganese at 20 mg/l and 2.6 mg/l respectively. Flows are generally of the order 5 l/s, but have been recorded up to 13 l/s. Treatment has reduced the outflow levels of iron (Fig. 2) to less than 1 mg/l and manganese (Fig. 3) to a little over 1 mg/l and within two months of the completion of reed planting all the ochre in the receiving watercourse had been remobilised and the rocky streambed left clear.

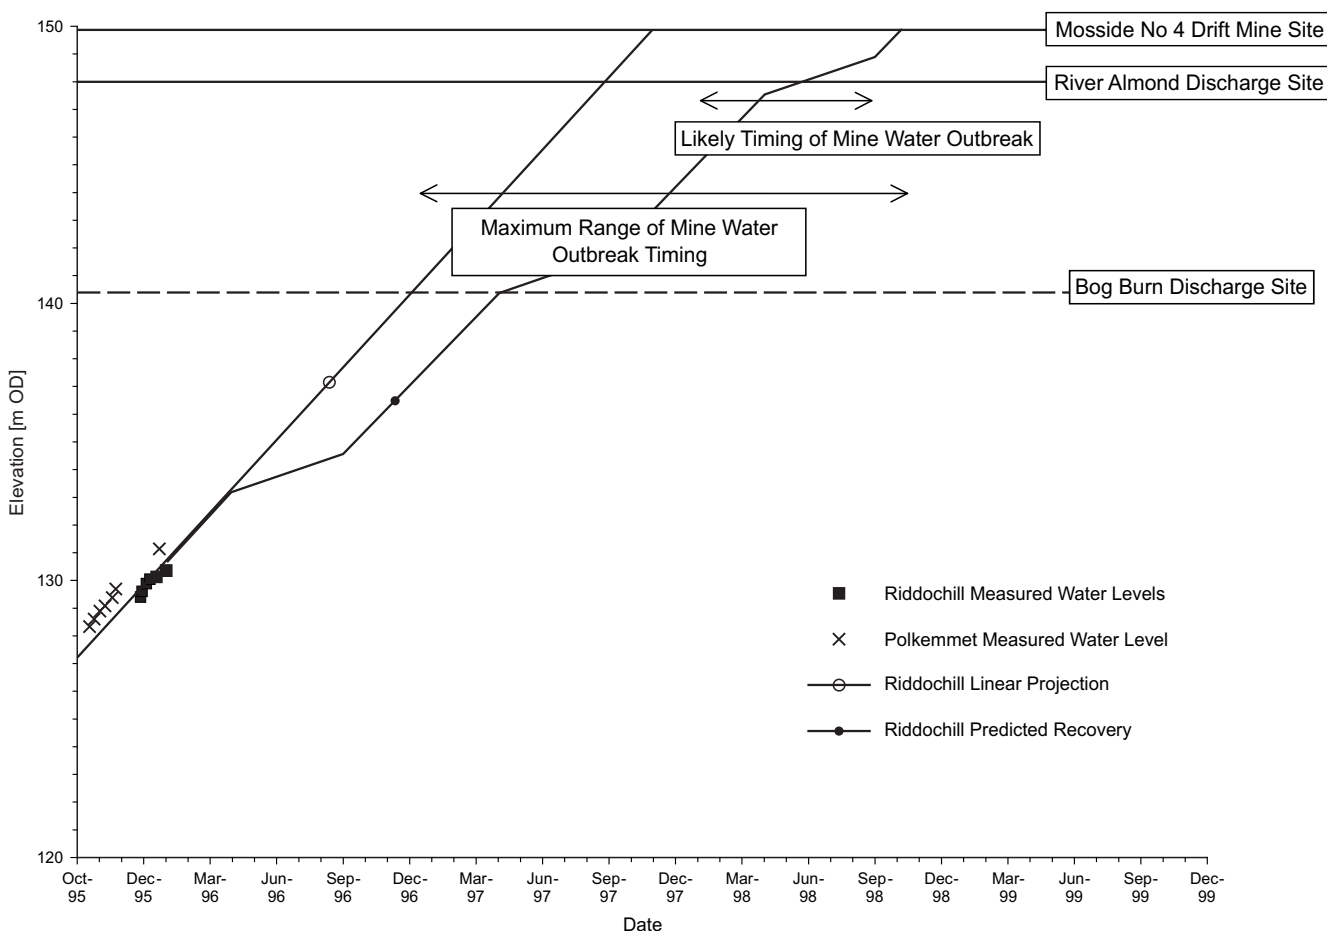
Fig. 6. Polkemmet, outbreak prediction

With regards to the timing of the outbreak (Fig. 6), two variations from the then current rate of rise were assumed, that is, a 5% reduction in rise due to reduced groundwater inflow and increased minewater outflow, and summer water level rising at one third of the winter rate. This gave a predicted date of January to August 1998, but with a worst case scenario of December 1996, based on a continuation of water rising at the then current rates.
