Correction of Acoustics in Historic Opera Theatres with the Use of Schroeder Diffuser

Tadeusz KAMISIŃSKI

AGH University of Science and Technology

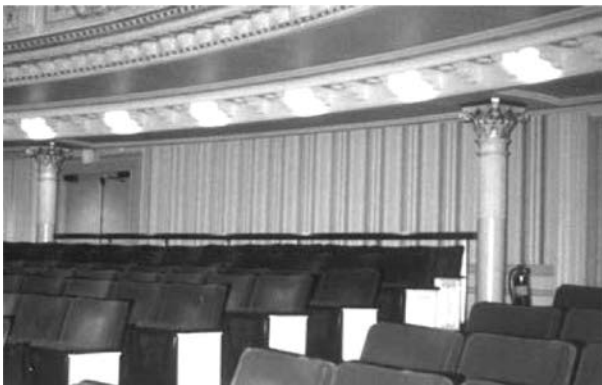
Fig. 2. Schroeder diffusers (QRDs) applied to the rear wall of Carnegie Hall to prevent echoes.

An example of the use of Schroeder diffuser in a concert interior of historic interest is the Carnegie Hall in New York (Fig. 2). On the rear flat wall, the diffuser was installed in order to reduce echo heard on the stage (COX, D'ANTONIO, 2003).

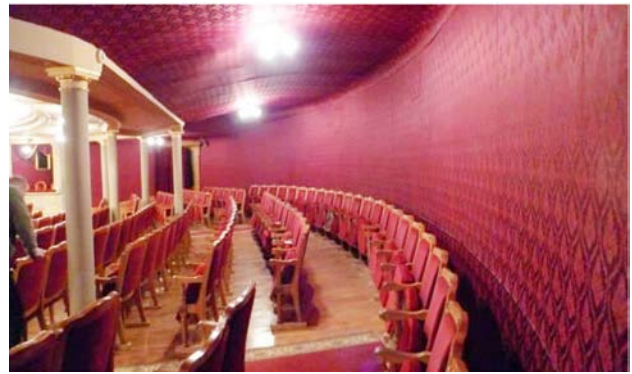
Fig. 3. A view of semicircular underbalcony space in Lviv Opera House before installation of diffusion panels.

Figure 3 shows a view of the underbalcony space in the Lviv Opera House hall before installation of diffusion panels. In this case, it has been decided that the diffuser would be installed on a semicircular wall which would allow to test the function of the structure in different geometrical situations.

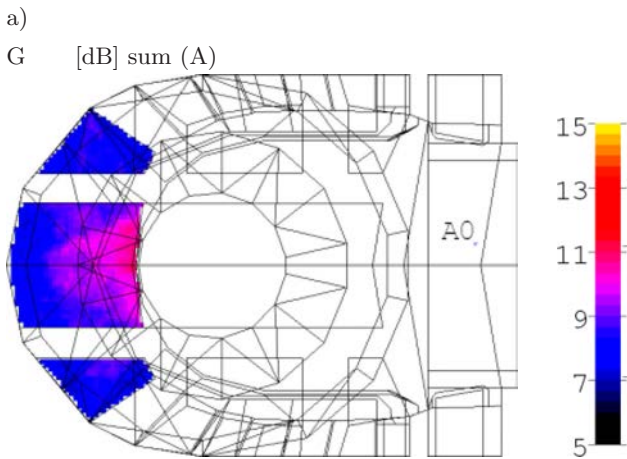
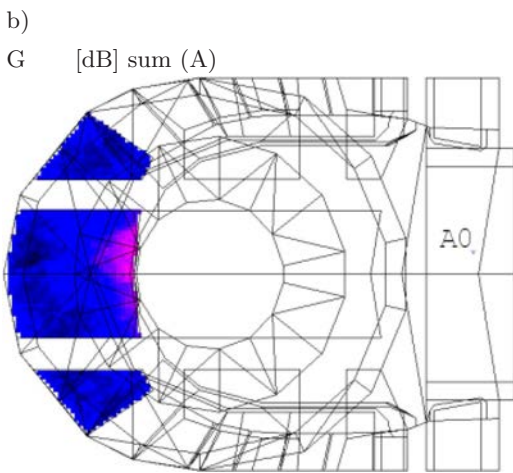
Fig. 4. The forecasted distribution of G values under the balcony in the hall's stalls: a) wall with tapestry; b) wall with the diffuser.

Results of both simulations are presented in Figs. 4a and 4b. To illustrate the effect of the planned adaptation, the parameter known as the sound strength G was selected, defined by means of formula (KULOWSKI, 2011):

hall centre a decrease of value of the indicator occurred after installation of the diffuser in the underbalcony cavity, but distribution of the parameter has clearly gained in evenness as a result of occurrence of diffused reflections. Based on the observation one can conclude that introduction of sound diffusing element onto the rear wall will cause reduction of the sound focusing phenomena in this area and have a positive effect on audition qualities. Much better results should be expected when observing the simulated parameters for frequencies above 1 kHz, as in this very range the sound absorption is being reduced, and diffusion increased (Fig. 4). When interpreting the plots, one should also bear in mind the limitations of the ray method used by CATT-Acoustic program.

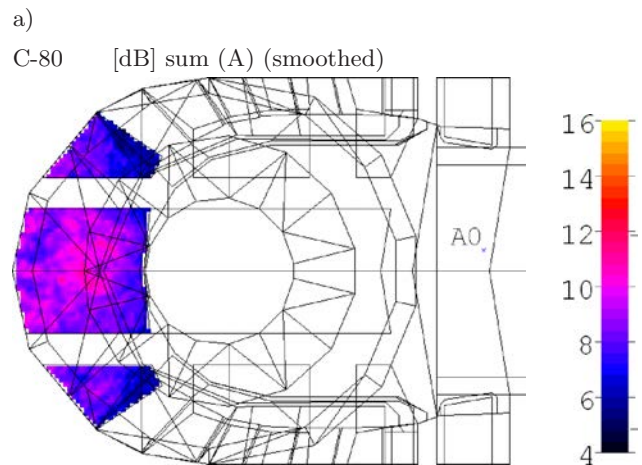
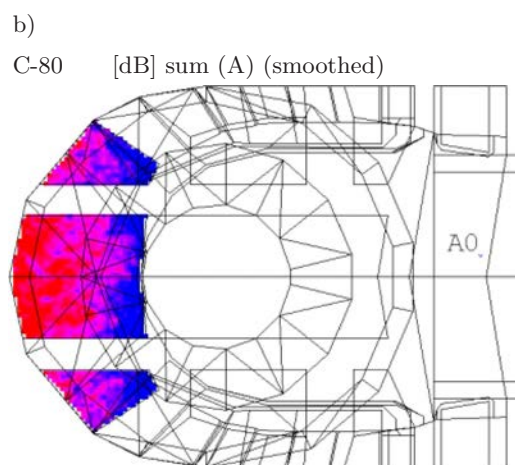
Fig. 5. Forecasted distribution of C_{80} values under the balcony in the hall's stalls: a) wall with tapestry; b) wall with the diffuser.

Figure 5 shows the forecasted distribution of C_{80} parameter under the balcony on the hall's stalls for: (a) the back wall with textile tapestry; (b) the same wall with Schroeder diffuser. The parameter, known

Analysis of simulation shows (Fig. 5) that the use of the diffuser will result in an increase of the sound clarity C_{80} in last rows of the stalls.

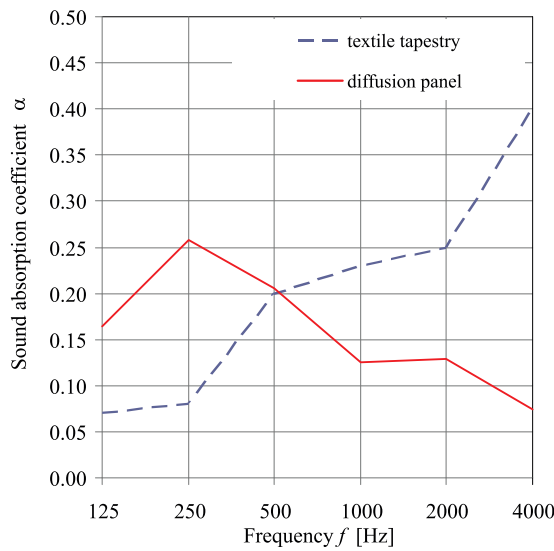
Fig. 6. Comparison of sound absorption coefficient values for textile tapestry and the diffusion panel.

Figure 6 shows the comparison of sound absorption coefficient values for textile tapestry and the diffusion panel.

tively diffuses the sound. Analysing absorption characteristics of the textile tapestry and the diffusing structure (Fig. 6) it can be found that below the frequency of 1 kHz, the diffuser is characterised with the sound absorption coefficient higher than this of the tapestry. As a result, after installation of the diffuser, a portion of energy is absorbed and does not come back to the auditorium. Above 1 kHz, sound diffusion starts to manifest itself with low absorption, giving the acoustic energy back to the hall in a way ensuring its uniform distribution. The phenomenon has been confirmed by means of analogous observation of the parameter $G_{4\text{kHz}}$ that more clearly depicts the effect of the diffuser on the hall's acoustic field.

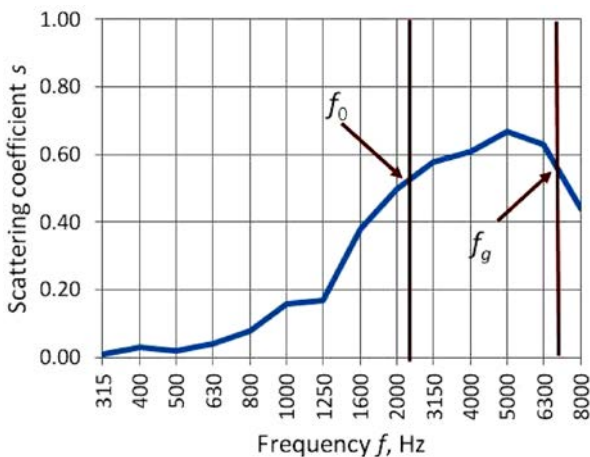
Fig. 8. The sound scattering coefficient s of the diffusion panel determined according to ISO 17497-1 (2004).

In Fig. 8, the lower f_0 and the upper f_g limit frequencies for sound diffusing effect of the examined structure are marked. It is assumed that the structure has the capacity to redirect the sound starting from frequency equalling $0.5 f_0$ (COX, D'ANTONIO,

2004). The design frequency f_0 is determined by the maximum depth of the diffuser. In the Opera House there was a very limited space designed for the diffuser, therefore it was very difficult to lower f_0 . What is more, as indicated by (PILCH, KAMISIŃSKI, 2011), the higher deep-to-width ratio of one well of diffuser, the bigger sound absorption of the entire structure in low and mid frequency range. Consequently it was impossible to increase the range of effective diffusion of panels without interference with the reverberation time of the hall.

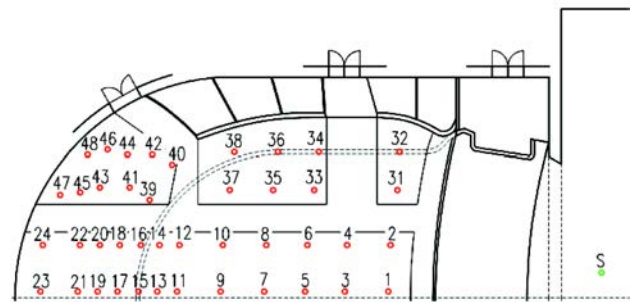
Fig. 9. Distribution of measurement points in the hall's stalls.

Repeated examination of the Opera House hall's acoustic parameters carried out, according to the pre-determined methodology, before and after installation of the structure on the rear wall, was used for verification of the implemented system. To increase precision of the analysis of acoustic phenomena occurring in locations where main changes were forecasted, the grid of measurement points has been condensed in the area under the balcony in the centre of the Opera's stalls (Fig. 9).

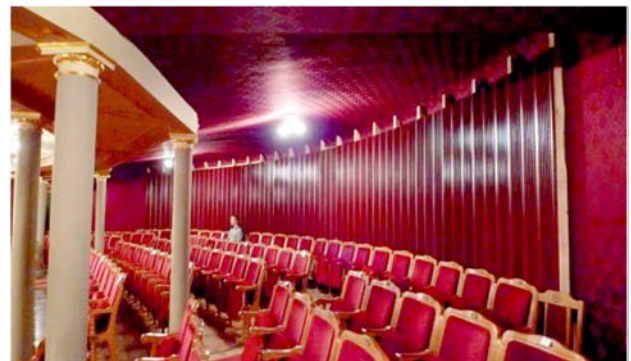
Fig. 10. A view of the semicircular back wall behind the underbalcony space in the Lviv Opera House after installation of diffusion panels.

Figure 10 shows a view of semicircular back wall of the underbalcony space in the Lviv Opera House after installation of diffusion panels in the course of verification measurements.

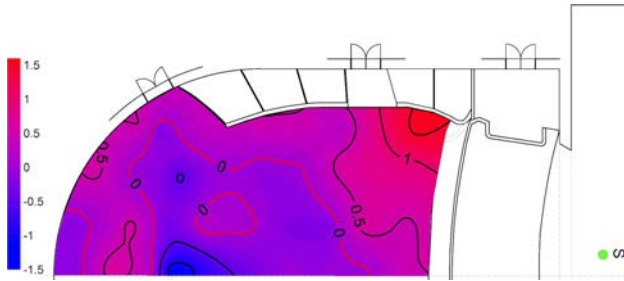
Fig. 11. Distribution of the sound strength G_{mid} increase after installation of the diffuser.

After application of the diffuser on the rear wall, one can observe a slight increase of value of the sound strength factor G_{mid} in the underbalcony area, while in the central part of the hall, values of the parameter have been reduced.

The analysis of acoustic parameters of the Lviv Opera House hall measured before and after installation of the diffuser has shown that the best parameters allowing for observation of the discussed structure's effect were the sound strength values G_{mid} and $G_{4\text{kHz}}$. To this end, interpolated distributions of measured values of the parameters over the stalls area were worked out. Parameters G_{mid} and $G_{4\text{kHz}}$ are presented in the form of difference of values observed before and after installation of the diffuser (Figs. 11 and 12).

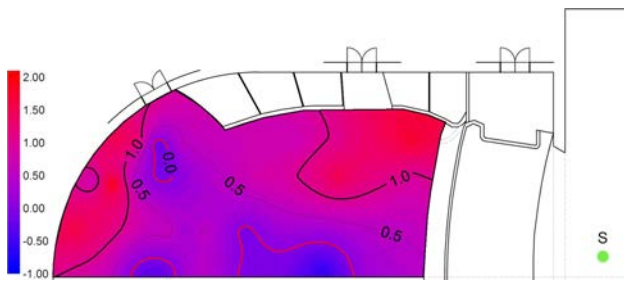
Fig. 12. Distribution of the sound strength factor $G_{4\text{kHz}}$ increase after installation of the diffuser.

Values of the $G_{4\text{kHz}}$ parameter, as shown in the figure above, are subject to distinct decrease in the central part of the hall, and locally increased as a result of providing the semicircular wall with the diffuser.

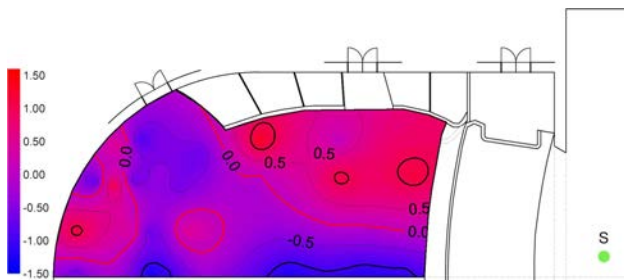
Fig. 13. Distribution of the sound clarity index C_{80} 4kHz increase after installation of the diffuser.

Analysis of the sound clarity index C_{80} for the 4 kHz has revealed (Fig. 13) that as a result of installation of the diffuser, values of the parameter significantly decreased on the hall's axis.

The performed research work revealed that significant changes in acoustic parameters occur for early reflections of waves incoming within the time interval of 80 ms, as can be seen from distribution of parameters G_{80} and C_{80} (Fig. 13). Its effect in later instants of time is not noticeable, as can be found based on analysis of the factor G_L (Fig. 14b).

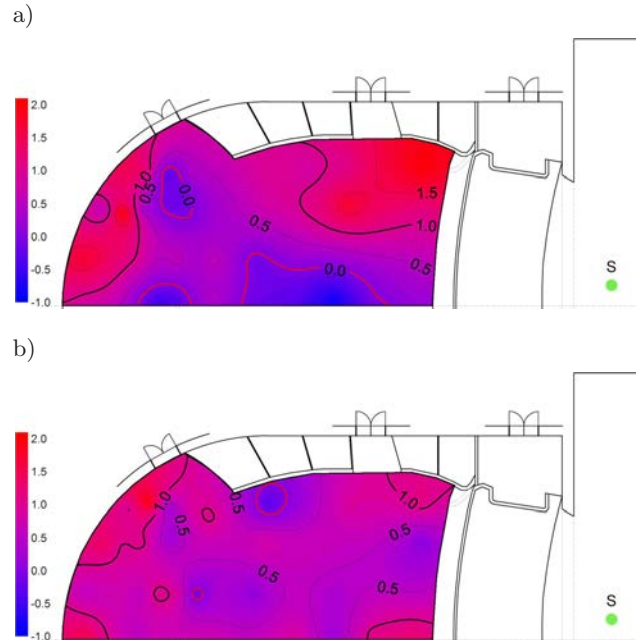
Fig. 14. Distribution of differences of sound strength factors: a) G_{80} 4kHz and b) G_{L} 4kHz.

G_{80} 4kHz (the early sound strength) and G_{L} 4kHz (the late sound strength) for 4 kHz were also investigated. On the basis of measurement before and after installation of the diffuser (Fig. 14), it can be said that the sound strength is changed mainly in the early part, as G_{80} 4kHz is very similar to $G_{4\text{kHz}}$. G_{L} 4kHz distribution is very regular and reveals an about 0.7 dB increase for the whole stalls surface.
