STEAM TURBINE STAGE MODERNISATION IN FRONT OF THE EXTRACTION POINT

Mariusz Szymaniak

Institute of Fluid-Flow Machinery, Polish Academy of Sciences, Poland

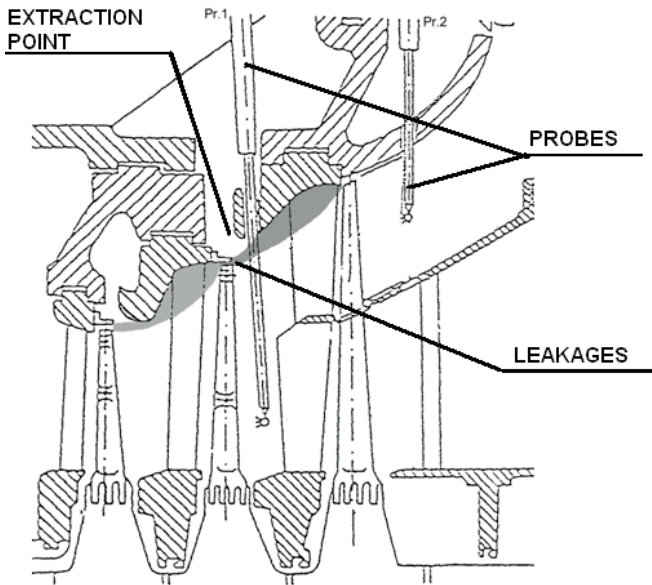
Fig. 1. Thermal measurement equipment in the LP section of 200 MW turbine with Bauman stage; zones of influence of the tip leakage flow are shadowed in grey

For operating reasons, some clearances are to be preserved over the rotor blades in the steam turbine design. The tip leakage flow of steam through the clearances has higher energy and different direction, as compared to the main flow, which is the source of losses in this part of the turbine duct, due to the generation of swirl zones, intensive mixing processes, and blockage of the flow to regenerative heat exchangers. These dissipative processes are particularly intensive in the last stages of LP turbines, where the velocity of the steam flow leaving the clearances over the unshrouded rotor blades is transonic. This effect has firstly been observed in experimental investigations carried out on 200 MW turbines with Bauman stage [1,2]. The thermal measurement instrumentation used for this purpose is shown in Fig. 1.

Plate probes inserted into the flow duct have made it possible to record pressure, temperature, and velocity distributions with high accuracy. Based on the results recorded in the turbine stages before modernisation, a new, more efficient design of steam turbine stage in front of the regenerative extraction point has been proposed, patented and practically applied [3], [4].

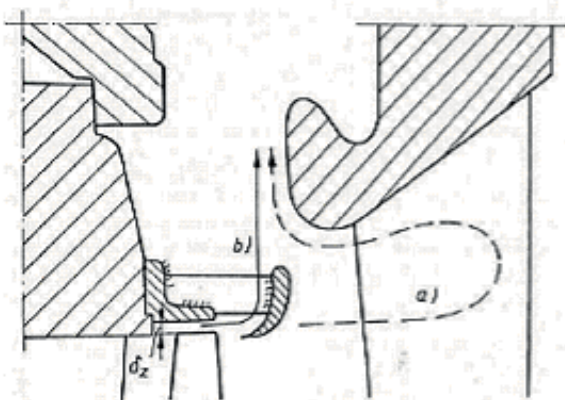
Fig. 2. New design of the stage in front of the extraction point

The idea of the new design is shown in Fig. 2. It mainly consists in installing a properly shaped ring in the tip clearance area of the unshrouded rotor blades to direct the leakage flow to the extraction chamber. Generally, the advantage of the presence of the ring results from eliminating the swirl zone in the flow, as the ring removes the so-called aerodynamic curtain generated by the transonic steam flow within the tip clearance area, see Fig. 2.

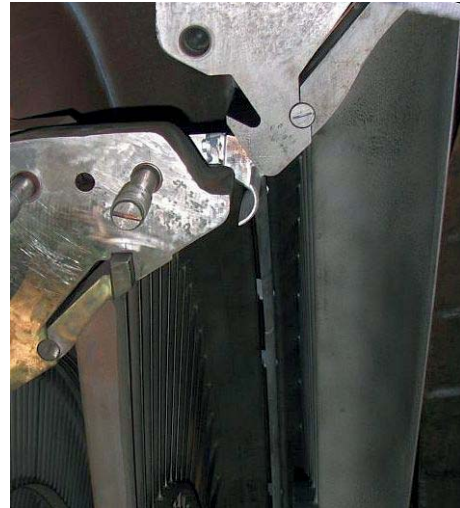
Fig. 3. View of the ring inside the turbine flow path [3]

In the turbines where this solution was applied, the resultant benefits were evaluated as equal to 400 - 800 kW, depending on operating conditions. Over the years 2008–2015, the new solution was applied in seventeen 200 MW turbines. No operational problems were observed, see Fig. 3.

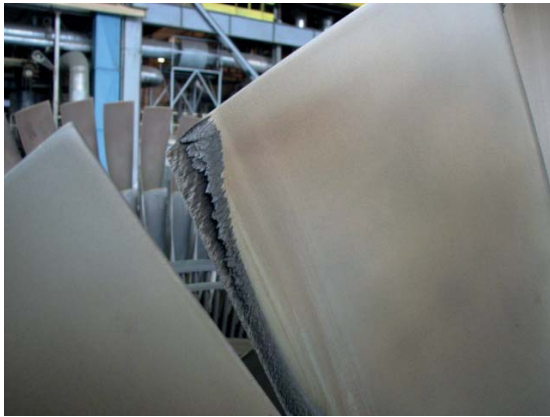
Fig. 4. Leading edge damage patterns observed in the 225 MW turbine last stage rotor blade system

Based on the results of examination of the ring operation in a number of old 200 MW turbines, a decision was made to install those rings also in LP sections of new 225 MW turbines which were modernised in Poland in 2008, in the diffuser area between the two last stages [5], [6]. One of basic motivations for this decision was intensive damages of rotor blade leading edge tip sections in the stages situated directly behind the diffuser, which were observed when inspecting this turbine part, see Fig. 4. These damages were believed to be mainly caused by large water droplets, transported with the steam flow, which were not disintegrated in the blockage area. Additional minor damages observed in the remaining part of the leading edges were most likely generated by smaller droplets splashed by the leakage flow. Of highest threat for

turbine operation were the erosion defects situated in the blade area beyond the hardened zone. Water droplets which reached this area had highly acidic nature ($\text{pH} < 5$) and were a possible source of dangerous cracks in the erosion zone [7].

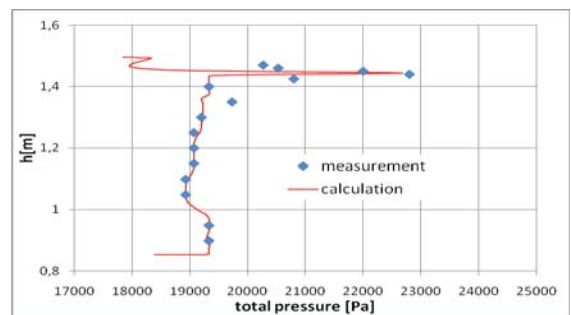
Fig. 6. Comparing the calculated radial distributions of total pressure with those measured in the real turbine

In preliminary tests, comparing the calculated radial distributions of pressure, velocity and temperature with those measured along the traversing line of the measuring probe confirmed the correctness and physical reliability of the boundary conditions assumed at the diffuser inlet in the calculations, see Figs. 6, 8.

The presented diagrams reveal remarkable effect of the stage 3 rotor tip leakage flow on the distributions of thermodynamic parameters in the diffuser. This effect manifests itself, among others, in incorrect flow inlet angles when the flow approaches stage 4 stator blades.

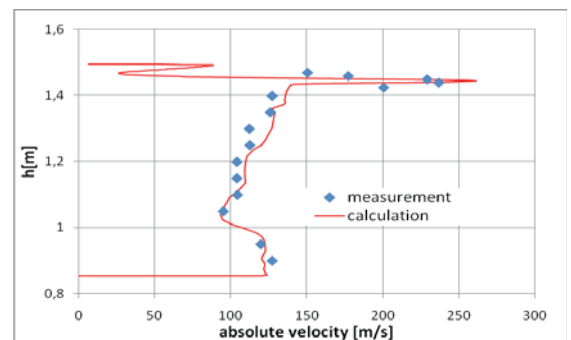
Fig. 7. Comparing the calculated radial distributions of absolute velocity with those measured in the real turbine

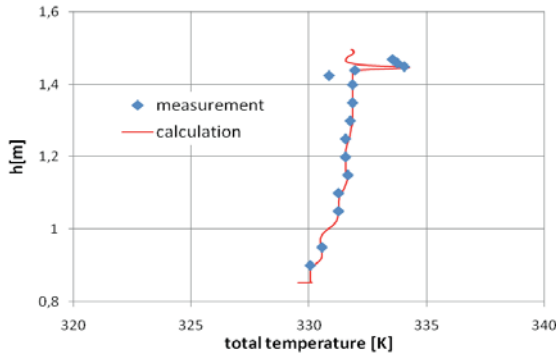
Fig. 8 Comparing the calculated radial distributions of total temperature with those measured in the real turbine

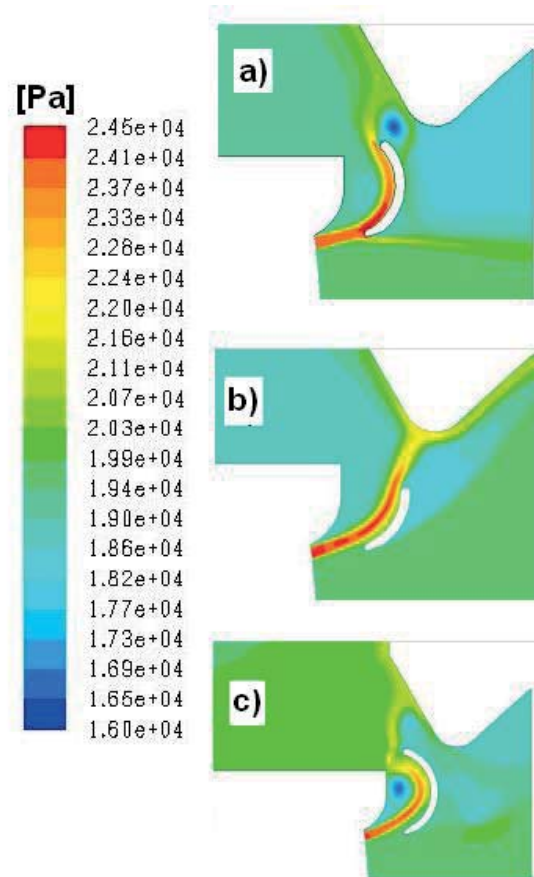
Fig. 10 Total pressure distribution behind the last-but-one stage for different ring positions in the turbine flow (a) ring too high, (b) ring too short, (c) ring too long

ring/blade system arrangements, some important and interesting tendencies have been observed, see Fig. 10. For instance, when the ring was positioned too high it did not eliminate the blockage, but divided the flow into two parts. It did not separate the water droplets collecting behind the last-but-one stage either (see Fig. 10a). On the other hand, when the ring was too low, it increased the swirl zone in the aerodynamic wake in the flow and unfavourably decreased the pressure in the extraction chamber. When the ring was too short, it rapidly stopped the leakage flow on the limiting wall, which was a source of energy losses and possible erosion of the stator grip (Fig. 10b). And when it was too long, it undesirably intensified swirls in the extraction chamber (Fig. 10c).

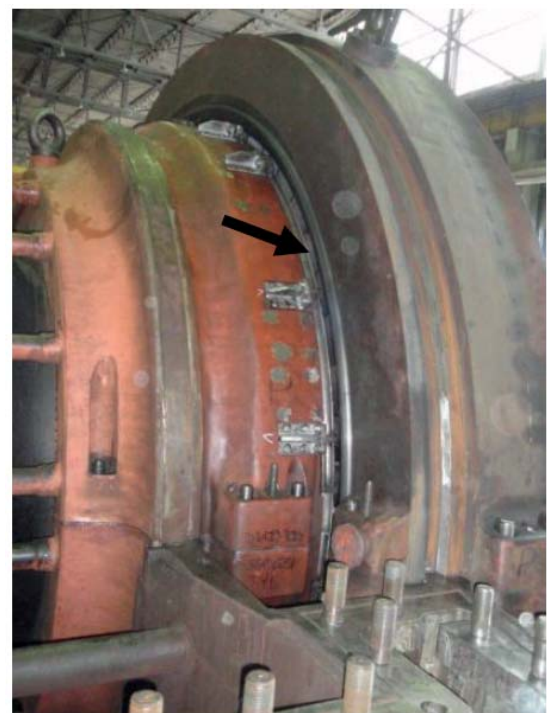
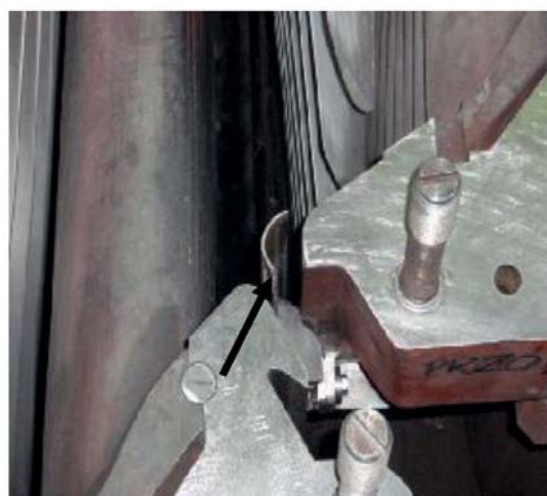
Fig. 13. Photos of the ring installed on stator grips in 225 MW turbine

The technology of manufacturing and assembly was carefully elaborated [15], taking into account specific conditions of steam turbine operation. The ring installed in the turbine is shown in Fig.13 [16].
