Nonsuch – zaginiony pałac Henryka VIII

Nonsuch – Henry VIII's lost palace

* Architekt/Architect, John Simpson Architects, London.

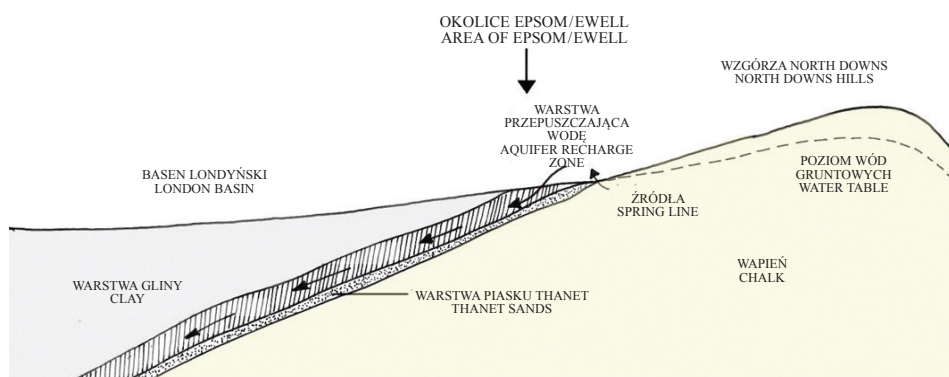
Il. 1. Uproszczony schemat warstw geologicznych (rys. B. Gloger)

Fig. 1. Simplified diagram of geological strata (drawn by B. Gloger)

the creation of numerous natural springs (Fig. 1). The characteristics of the entire region are a good microclimate, scenic beauty and a profusion of springs (admired since the Roman times). The hills are intersected with many river valleys and are of outstanding natural beauty, which attracted humans to build their settlements here. The traces of the first settlers in this area date back as far as prehistoric times [1], [3].

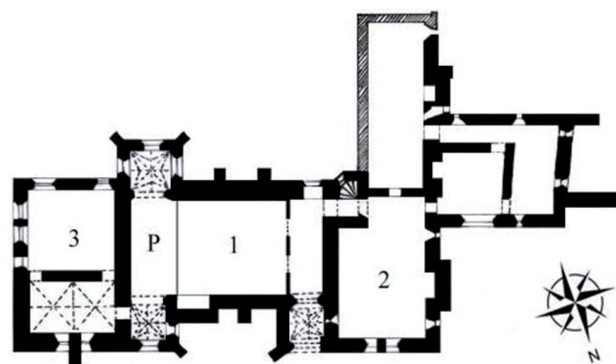
Il. 2. Plan Great Chalfield Manor w Wiltshire (rys. B. Gloger).
1. Hall. 2. Kuchnia i pomieszczenia pomocnicze. 3. Salon. P. Podium
Fig. 2. Great Chalfield Manor in Wiltshire (drawn by B. Gloger).
1. Hall. 2. Kitchen and ancillary rooms. 3. Parlour. P. Dais

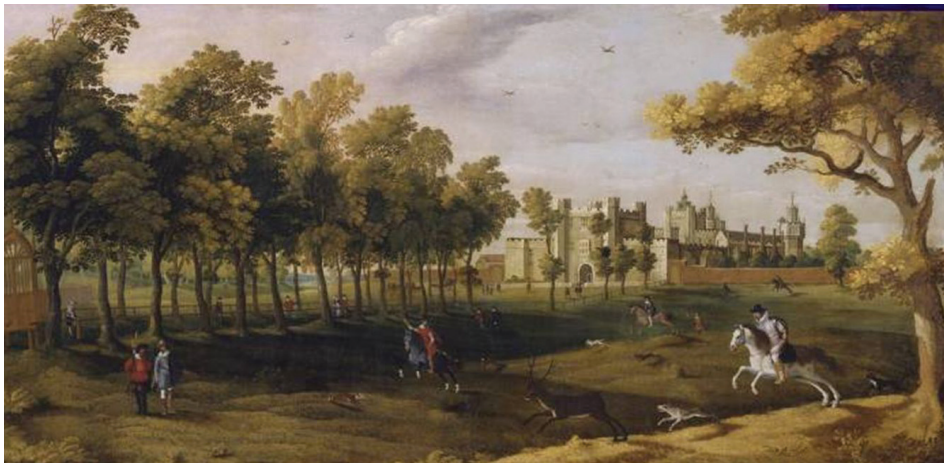
Il. 4. Widok na północną fasadę Nonsuch, XVII w., nieznaną artystą (©The Fitzwilliam Museum, Cambridge)

Fig. 4. North view of Nonsuch, 17th century, unknown artist (©The Fitzwilliam Museum, Cambridge)

The stone and brick used to construct the north facade maintained the typical Tudor style with octagonal towers

at each corner of the gatehouse. The windows were located on the upper floors in walls with crenellations giving the palace a military character. Additionally two sections of front wall at each end projected outwards to achieve the symmetry of the elevation, which was an unusual composition feature at this time. The brick wall running to the east side of the palace probably contained two entrances to the courtyard of the royal kitchens. The adjacent vegetable garden to the east side of the kitchen building was enclosed by the same wall, which also provided the separation for the private garden to the south.

The appearance of the north facade was no different to the buildings erected in this period in the widely popular Gothic style. The inventory written in 1650 describes the central tower of the gatehouse as 17.5 metres wide and three storeys high. It is known that the ground floor contained two rooms that were probably used by the porter. Unfortunately there is insufficient information relating to the functions of the rooms on the upper floors as the historic sources remain silent [3]. A view of the first courtyard opened up as the visitor passed through the gate that was *the most beautiful in its size and appearance and that rose high above the battlemented stone walls on either side* [8, p. 34] as described by the rector of Cheam, Anthony Watson [14], (Fig. 5).

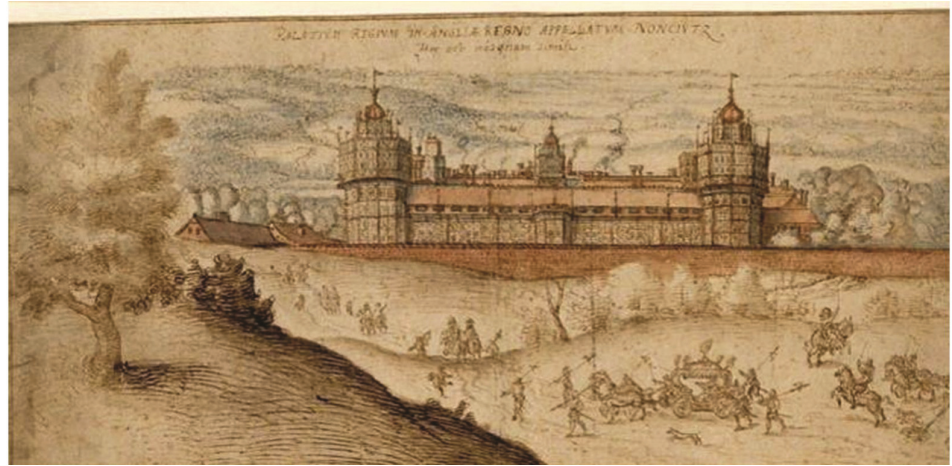
Il. 6. Południowa fasada Nonsuch, Joris Hoefnagel, akwarela 1572 r. (© The Trustees of the British Museum)

Fig. 6. South facade of Nonsuch, Joris Hoefnagel, aquarel 1572 (© The Trustees of the British Museum)
