MAREK CAŁA*, MICHAŁ KOWALSKI*, AGNIESZKA STOPKOWICZ*

**THE THREE-DIMENSIONAL (3D) NUMERICAL STABILITY ANALYSIS
OF HYTTEMALMEN OPEN-PIT****PRZESTRZENNA ANALIZA STATECZNOŚCI WYROBISKA ODKRYWKOWEGO
KOPALNI HYTTEMALMEN W NORWEGII**

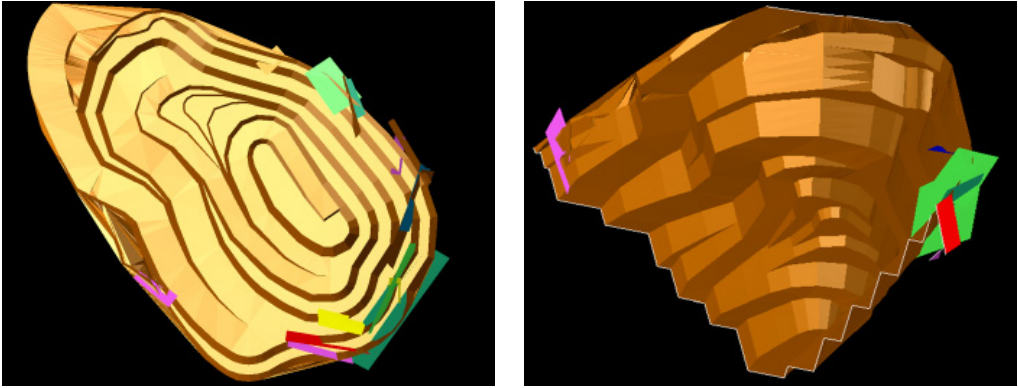
Fig. 2. Joints from Wardell Armstrong Documentation (2010)

Analysing stability of rock slope, the most important factor to consider is the relationship between the orientation of discontinuities and of the excavated face (Wyllie & Mah, 2005). Fig. 2 shows main joints from Wardell Armstrong Documentation (2010). Fig. 3 shows the results of geometrical field investigations which demonstrate the character of discontinuities along the exposed benches of the partially developed open pit.

The differences between Fig. 2 and Fig. 3 show how difficult it is to choose the main joint system. The Bjornevaten Group is a volcano-sedimentary sequence. This rock formation is the most structurally complicated area affected by the tectonic process. Rock slope stability in the Hyttemalmen open-pit is governed by joints. Additional, excavation work using explosives has caused secondary cracking, which exposes rock to weathering, especially of mechanical weathering (Freeze/Thaw action). The most important factor to be considered in the Hyttemalmen open-pit, is the relationship between the orientation of discontinuities and of the excavated face.

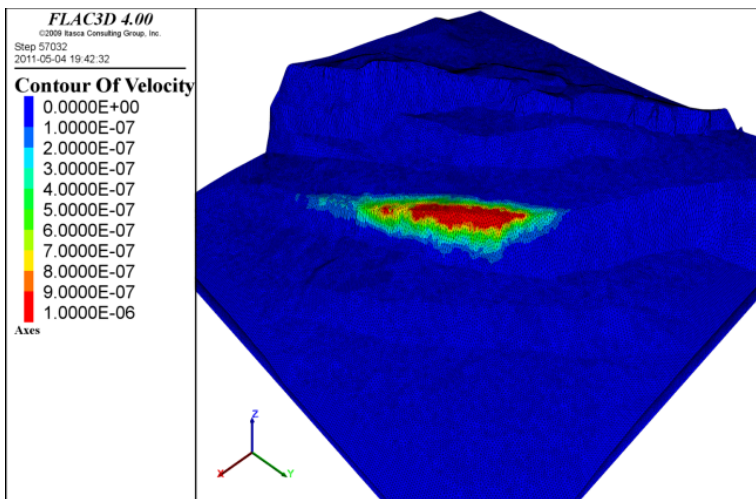
All of the nodes at the bottom surface of the model were fixed. For all four walls of the model, the only displacements in the perpendicular direction to each wall were fixed. Including above conditions into a numerical model, the failure mode of the ramp was simulated. Fig. 4 shows the mas of velocity for the $FS = 1$, the light blue color shows the actual range of the rockslide.

Fig. 4. Rockslide range for the ramp, $FS = 1.00$

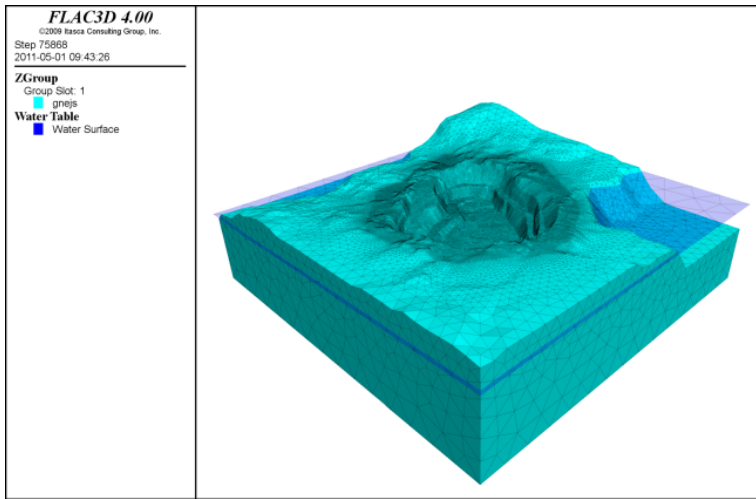
Figure 5 shows the geometry of the entire open-pit (with water table) for the state after the ramp rockslide (state for March 2011). The SSR calculations for this state provided the $FS = 1.36$. That amounts to a stable situation, because generally, the minimum factor of safety should be equal to 1.3, which is widely accepted in open pit mining all over the world.

Fig. 5. Geometry of open pit for state after rockslide, March 2011

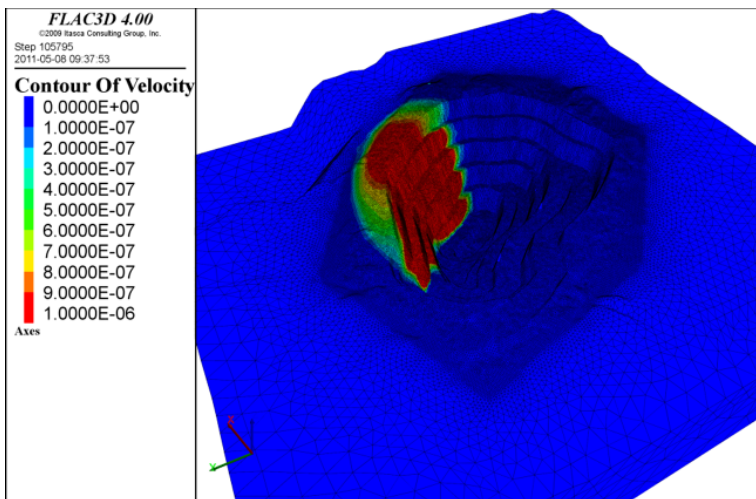
However two or three (depending on open-pit side) deeper levels were planned for further excavation. The final state of the open pit may be observed in figures 2 and 3 (the golden color). Here FS value is equal 1.06. Figure 6 shows the contours of velocity vectors and the failure of the entire open-pit wall, which can be easily observed.

Fig. 6. Rockslide range for final state, $FS = 1.06$, unsafe situation

This is considered to be a minor FS value, therefore such an excavation option should not be executed. The normal level of inclination for the Hyttmalmen open-pit level is 80° . It was however proved that for such a slope, global open-pit stability cannot be assured. The change of slope geometry seemed to be unavoidable. The Hyttmalmen open-pit is in a very poor state due to blasting damage, water inflow and the freeze/thaw processes. These seriously reduced the rock mass and joint strength. That's why, two options were analysed to establish whether it's enough to optimise this geometry for the lower stages – decreasing the inclination to 60° and 70° respectively.

At the final planned stage of excavation, the factor of safety drops to 1.06 with failure surface ranging through all of the slopes (Fig. 6). Options for decreasing the inclination of lower slopes to 60° or 70° degrees are not fully satisfactory. In the case of a 60° inclination, safe FS ranges equal a value of 1.3. This option is however not technologically executable due to the limitations of drilling equipment. In the case of a slope angle 70° for lower stages, $FS = 1.26$, which is not enough to provide slope stability. Another series of calculations were therefore performed taking water table lowering into consideration, which increases the global safety factor. It was finally evaluated, that for a water table level of 72 m the factor of safety equals 1.3, which is enough to assure global open-pit stability.

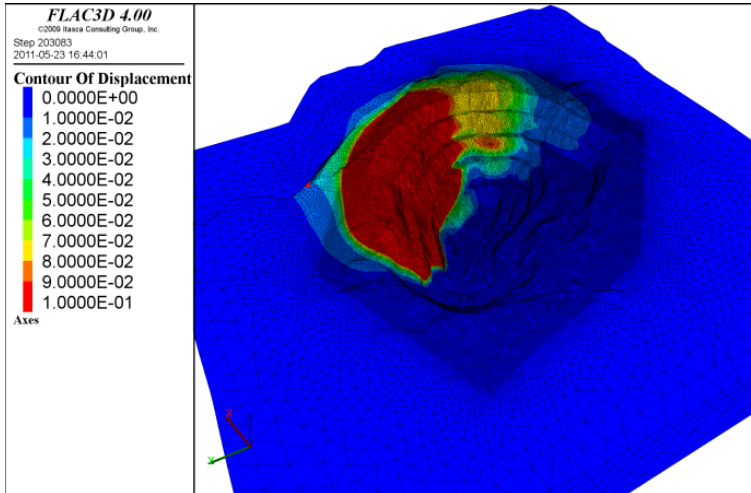
Assuming a slope angle of 60° for the lower stages, FS for such a proposition is equal 1.30, which is enough to provide slope stability (Fig. 7). The failure surface ranges of the upper level of the open pit suggests that geometry change improves stability and is satisfactory for providing the necessary safety level.

Fig. 7. Rockslide range for final state, slope inclination 60° ,
 $FS = 1.30$ safe situation

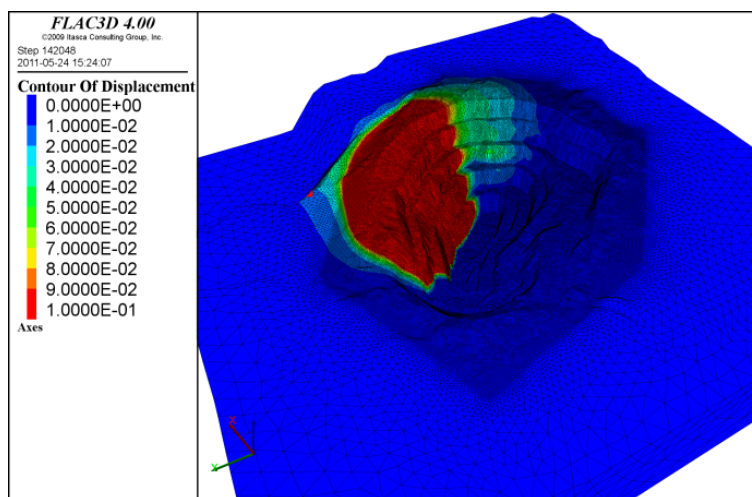
This allowed for the following series of calculations to be performed. The object of the analyses was to estimate, what the water level for the option of slope angle 70° for lower stages should be in order to obtain a factor of safety value equal 1.3. therefore, lowering the water table through dewatering improves global slope stability. After a few calculations for different water levels, it was evaluated that for a water table at the level of 72 m, the factor of safety equals 1.3 (Fig. 8). The failure surface is slightly different than in the case of fig. 6, but the safety factor of 1.3 assures the necessary stability level.

Fig. 8. Rockslide range for final state, slope inclination 70° , water level at 72 m a.s.l., $FS = 1.30$ safe situation
