ELECTROPLASTIC EFFECT OF HIGH MANGANESE AUSTENITIC STEEL

Keywords: electroplastic effect, high manganese steel, TWIP effect

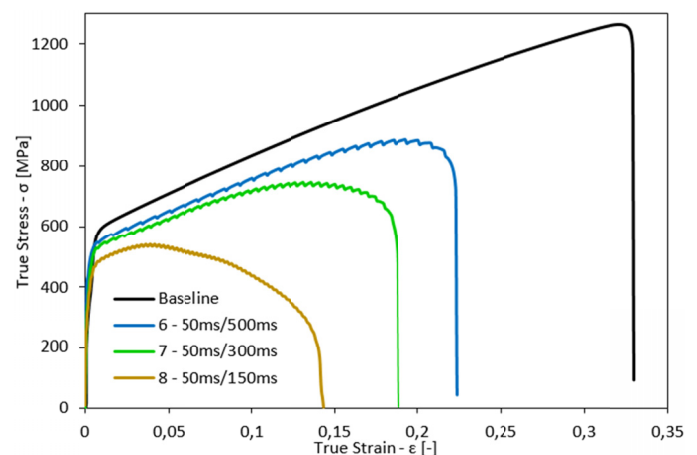
Fig. 5. True stress-strain curves without and with the application of electric current impulses

As it has been shown in Figure 5, the presence of characteristic “serrations” on the stress-strain curve was observed when the impulse's duration time and the period were increased. Such a behaviour should be explained by the fact that, at the moment of applying the electric current impulse, a drop of flow stress takes place (stress-drop), whereas, during the pause between the impulses, the material begins to strain-hardening behaviour again, which is a commonly known phenomenon [13]. A significant drop of stress and elongation were observed when the frequency of the flowing current increased, while the impulse's length was maintained on the same level. Especially when the value of the maximal stress dropped from 1263 to 538 MPa and the elongation decreased from 0,33 to 0,143, for the parameters no. 8 (50 ms/150 ms) and the highest current density, equalling $55,6 \text{ A/mm}^2$ has been obtained. It is also worth mentioning that, in each case, a lower value of flow stress was observed.

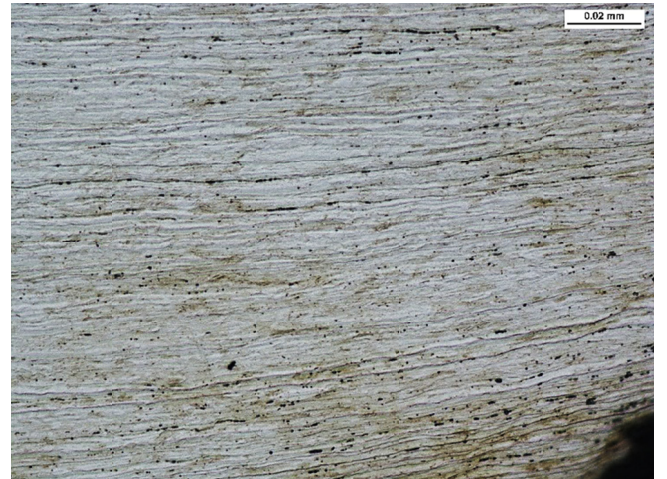
Fig. 12. Microstructure of the baseline sample, LOM, etched in nital

The observation was carried out in order to evaluate the microstructural evolution of deformed zones at different conditions (Fig. 12-14). In case of each micrograph the direction of tensile force is parallel to horizontal direction of the picture and banding of the microstructure. Due a strong deformation and banding of the microstructure it is very difficult to identify its evolution. However, figure 13 shows deformation zone of

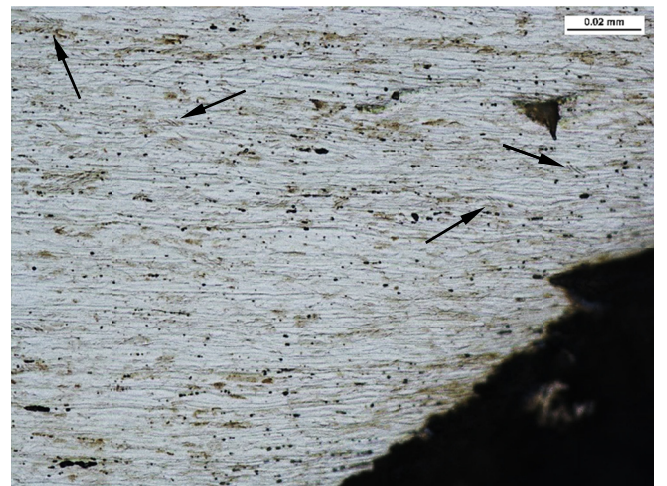
Fig. 13. Microstructure of sample 280°C, LOM, etched in nital

sample investigated at elevated temperature, it is seen that examples small groups of slip bands are inclined at the angle of 45° to the direction of tensile force (marked by black arrows). That slip systems (in the grains interior) were activated by plastic deformation. Mechanical twins, which occur at such a high level of deformation in this type of steel are not visible. Also the strain-induced martensite and differences in the grains size were not observed. TEM observation should be carry out to further studying the microstructural evolution, especially to revealing the mechanical twins and their intensity depending on the conditions and eventual confirming the absence of martensite. Moreover, in the each of micrographs presence of the voids, in the form of black dots, were observed. They are identified with micro-tunnels, which were found in the images of fractures (Fig. 8-11). Additionally, in the case of samples deformed with application of current impulses, near the edge of the fractures, the specific bands were revealed, inclined at the angle of 135° to the direction of tensile force (marked by black arrows in Fig. 14).

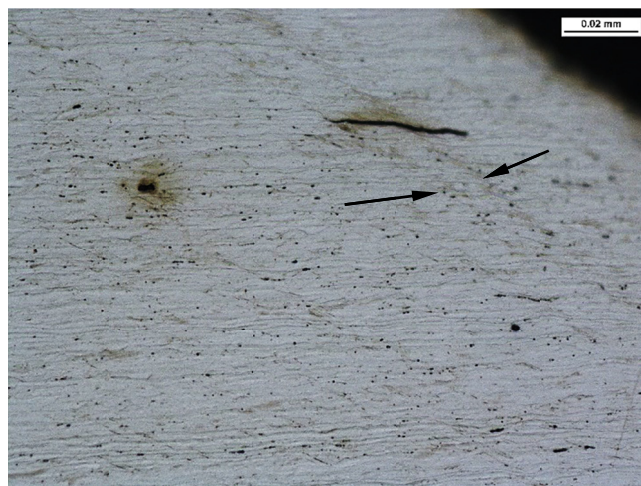
Fig. 14. Microstructure of sample no. 6, LOM, etched in nital
