# THERMOGRAPHIC STUDY OF CHIP TEMPERATURE IN HIGH-SPEED DRY MILLING MAGNESIUM ALLOYS

This paper presents an overview of the state of knowledge on temperature measurement in the cutting area during magnesium alloy milling. Additionally, results of own research on chip temperature measurement during dry milling of magnesium alloys are included. Tested magnesium alloys are frequently used for manufacturing elements applied in the aerospace industry. The impact of technological parameters on the maximum chip temperature during milling is also analysed. This study is relevant due to the risk of chip ignition during the machining process.

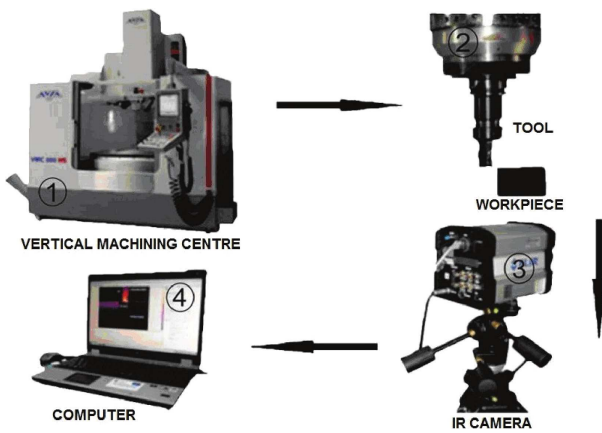
In tests, thermal images were taken with a resolution of  $320 \times 256$  dpi. Total recording frequency set to the value of 100 Hz accounted for dynamic extension of the measuring range in value  $360^\circ\text{C}$  and time of recorded sequences. Schematic diagram of test setup is shown in Fig. 1.

Fig. 1. IR measurement setup.

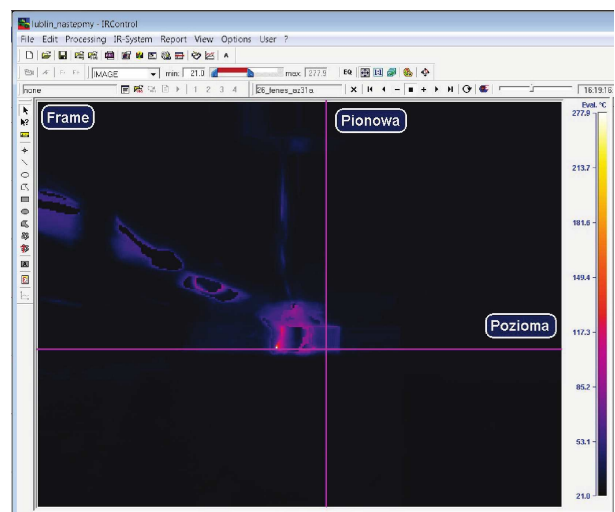
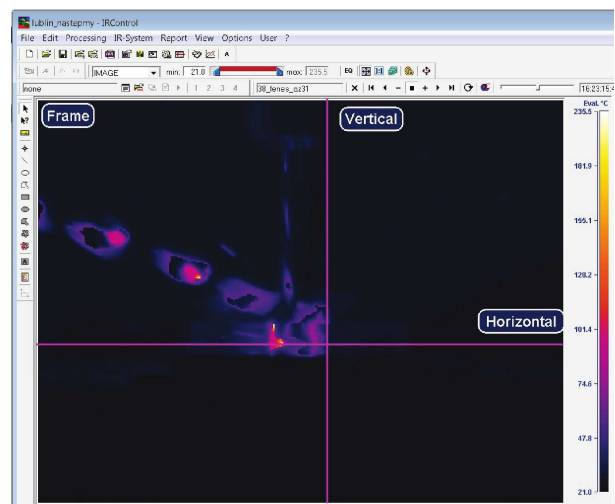
Thermal images of chips machined at the highest cutting speed and feed rate applied in the tests are shown in Fig. 2.

Fig. 2. Thermal images of AZ31 magnesium alloy cutting process: a) maximum cutting speed  $v_c = 1200$  m/min,  $a_p = 6$  mm,  $f_z = 0.15$  mm/tooth; b) maximum feed per tooth  $f_z = 0.3$  mm/tooth,  $v_c = 800$  m/min,  $a_p = 6$  mm.

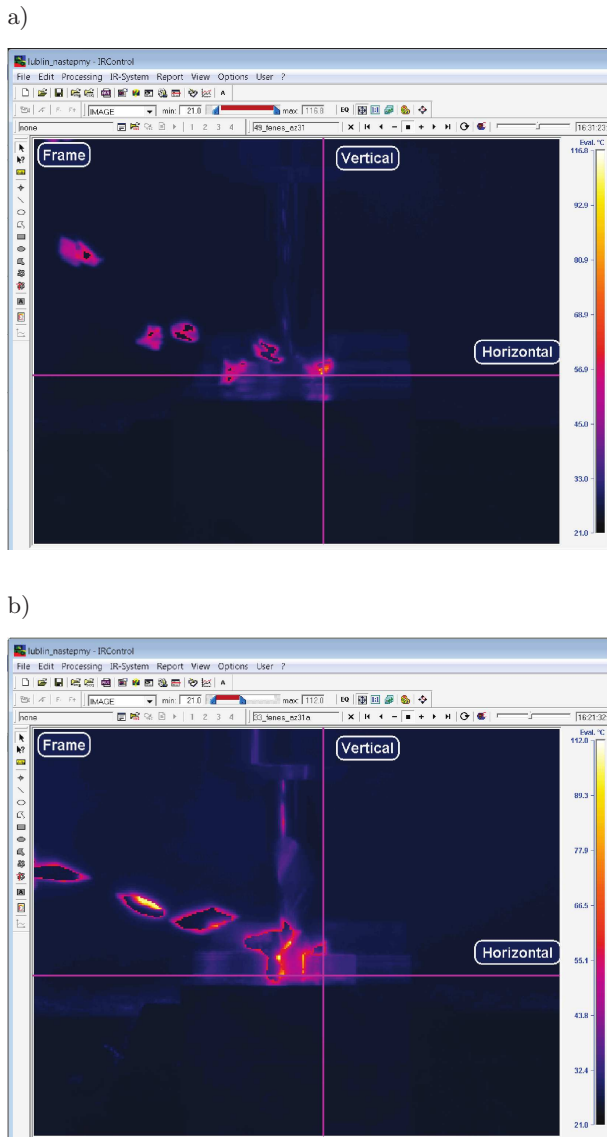
Thermal images for various depths of cut, constant feed rate and cutting speed are shown in Fig. 3.

Fig. 3. Thermal images of AZ31 magnesium alloy cutting process: a)  $a_p = 0.5$  mm,  $v_c = 800$  m/min,  $f_z = 0.05$  mm/tooth; b)  $a_p = 6$  mm,  $v_c = 800$  m/min,  $f_z = 0.05$  mm/tooth.

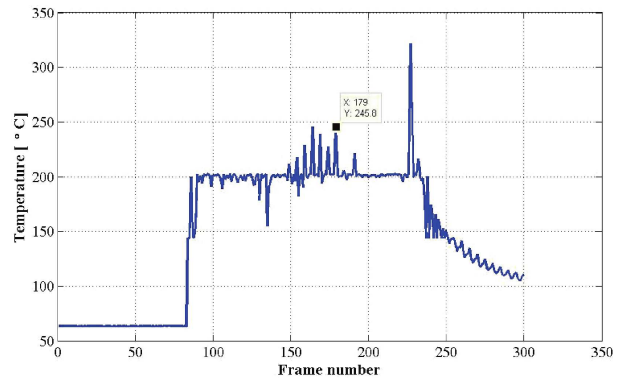
The aim of the study was to compare maximum temperature in subsequent frames during cutting. Frames with maximum temperature were chosen for the analysis. The frame selection method is shown in Fig. 4.

Fig. 4. Frame selection method for evaluation of relationship of cutting parameters.

In order to compare relationship of selected cutting parameters, several cutting test were carried out. The frames located approximately in the middle of the recorded thermal image sequence where the greatest value of temperature was detected were chosen for subsequent analysis. What is more, in a recorded frame chips must be detected. Frames in which extreme values were not observed, were not taken into consideration in analysis. Examples of experimental data concerning AZ31 magnesium alloy samples are shown in Table 1. Values of maximum temperatures detected in frames, taken from different cutting tests, are arranged in column T (Table 1). Column T Max is the sum of T and Error +2%, whereas T Min is equal to the sum of T and Error -2%.

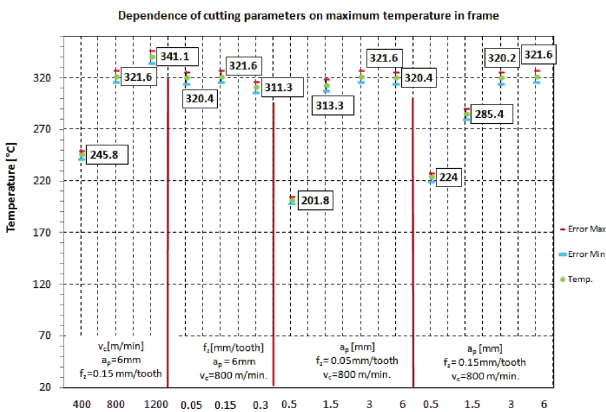
Error values were calculated from technical parameters provided by the manufacturer of FLIR SC6000HS thermal camera [20]. Based on recorded sequences the ranges of temperatures were defined, and next 2% of evaluated range for each test was calculated and put in Table 1. Measured temperatures and values of camera errors are shown in Fig. 5.

The dependence of cutting speed, feed per tooth and depth of cut on temperature in frame, where the milling cutter is in mid-position of the workpiece is shown in Fig. 5.

Fig. 5. Overall comparison of the relationship between cutting parameters and temperature with measurement error at  $\pm 2\%$  of measuring range.

Test results indicate that an increase in cutting speed induces a significant increase in temperature measured in a frame. The same relationship was observed for different feed per tooth rates in three variants (Fig. 5). A slight temperature decrease was observed at low feed per tooth in cutting conditions with depth of cut equal to  $a_p = 6$  mm, as compared with  $a_p = 0.5$  mm. In the former, an increased friction could have occurred causing an increase in temperature. Temperature difference was insignificant and equalled  $5^\circ\text{C}$ . Based on Table 1, presenting the correlation between depth of cut and temperature, it was proved that measurement error amounted to maximum  $\pm 2^\circ\text{C}$ , as estimated by the camera manufacturer.

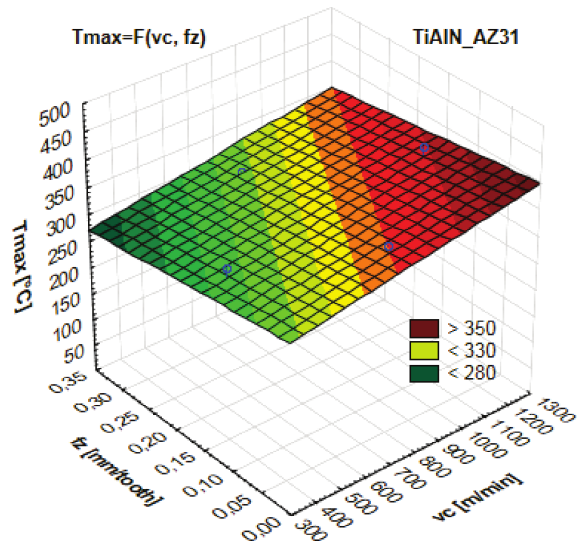
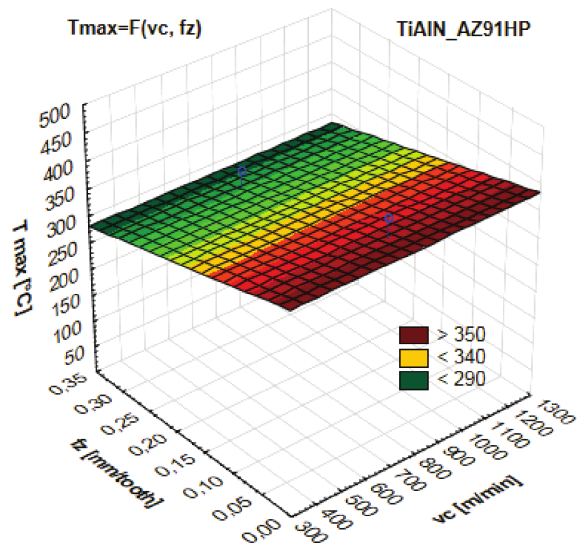
Fig. 6. The dependence of cutting speed  $v_c$  and feed per tooth  $f_z$  on the maximum chip temperature in the cutting area: a) AZ31 alloy, b) AZ91HP alloy.

The relationship between cutting speed  $v_c$  and feed per tooth  $f_z$  on chip temperature in the cutting area is presented in Fig. 6, and the relationship between depth of cut on chip temperature in the cutting area is presented in Fig. 7.

finding maximum temperature occurring in the cutting area since they pose the risk of ignition. Maximum temperatures are shown in Fig. 6 and Fig. 7.

Neither cutting speed nor feed rate significantly influence chip temperature. Temperature growth is more significant for higher depths of cut. This obser-

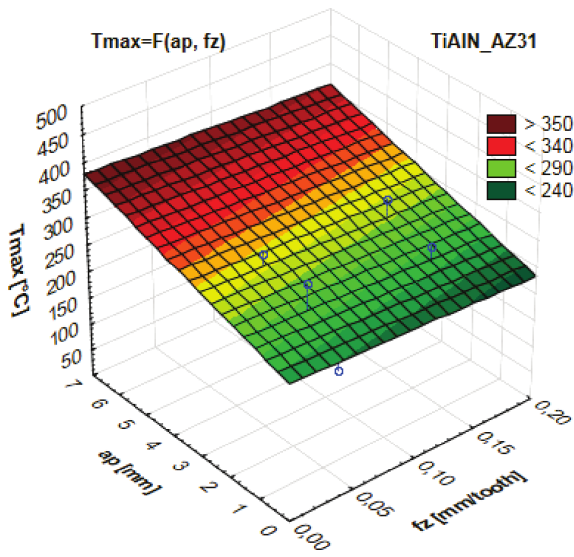
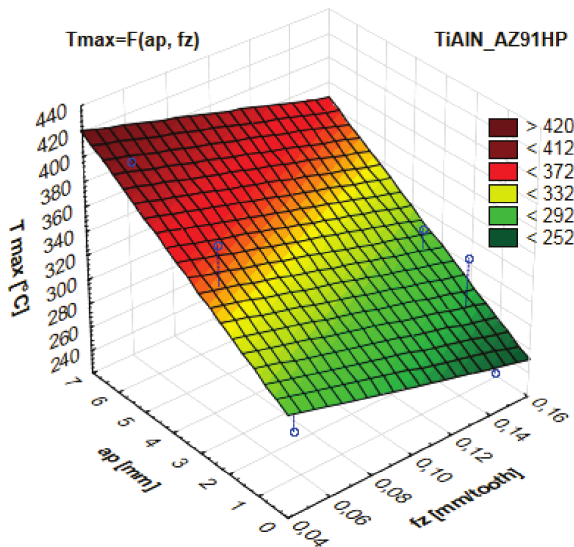
Fig. 7. Relationship between depth of cut  $a_p$  and feed per tooth  $f_z$  and maximum chip temperature in the cutting area: a) AZ31 alloy, b) AZ91HP alloy.

vation seems vital as far as chip ignition is concerned, as for the machining safety it seems well-founded to increase feed rate and cutting speed rather than depth of cut. It should be, nevertheless, kept in mind that too extensive reduction of depth of cut is dangerous, as fine chips are more susceptible to risk of ignition.
