METROLOGY AND MEASUREMENT SYSTEMS

APPLICATION OF INFRARED THERMOGRAPHY TO NON-CONTACT TESTING OF VARISTORS

Stanisław Galla, Alicja Konczakowska

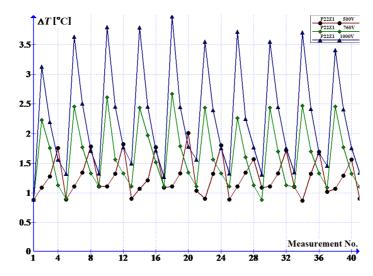
Fig. 2. Temperature increments ΔT recorded in successive measurements with an infrared camera during application of surges at 3 voltage levels: 500 V, 760 V and 1000 V for varistor No. 5 of P22Z1 type.

On the basis of recorded temperature increments, average values (for tested varistors) were assessed. The values were not exceeding 2°C, 3°C and 4°C for P22Z1 and S07K14 type varistors, for voltage surge levels of 500 V, 760 V and 1000 V (Fig. 2 and Fig. 3), respectively.

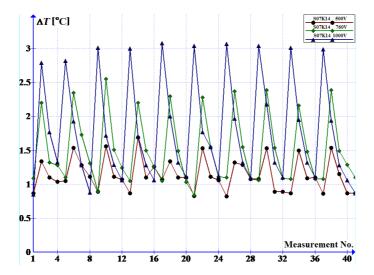
Fig. 3. Temperature increments ΔT recorded in successive measurements with infrared camera during application of surges at 3 voltage levels: 500 V, 760 V and 1000 V for varistor No. 5 of S07K14 type.

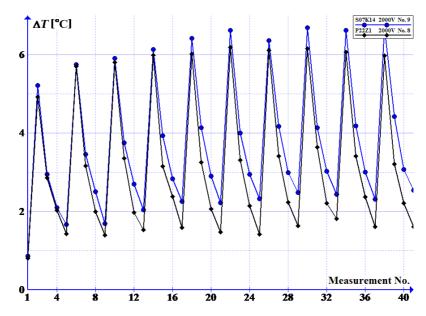
Fig. 4. Temperature increments ΔT recorded in successive measurements with infrared camera during application of surges of 2000 V voltage level for varistor No. 8 of P22Z1 type and varistor No. 9 of S07K14 type.

For P22Z1 type varistors average values of recorded temperature increments were calculated. They exceeded 6°C for varistors Nos. 6, 7 and 8, whereas for varistors No. 9 and No. 10 were smaller than 6°C. The capacitance values $C(t_N)$ for varistors Nos. 6, 7 and 8 exceeded 2612 pF, whereas for varistors No. 9 and No. 10 were smaller than the above value. Thus, the capacitance changes, as well as temperature increment values, indicate that varistors Nos. 6, 7 and 8 lose their protective properties.

For S07K14 type varistors average values of recorded temperature increments were calculated. For all varistors the values exceeded 6°C. The capacitance values $C(t_N)$ for all varistors exceeded 2530 pF. Thus, the capacitance changes, as well as temperature increment values, indicate that all S07K14 type varistors lost their protective properties.

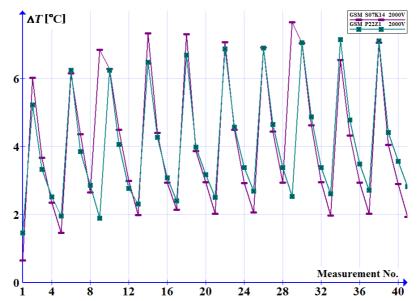
Fig. 5. Temperature increments ΔT recorded in successive measurements with infrared camera, during application of surges with 2000 V voltage level for P22Z1 and S07K14 type varistors operating in communication modules No. 3.

The recorded temperature increments for surges with 500 V, 1000 V and 2000 V levels were equal to 1.3°C, 3.15°C and 6.3°C for modules with P22Z1 type varistors, and 1.35°C, 3.52°C and 7.24°C for modules with S07K14 type varistors. The capacitance values of varistors submitted to surges with voltage levels of 500 V and 1000 V, measured 24 hours after completion of tests, have not changed significantly, i.e. to the point that corresponds with losing protective properties by varistors. Thus, it can be stated that the varistors have not changed their protective properties. The temperature increment values on the varistor surfaces have not also suggested loss of protective properties by varistors, i.e. they have not exceeded 6°C. However, the capacitance values of varistors operating in modules No. 3 submitted to surges with the 2000 V voltage level, measured 24 hours after completion of tests, have increased considerably. The temperature increment values on the varistor surfaces were higher – from the 20th measurement on – than the values suggesting loss of protective properties of varistors, i.e. exceeded 6°C (Fig. 5).

Fig. 5 illustrates that S07K14 type varistors showed a higher temperature increment (7.24°C) than the P22Z1 ones (6.3°C).

The level of changes in capacitance values and temperature increment values for varistors operating in modules No. 3 suggests recommending their replacement with other varistors before launching the GSM modules into the market.
