High temperature resistance of silicide-coated niobium

Abstract. In this paper, thermal oxidation resistance of silicide-coated niobium substrates was tested in a temperature range of 1300–1450°C using an HVOF burner. Pure niobium specimens were coated using the pack cementation CVD method. Three different silicide thickness coatings were deposited. Thermal oxidation resistance of the coated niobium substrates was tested in a temperature range of 1300–1450°C using an HVOF burner. All samples that passed the test showed their ability to stabilize the temperature over a time of 30 s during the thermal test. The rise time of substrate temperature takes about 10 s, following which it keeps constant values. In order to assess the quality of the Nb-Si coatings before and after the thermal test, light microscopy, scanning electron microscopy (SEM) along with chemical analysis (EDS), X-ray diffraction XRD and Vickers hardness test investigation were performed. Results confirmed the presence of substrate Nb compounds as well as Si addition. The oxygen compounds are a result of high temperature intense oxidizing environment that causes the generation of SiO phase in the form of quartz and c

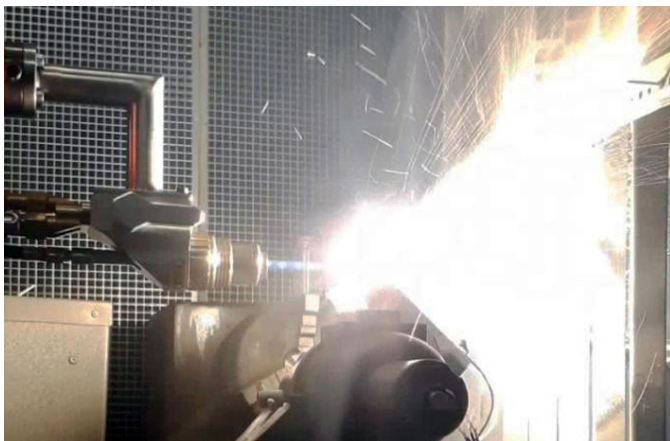
Fig. 1. Thermal test of Nb sample without coating

Pure and coated Nb samples were subjected to thermal testing using an HVOF flame in a fixed process parameter. The purpose of the test was to pre-determine the suitability of the produced coatings for use in high temperature applications. In addition, temperature was measured on the opposite side of the sample relative to the flame, in order to determine the thermal resistance of the coatings deposited on Nb substrates. The course of the thermal resistance test consisted of the following steps (Fig. 1):

1. Clamping a cylindrical sample with a diameter of 50 mm in the holder (tools steel) under 45° to the flame axis.
2. HVOF ignition and stabilization of combustion conditions away from the sample.
3. Rapid approach of the HVOF gun to the central position of the sample at the distance of 80 mm between the nozzle exit and the sample surface.
4. Holding for 30 s and simultaneous temperature measurement on the other side of the sample.

5. Quick nozzle departure, flame extinguishing and slow cooling of the sample in the air flow.

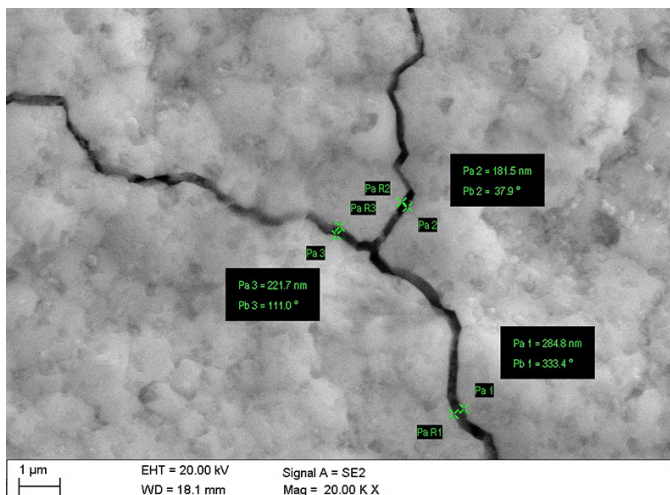
Fig. 9. Surface morphology of NbSi layer (W2 specimen). Cracks were observed on the NbSi surface

The coating surface topography it is not homogenous. Characteristic relief was observed as well as small cracks on the top. The cracks size relates to the specimen type. The smallest width of cracks occurred for sample W2.

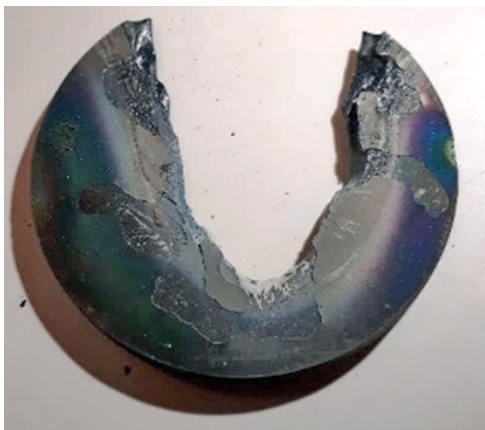
Fig. 18. W2 sample after high temperature oxidation thermal test (failed). Critical material sputtering process occurred. The specimen was destroyed. Magnification $\times 1$

As a result of the thermal test of Nb-NbSi TBC samples, the traces of wear were observed and rated. All of the samples, except for Nb-NbSi W2 (Fig. 18), passed the thermal test without significant destruction of the TBC layer or the metallic Nb substrate (Fig. 17, 19).

The NbSi structure has a characteristic columnar shape. It may grow according to Thornton's rule [27]. Only the Nb-NbSi W2 sample exhibits total destruction as a result of damage to the TBC layer. It is thought that the NbSi coating on the sample showed some defects before the test. Probably the present cracks were formed during the coating process. This stands as clear evidence that even a small defect of the TBC layer may cause rapid destruction of whole composite material. In the case of sample W2, the depth of cracks could be higher than those of sample W1 and W3.

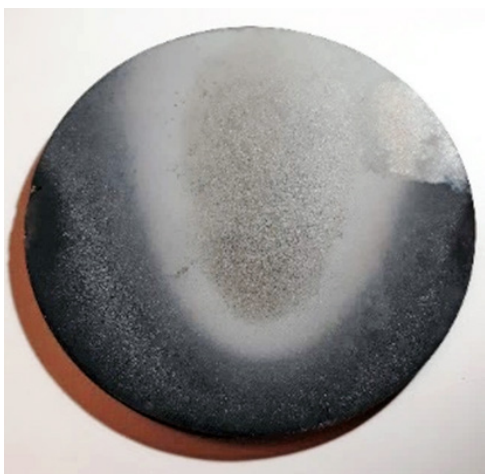
Fig. 19. W3 sample after high temperature oxidation thermal test. Magnification $\times 1$. No material sputtering effect occurred

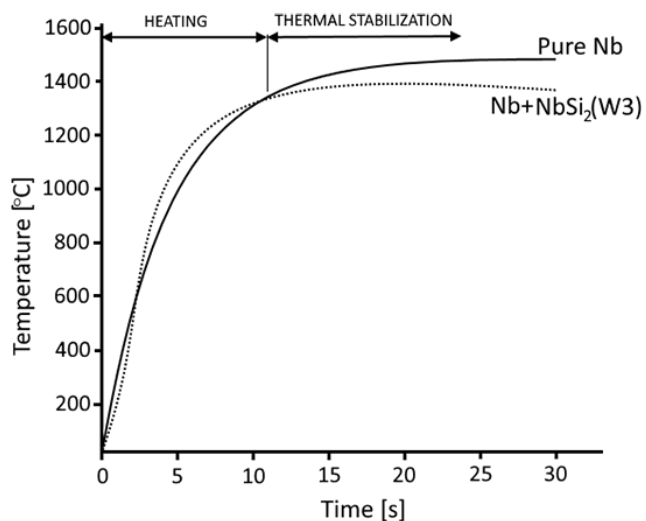
Fig. 20. Heating rate characteristic during thermal test of W3 sample (NbSi thickness – 90 μm) and pure niobium

All samples that passed the test showed their ability to stabilize the temperature over time of 30 s during the thermal test. The rise time of substrate temperature takes about 10 s, after which it keeps constant values (Fig. 20).
