M. SOLECKA<sup>\*,#</sup>, M. KOPYŚCIAŃSKI\*, J. KUSIŃSKI\*, A. KOPIA\*, A. RADZISZEWSKA\***EROSIVE WEAR OF INCONEL 625 ALLOY COATINGS DEPOSITED BY CMT METHOD**

*Keywords:* Inconel 625, erosion wear, solid particles erosion, alloys

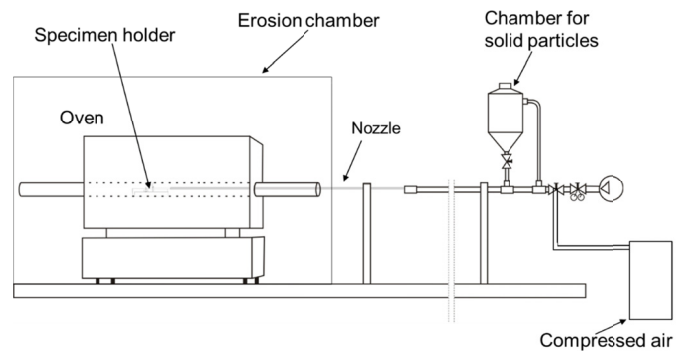
Fig. 1. The diagram showing the position of to simulate erosive wear

The erosive wear tests were performed using the author's testing stand. The abrasion wear testing stand is shown in (Fig. 1). The proposed concept of the device for erosive wear process simulation refers to the method that reproduces the mechanism of impact erosion that is caused by the impact of hard particles, where the abrasive carrier is a stream of compressed air [17]. The basic objective was to enable the tests to be conducted under high-temperature conditions. To be able to perform the tests not only at ambient temperature, but also at an elevated temperature, the device was equipped with a pipe furnace, for which a special holder was designed to enable the control of the impingement angle of abrasive hitting the specimen. The erosive wear process simulation stand according to ASTM G 76 consisted of a compressed air source, an abrasive batching system, a mixing chamber and a nozzle [18]. Compressed air and solid particles are delivered to the mixing chamber, from where the mixture is discharged via a 1 mm-diameter 570 mm-long nozzle. After leaving the nozzle, accelerated abrasive particles carried by the air stream hit the surface of a test sample positioned at a distance of 5 mm from the nozzle, with a specified kinetic energy. During testing, the velocity of solid particles discharged from the nozzle should be approx. 90-110 m/s. The air flowrate should be maintained at a level of approx. 16 m<sup>3</sup>/h at a pressure of 0.3 MPa. The tests were conducted, respectively, at ambient temperature, i.e. 20°C, and at a temperature of 650°C, which simulates the boiler operation temperature. The test specimens, in the form of an 12×20×2 mm rectangular prism, were fixed on the table at an appropriate abrasive particle impingement angle.

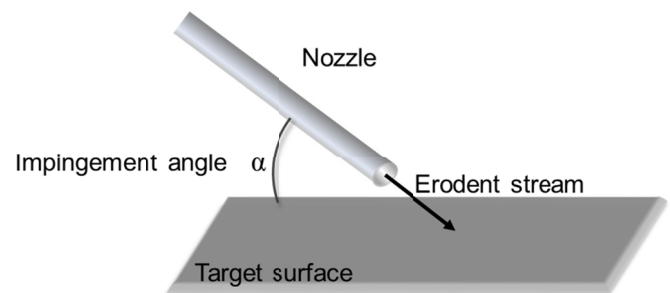
Fig. 2. Schematic diagram depicting the impingement angle of solid-particle erosion [19]

To determine the erosion wear resistance, the weld clad layer of the Inconel 625 alloy and the same material after plastic working condition, were subjected to erosive wear testing at different abrasive solid particle impingement angles of, respectively: 30°, 45°, 60° and 90°. The differentiation of abrasive particle impingement angles, as well as the temperature, allowed the determination of the course of erosive wear processes. As the abrasive, Al<sub>2</sub>O<sub>3</sub> with a grain size distribution of 180-220 μm was used. The particles of the abrasive used were characterized by high hardness – above 2000 HV, and the presence of sharp edges. Using a precision laboratory balance, all specimens were weighed prior to and after the erosive wear test. On that basis, the ratio of the specimen mass loss to the mass of the abrasive striking the specimen was determined. In the erosive wear tests, the impingement angle of incidence of abrasive particles was measured between the particle incidence direction and the disc surface (Fig. 2).

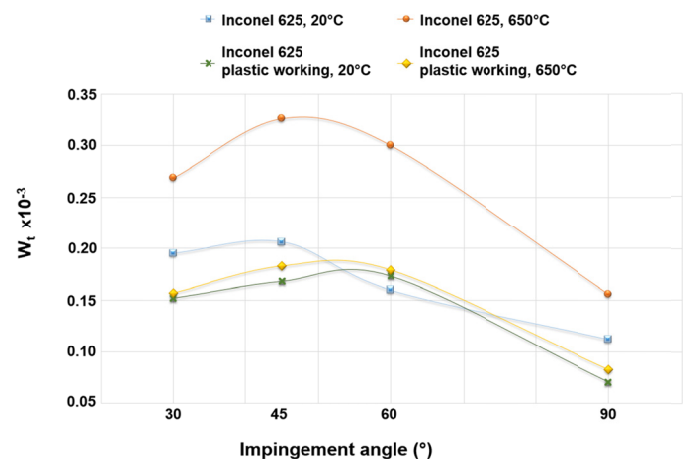
Fig. 3. Graph showing the dependence of erosive wear ( $W_t$ ) with respect to the impingement angle incidence of the abrasive material

Assuming the coefficient as the intensity of the material erosive wear ( $W_t$ ), a diagram has been plotted (Fig. 3), which illustrates the dependence of the material erosive wear on the abrasive particle incidence angle for two materials tested at two temperatures. It can be noticed from the diagram that the material wears faster at elevated temperature, which may suggest that erosive wear intensity at higher temperature (650°C) is often due to the erosive wear of the surface and the formation of an oxide protective layer on the material surface, which is brittle and more prone to chipping off as a result of erosion. It is supposed that the greater mass loss of Inconel 625 clad layer compared to the material after plastic working may be due to the greater inhomogeneity. Then Inconel layer has worse mechanical properties for example elongation or tensile strength in comparison with plastic worked alloy. Therefore material after

plastic working has higher corrosion resistance than clad layer. During heating, the surfaces of the specimens become oxidized before undergoing erosion. Thus, if the oxide film on the layer is thicker, the erosion loss will be greater. It was also found that the greatest mass loss, for the investigated Inconel 625 alloy and for the same material after plastic working, took place at an abrasive impingement angle of 45°. The smallest mass loss for all of the tested materials was found at an impingement angle of 90°. Inconel 625 after plastic working is characterized by a much smaller mass loss compared to the weld clad made of the same material (Fig. 3) [19].

At an elevated temperature, the wear profile is distinct at the impingement angle 45° for both materials, as confirmed by the data in (Fig. 3).

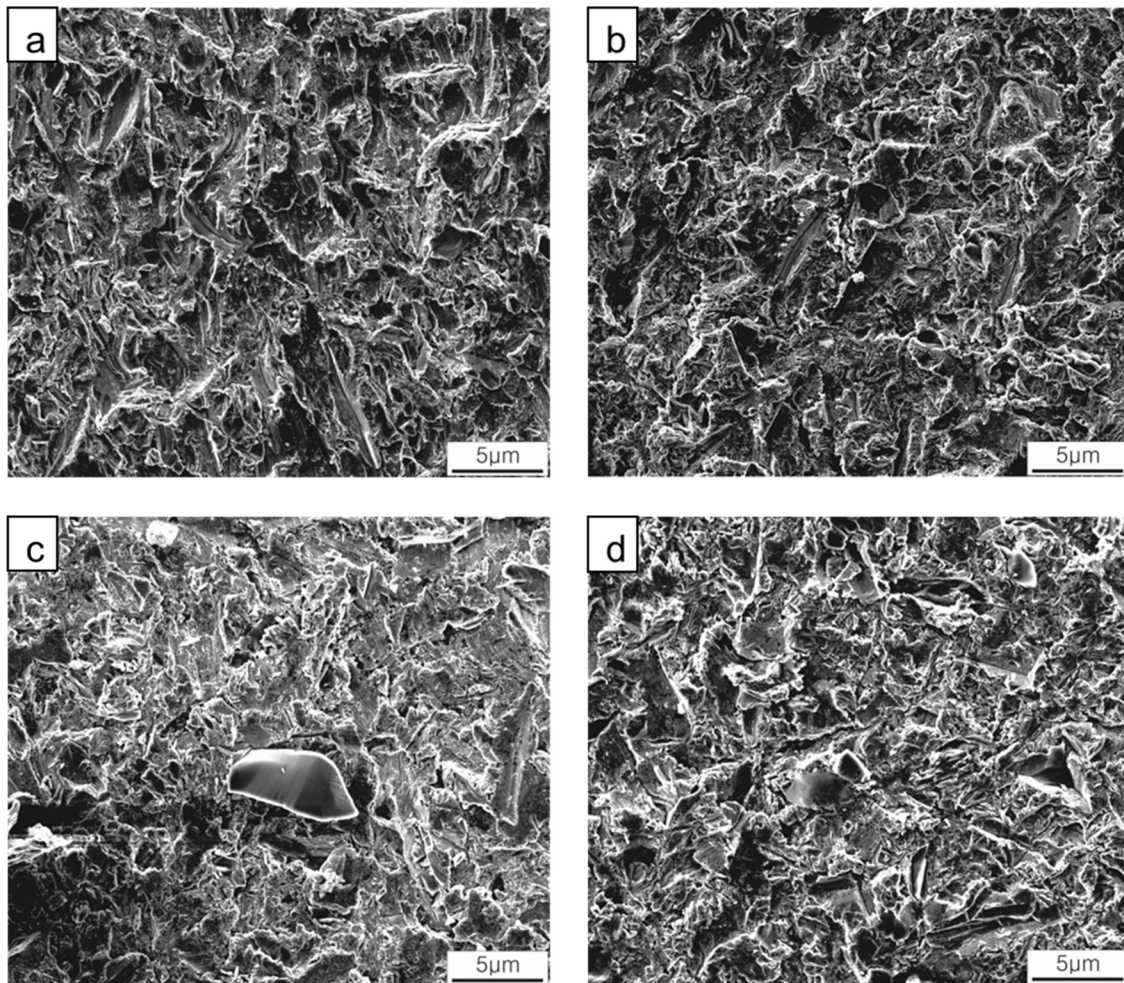
Fig. 4. Typical erosion scars and SEM micrographs of Inconel 625 eroded areas with impingement angles of: a) 30°, b) 45°, c) 60°, d) 90°. Erodent  $\text{Al}_2\text{O}_3$

The examination of the eroded surface, illustrated in figure 4, shows that, at the abrasive particle impingement angles of 30° and 45° (Fig. 4a,b), a visible removed material occurred due to microcutting, while at greater abrasive particle impingement angles of 60° and 90° (Fig. 4c,d), due to microcutting and microfussiring – the removal of the material occurs due to the formation of sub-surface cracks. At greater impingement angles, the contribution of abrasive solid particles, which were stuck in the eroded material surface, was also observed. This relationship

was observed for all investigated materials. The SEM pictures taken in eroded specimen regions indicate that the predominant mechanisms responsible for the erosion process are microcutting and microfussiring. They depend on the shape of erodent particles and their kinetic energy at the moment of hitting of the tested material. In the fussiring process, after plastic working in the form of an elongated furrow with characteristic creases occurs on the material surface. The detachment of material from the groove is a sign of erosive wear.

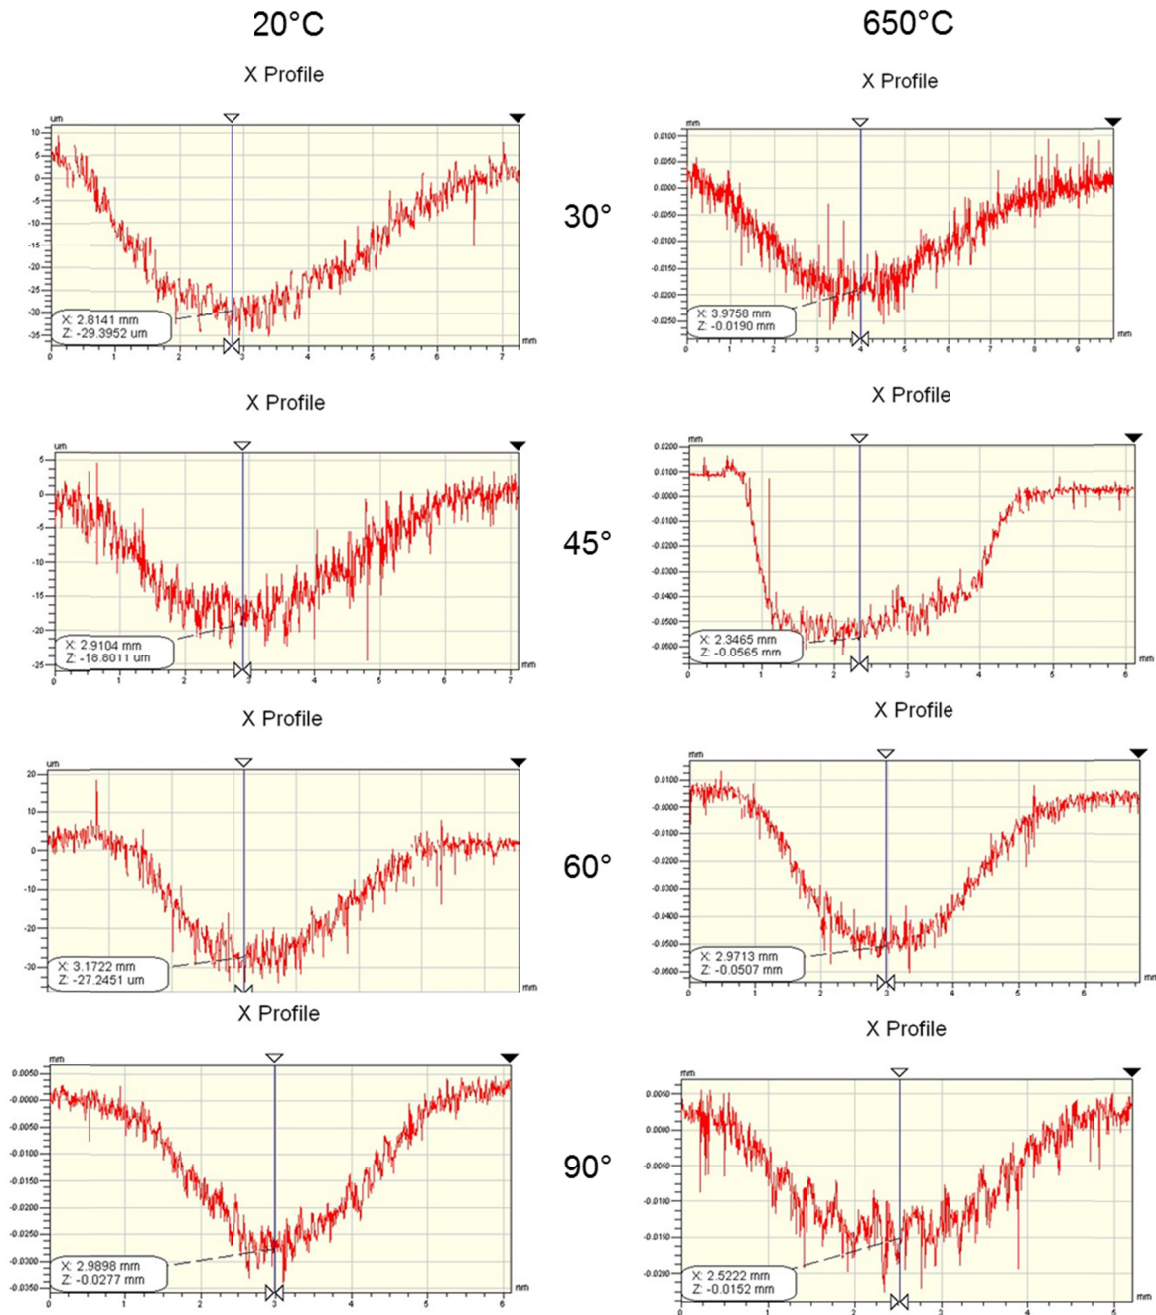
Fig. 5. Erosion craters profiles in Inconel 625 after plastic working

The changes in the shape of the eroded material surface are very well illustrated by surface profiles recorded using an optical profilometer. (Fig. 5) shows the surface profiles of Inconel 625 alloy and after plastic working after erosive wear for the temperatures 20°C and 650°C. While (Fig. 6) shows the surface profiles of Inconel 625 weld clad layer after erosive wear. Changes in the surface shape with increasing impingement angle are perfectly visible in these profiles. For smaller impingement angles, the shape is elongated in the direction of the x axis, whereas for angles equal to 90° it is more symmetrical. At an elevated temperature of 650°C, the shape changes for the eroded surface are, for both materials, more visible than for the temperature 20°C; this is especially true to the angle 90°.
