FUNCTION OF WATER IN THE LANDSCAPE OF THE VILLAGES IN THE PAST AND IN PRESENT, ON EXAMPLE OF VILLAGES IN LOWER SILESIA

Irena Niedźwiecka-Filipiak¹, Liliana Serafin¹

¹ Institute of Landscape Architecture, Wrocław University of Environmental and Life Sciences, pl. Grunwaldzki 24a, 50-363 Wrocław, Poland, e-mail: irena.niedzwiecka-filipiak@up.wroc.pl

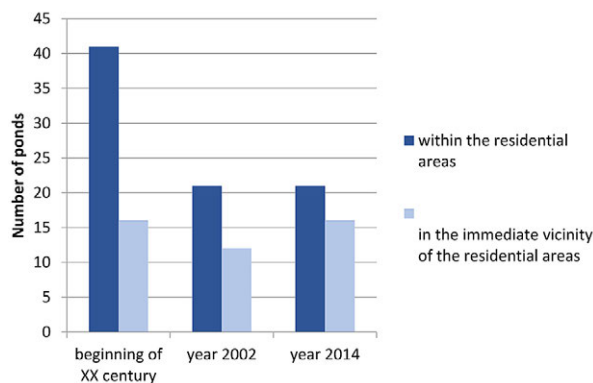
Figure 2. Number of ponds with division on ponds within the residential areas and ponds which are in the immediate vicinity of the residential areas

In terms of water reservoirs situated in the immediate vicinity of the built-up areas the quantitative changes are much smaller. Their number decreased till 2002, but in the last 10 years has risen to the status of the early twentieth century (Figure 2). The biggest changes concern the development of the two recreational areas, in which new water reservoirs were created. The first is the restaurant Miłocin with water reservoir in Pier-

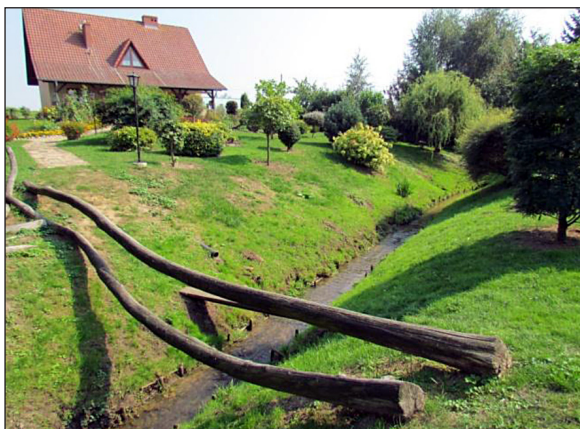
Figure 5. Mienice. The development of the neighbourhood of the river on a private property

However, it should be noted that in any villages from the studied area the potential of watercourses flowing through the villages was not used to improve the quality of space around. In the village of Mienice a small part of the river surroundings within the private property have been developed in a model way (Figure 5), while within the area around the common building located by the river, the values of water haven't been taken into account. The building is fenced, cut off from the watercourse, both functionally and visually (Fig.6). Although the public space could be enlarged by designing a descent to the water and including the river into the project, as was it done in the private property. It should be added that this is not a bad will of the inhabitants, more the lack of awareness, because the village is well cared for, and its inhabitants are active.

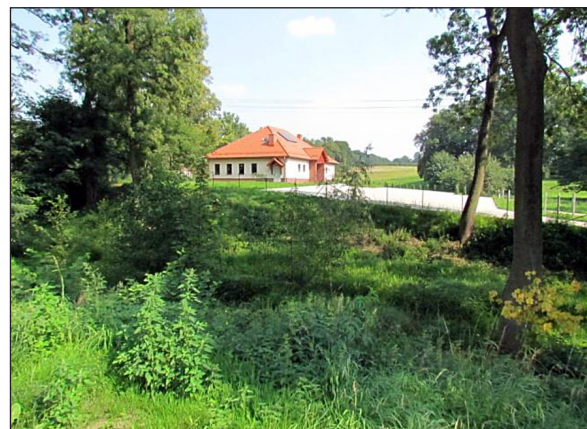
Figure 6. Mienice. On the first plan the undeveloped surroundings of the river, which is isolated from the common building by a fence

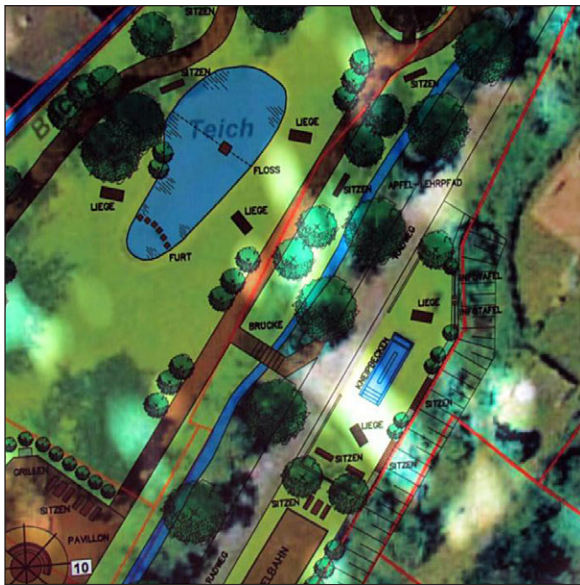
Figure 7. Fragment of the plan of development of the interior of the village with use of the pond, below Kneipp therapy pool

area of the village covers about 1,500 hectares, of which 1,000 hectares are forests. The village has a pond and touristic trail called “Rumbach and its springs”. Each of the seven springs and wells is properly exposed and beard with the information board. Examples are shown on Figure 7 and 8. Inside the village there is also a small water reservoir. The project of this reservoir and its surroundings takes into account children’s playing area, recreation for the elderly, as well as places where all residents can make barbecue or play active sports. It is now under construction. The idea of Sebastian Kneipp, which involves treat-

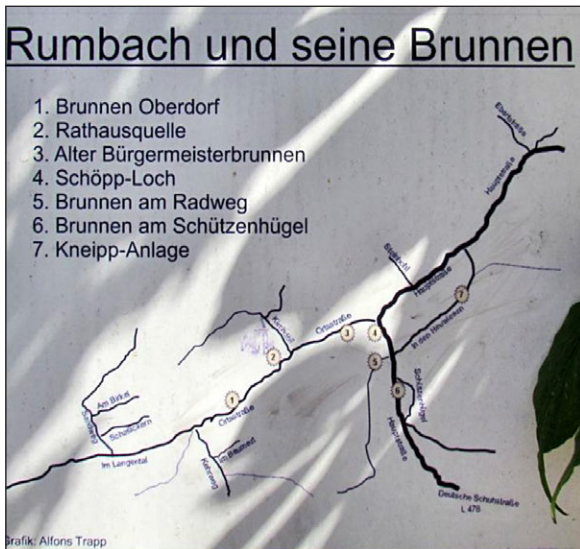
Figure 8. Sketch of the stream flowing through the village along with showing the location of seven springs

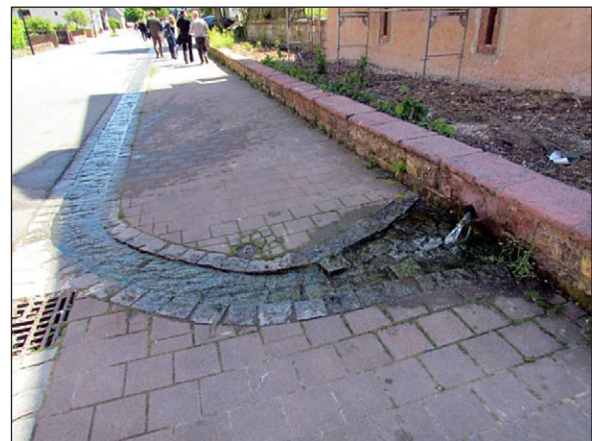
Figure 9. Spring number 3. The water flows freely in the gutter along the street

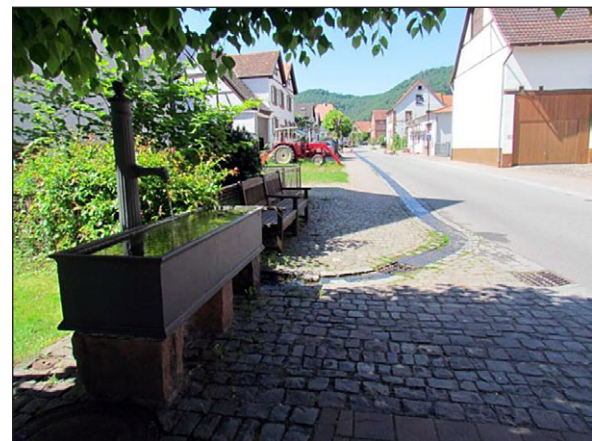
Figure 10. The so-called Mayor Spring
