FEM analysis of magnetic field and forces in area ARC fault of autotransformer HV winding

Abstract: In this paper the electric arc fault in the high voltage winding turn of the power autotransformer has been investigated. 3D magnetic field distributions in the leakage domain and electrodynamic forces acting on high voltage winding have been calculated. Finite Element Method was used for the magnetic flux density simulation. The electrodynamic force value under the fault exceed significantly the nominal mechanical stresses of the winding.

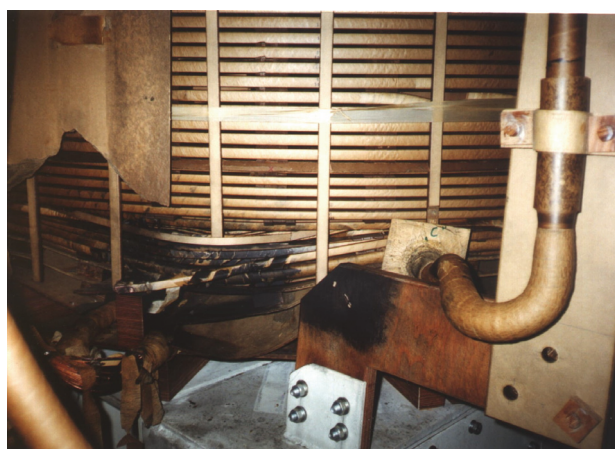
Fig. 4. Deformation of the lower part of the HV winding of the analysed autotransformer

many times greater than the short-circuit one I_{1z} in the remaining part of the winding. In picture (Fig. 4) is presented the real deformation of the HV winding part. These figure shows, that the surge current of the arc has flowed by the HV winding lower final turn and forced electrodynamic strengths.

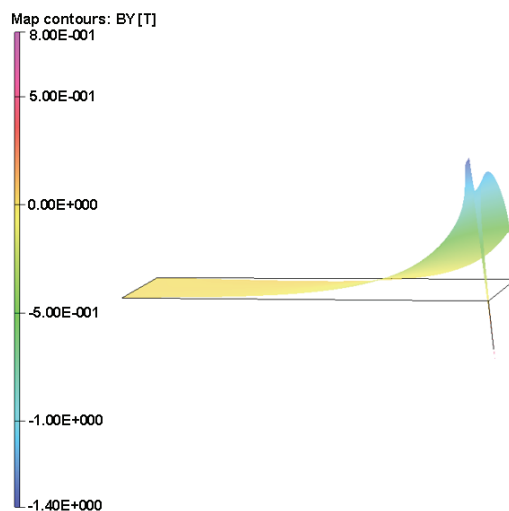
The real damage was appeared in the outer area of the autotransformer, but in this paper were investigated results of the impact of the electric arc as well as in outer area of the HV (case 1) winding and in the window of the autotransformer (case 2). In Figures 7 and 8 the magnetic field density B_Y and B_Z components spatial distributions are presented inside HV winding, for the case 1. In Figures 9 and 10 are presented the flux density distributions (B_X and B_Z) for the second case. The results concern the attacked winding cross-section which has been depicted as rectangle in each figure.

Fig. 7. B_y component distribution inside HV winding for the case 1 (in Tesla)

These figures show, that the investigated fault caused disturbance in spatial distributions near attacked turn only. Because of that fact, the maximal values of the short-circuit current of the windings is assumed in analysed models, the maximal value of the B_z component between MV and HV windings reached 3.5 T. After 3D magnetic field analysis the magnetic flux density \vec{B} , and the unit forces \vec{F} acting on the damaged turn has been calculated using below relationship

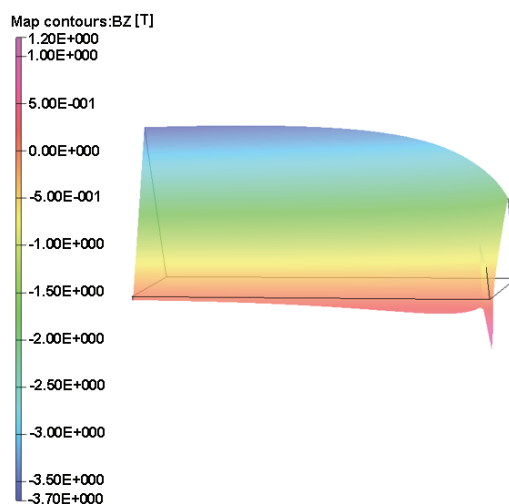
Fig. 8. B_z component distribution inside HV winding for the case 1 (in Tesla)

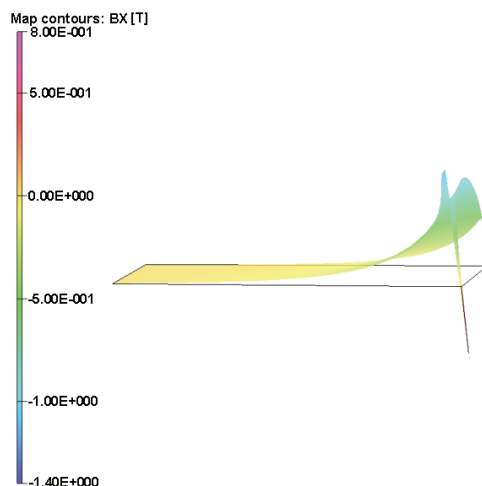
Fig. 9. B_x component distribution inside HV winding in the transformer window (in Tesla)

The obtained values of the magnetic forces acting on the wire length in the transformer window are $F_{YW} = 10556 \text{ N/m}$ and $F_{ZW} = -21968 \text{ N/m}$, while the forces on the wire in the outer region are $F_{XO} = 1722 \text{ N/m}$ and $F_{ZO} = -20551 \text{ N/m}$. The forces cause mechanical stresses (radial $\sigma_{RO} = 5281,6 \text{ N/m}^2$ and axial $\sigma_{AO} = 1736 \text{ N/m}^2$) in the part of the winding with the damaged turn excide many times the permissible value. For the copper wire the value is equal to $\sigma_{AO} = 105 \text{ N/m}^2$. Thus the occurred electrodynamic forces damaged the part of the HV winding.

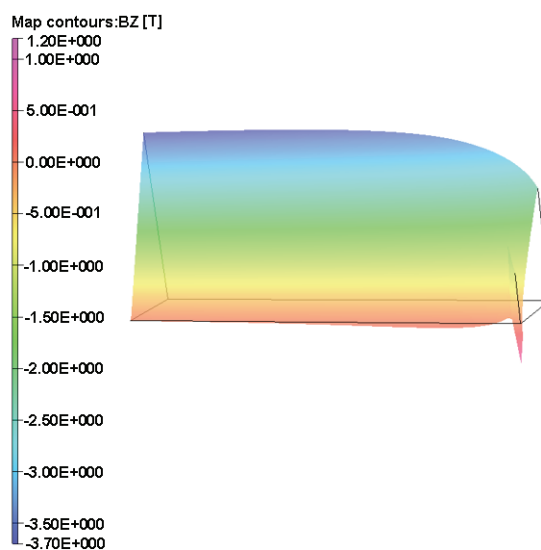
Fig. 10. B_z component distribution inside HV winding in the transformer window (in Tesla)
