AWARENESS OF MATERIALITY IN TIME AND CONDITION. THOUGHTS ON THE RELATION BETWEEN ART HISTORY AND CONSERVATION

KEYWORDS: Restoration, conservation ethics, art history, wall painting, sgraffito

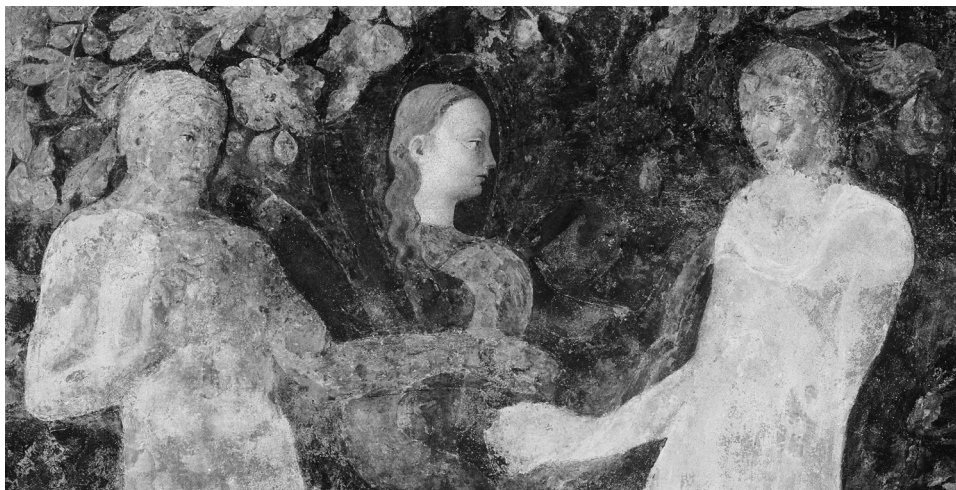
Fig. 1 Santa Maria Novella, Chiostro Verde, Paolo Uccello, Original Sin (detail), Photo: Alinari N. 4027 B, 1930.

condition of the cloister.¹⁷ Restoration of the murals began again only in 1929 with Amedeo Benini.¹⁸ Differently than in the previous campaign, the intention was to leave the paintings in their original location, thus avoiding the complicated and expensive process of detachment. The first murals Benini worked on were Paolo Uccello's *Creation scenes*.¹⁹ The sources are full of descriptions of the disastrous state of the pictorial surface, which makes the legibility of the painting today quite surprising. Benini focused his intervention on the consolidation of the surface.²⁰ The reviving substances applied by Benini to the murals most likely caused the major damage we see today, accelerating the destructive effects of the humidity and salt migration. In fact, only three years after his operations on the Creation, in 1934, the documents cite "*da pochi mesi a questa parte, tutto ciò che di vivo e apparentemente brillante era tornato in luce, è oggi smorzato e in parte addirittura svanito*".²¹ What makes the case study on the Chiostro Verde particularly interesting and relevant to the topic of this publication is the possibility of juxtaposing written sources with historical photographs of the murals. Two photographs by Alinari from 1930 and 1933 (Fig. 1 and 2), for instance, are evidence for the massive abrasion the pictorial surface has suffered as a consequence of the substances used in the consolidation by Benini. The later photograph of 1933 precedes the detachment of this scene, carried out a decade later, in 1941, by Mauro Pelliccioli (1887-1974) of the Istituto Centrale di Restauro, under the direction of Cesare Brandi.²²

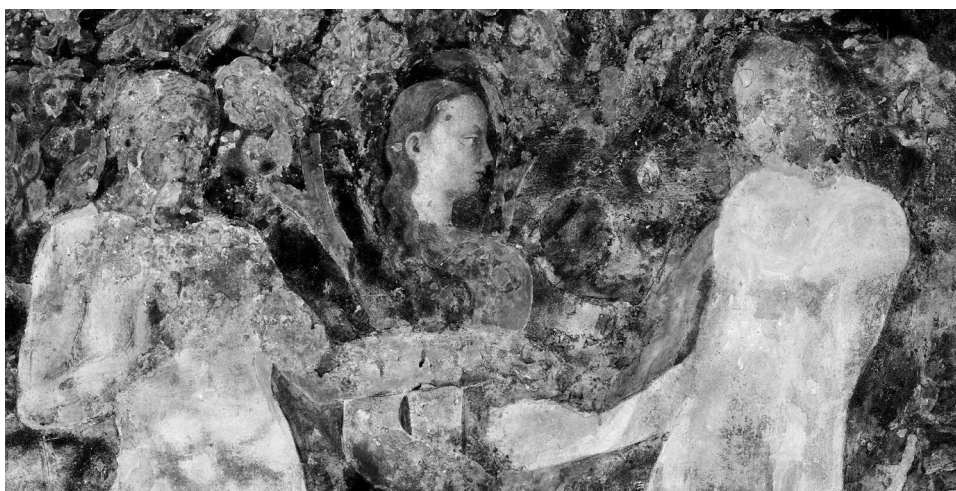
Fig. 2 Santa Maria Novella, Chiostro Verde, Paolo Uccello, Original Sin (detail), Photo: Alinari N. 4027 D, 1933.

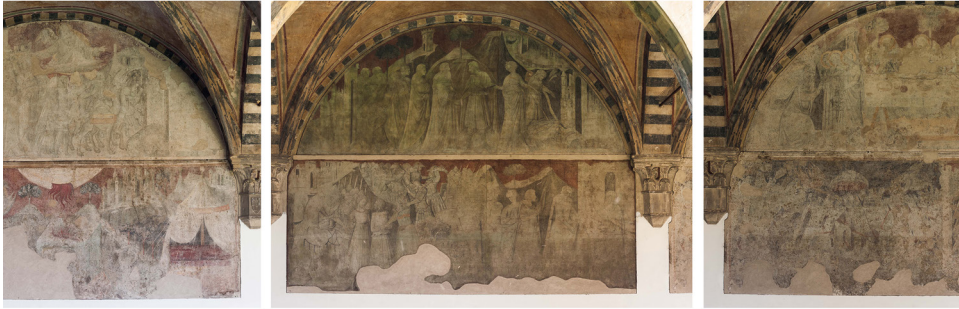
Fig. 3 Scheme of the first three bays of the southern wall in the Chiostro Verde, Santa Maria Novella.

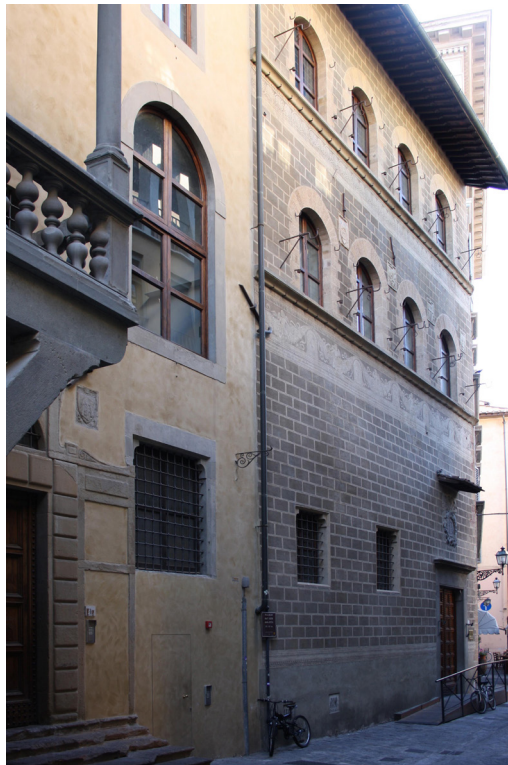
Fig. 5 Residenza dell'Arte della seta, Florence, situation 2016.

Around 1460 the building was adorned with a *sgraffito* facade showing a depiction of ashlar work, a frieze with putti, garlands, and the guild's symbol (Huth, 2016, vol. 1, cat. no. 24; Thiem/Thiem, 1964, cat. no. 25, 70-1). However, in 1921 the building was reconstructed and the facade was redesigned – with significant changes, as evinced by comparison. Not only the remains of the Quattrocento decoration have been lost, but so have the original motifs and structure of the facade's design as well as all information regarding its material and technical execution. Today, the facade shows a strange brownish coloring, and the lighter ornaments have a drab or yellowish tone. A similar situation is evident on the Palazzo Corsi in Borgo Santa Croce,²⁹ which was recently renovated.³⁰ The *sgraffito* facade largely dates back to 1938.³¹ Only small portions of the original decoration were preserved as references. Before the most recent renovation, it was possible to distinguish between original and renovated elements, but now the entire surface has a uniform appearance, as the result of a highly questionable conservation approach (Fig. 6). Whenever the existing standards of conservation ethics are ignored, this needlessly complicates any examination. The treatment of this facade is truly regrettable, especially given that there are two exemplary restored *sgraffito* facades in Florence, namely those of the Palazzo Dietisalvi Neroni and the Casa Lapi.³² In the case of Palazzo Corsi, one hopes that a meticulous preliminary examination and a complete documentation of all interventions exist. Precise and publicly available documentations of restoration measures form the basis of later research. Therefore, such documentation is an important joint source for restoration practice and art historical study.

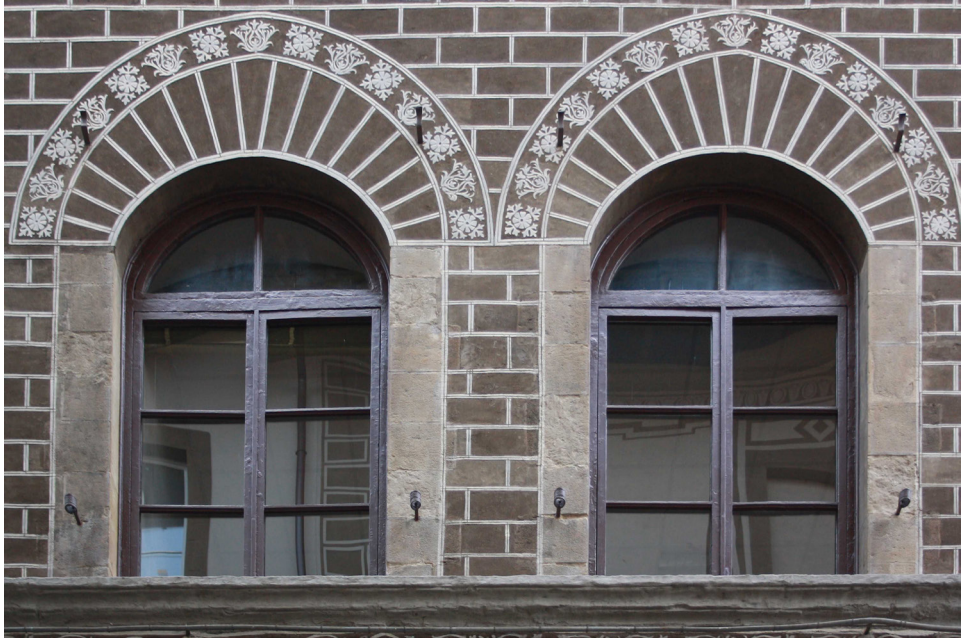
Fig. 6 Palazzo Corsi, Florence, facade after the 2017 restoration.

As with the Arte della Seta residence, the facade of the Palazzo Corsi shows an obtrusive brownish coloring. One can exclude the possibility that this corresponds to the original Quattrocento coloring, because no plaster or whitewash of the fourteenth or fifteenth century contains such pigments. Furthermore, the current surface has a scratched decoration, but painted. Color and technique are essential in producing the aesthetic effects of a building front – or any other pictorial object. Therefore, in terms of art historical research, questions of color and technique are not secondary matters; they are of equal importance as any other topic of discussion, such as problems of dating, the transfer of motifs and ornaments, the attribution to a specific artist or artisan, or the overarching cultural context.

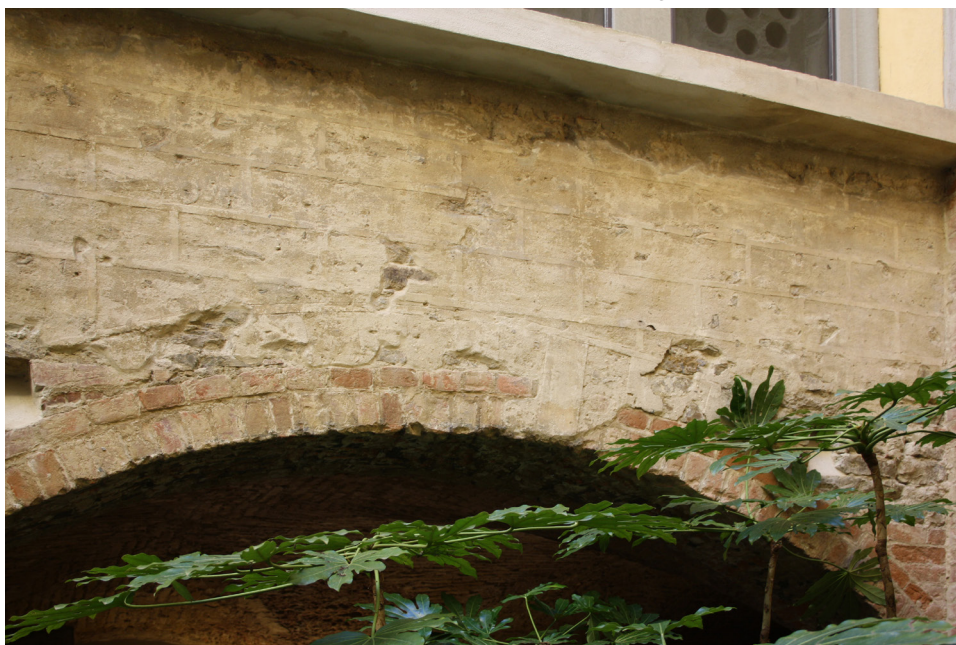
Fig. 7 Chiostro antico, S. Croce, Florence, sgraffito decoration, ca. 1325.

Other *sgraffito* facades that have not undergone later interventions also lack intense contrast, which has commonly been considered as key feature of this kind of wall decoration. This is amazing, given that the art historical perception of *sgraffito* is based on a bold bichrome contrast and also that the purpose of restoration is often defined as the renewal or reconstruction of this contrast, as demonstrated in examples mentioned above. However, an analysis of the material and execution of these unrenovated examples argues for a new perspective. The technique was not developed as cheap substitute for bichromatic marble incrustations, but as a simple regulation of joints. The earliest known *sgraffito* decoration in Florence can be found in the so-called Chiostro antico in the complex of the Florentine monastery of S. Croce. Dating circa 1325 and located in the little-known narrow cloister behind the Cappella Pazzi in S. Croce, it covers the brickwork of the ground floor arcades below the Corridoio del Noviziato (Fig. 7).³⁴

As demonstrated by this example, from the invention of the *sgraffito* in early Trecento until mid fifteenth century the plaster was always uncolored. The use of black pigments was probably introduced for the decoration in the courtyard of the Palazzo Medici (Huth, 2016, vol. 1, 64). The new, elegant grey – or “silver” as Vasari later writes³⁵ – was intended to harmonize with the walls and the architectonic elements made of grey macigno. The current coloring of the restored courtyard is not reliable proof.³⁶ However, many *sgraffito* decorations in Florence were executed shortly after those of the Palazzo Medici, and they adapted the motifs and coloring of the decorations in the Medici courtyard.³⁷ One example is the decoration in Villa La Pietra.
