# REAKCJE ZACHODZĄCE NA IMPLANCIE WSKUTEK KONTAKTU Z TKANKĄ LUDZKĄ

[Inżynieria Biomateriałów, 89-91, (2009), 38-39]

# THE REACTIONS OCCURRING ON THE IMPLANT AS A RESULT OF CONTACT WITH HUMAN TISSUE

[Engineering of Biomaterials, 89-91, (2009), 38-39]

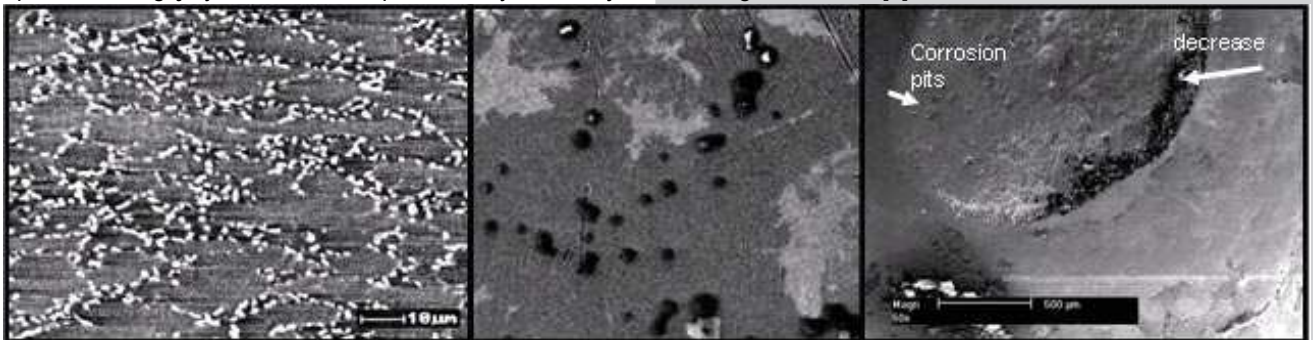
RYS.1. Mikrostruktura stopu Ti-6Al-4V zawierająca fazy ( $\alpha+\beta$ ).  
FIG.1. The microstructure of Ti<sub>6</sub>Al<sub>4</sub>V alloy containing phase combination ( $\alpha+\beta$ ).

RYS.2. Wżery korozyjne widoczne na próbce po 6-cio miesięcznym przebywaniu w bulionie bakterijskim.  
FIG.2. The corrosion holes noticeable on specimens after 6 months' stay in bacteria liquid.

RYS.3. Ubytki w materiale. Mikroskop skaningowy, pow. 50x.  
FIG.3. The holes in material. Scanning electron microscope, 50x

Materiałem były okrągłe próbki o średnicy 5mm zanurzone w bulionie bakteryjnym (*Enterobacter cloacae*) na okres 6-ciu miesięcy oraz trzpień endoprotezy usunięty pacjentowi po 8 latach przebywania w organizmie. Przedmioty badań były ze stopu  $Ti_6Al_4V$ , o składzie chemicznym: Ti, 4,08%V, 6,39%Al, 0,17%Fe, 0,015%C, 0,185%O, 0,005%N, 0,0035%H, i mikrostrukturze jak na RYS.1.

Na RYS.2 zaobserwować można głębokie wżery korozyjne na powierzchni próbki (po 6-ciu miesięcznym przebywaniu w bulionie bakteryjnym - *Enterobacter cloacae*).

RYS.3. pokazuje wyraźne ubytki w materiale w trzpieniu endoprotezy.

W przypadku próbek okrągłych zanurzonych w bulionie bakteryjnym zaobserwowano po usunięciu bakterii *Enterobacter cloacae* głębokie wżery. Natomiast zdjęcia z mikroskopu skaningowego trzpienia endoprotezy wykazały duże ubytki w materiale.

The round samples with the diameter of 5mm dipped in bacteria liquid (*Enterobacter cloacae*) for the period of 6 months as well as the endoprosthesis removed from the patients body after 8 years. The research materials were made of  $Ti_6Al_4V$ , chemical composition: 4,08%V, 6,39%Al, 0,17%Fe, 0,015%C, 0,185%O, 0,005%N, 0,0035%H, Ti as the rest, and microstructure as shown in Fig.1 were examined.

In FIG.2 the deep corrosion holes can be observed (after 6 months' stay in bacteria liquid - *Enterobacter cloacae*).

FIG.3 shows significant holes in endoprosthesis.

In case of round samples dipped in bacteria liquid *Enterobacter cloacae* deep holes were observed after removing them from the liquid. The Fig.3 of the implant from scanning electron microscope showed significant decrease in the material.
