## Filtration Properties of Anthropogenic Soils in Kozłówka Manor Park

### ABSTRACT

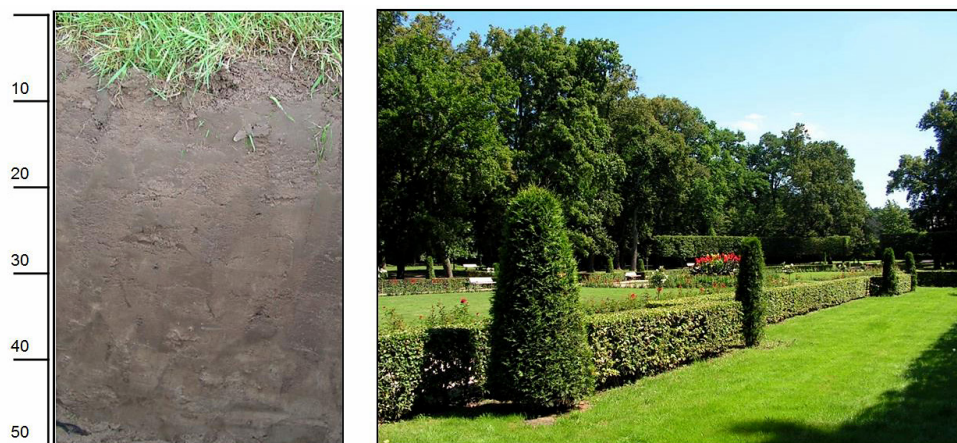
**Figure 1.** Pedon I Plaggic Anthrosol, a site of soil excavation (the lawn at the end of the French garden) (Photo: M. Jaroszuk-Sierocińska)

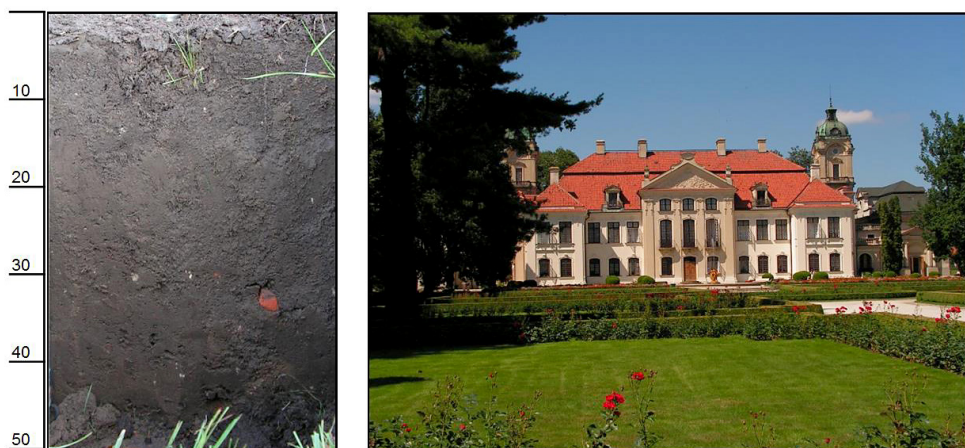
**Figure 2.** Pedon II Terric Anthrosol, a site of soil excavation (the lawn next to the chateau in the French garden) (Photo: M. Jaroszek-Sierocińska)

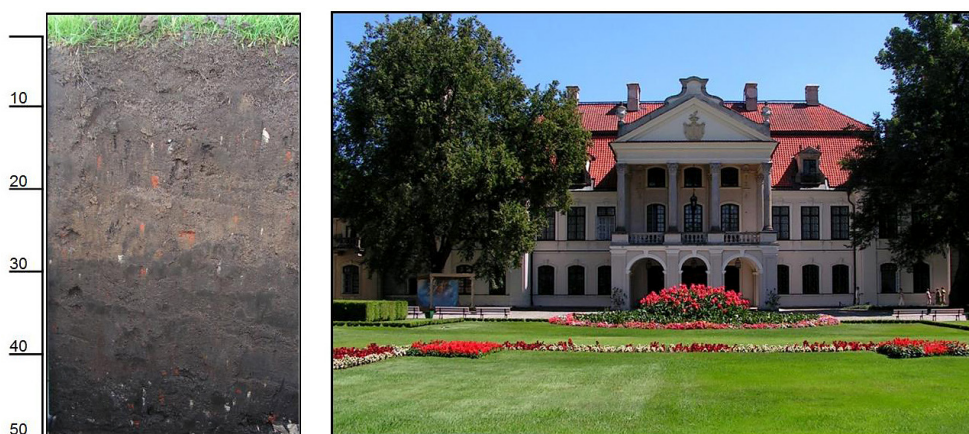
**Figure 3.** Pedon III Urbic Technosol, a site of soil excavation (the front lawn of the palace) (Photo: M. Jaroszek-Sierocińska)

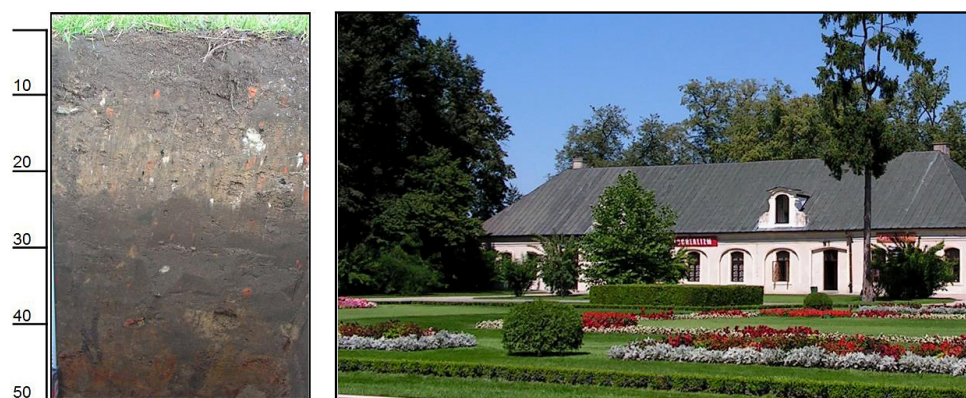
**Figure 4.** Pedon IV Urbic Technosol, a site of soil excavation (the lawn on the side of the entrance gate) (Photo: M. Jaroszek-Sierocińska)

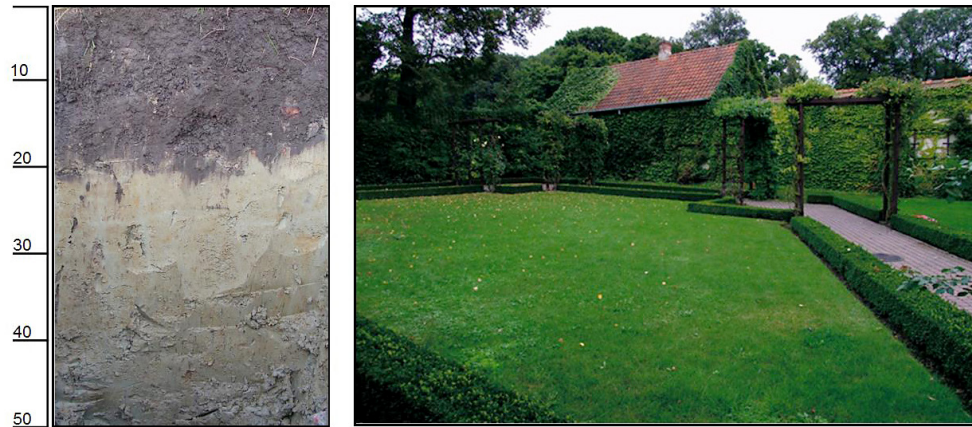
**Figure 5.** Pedon V Terric Anthrosol, a site of soil excavation (the lawn next to the rose garden) (Photo: M. Jaroszuk-Sierocińska)

matter enrichment, and a 20–60 cm layer, formed by the addition of large amounts of clay to the clayey-sandy material (Figure 5). Considering the texture of the investigated soils, it should be noted that the majority of pedons were dominated by loamy sand or sandy loam (Tables 1–5). The
