ANALYSIS OF ILLEGAL LANDFILLS IN THE NORTH-WEST PART OF BARLINEK MUNICIPALITY

Kamil Szydłowski, Joanna Podlasińska
West Pomeranian University of Technology Szczecin

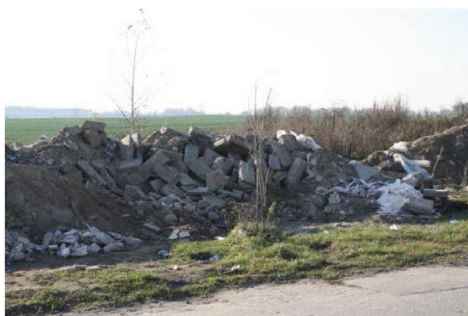
Photo. 1. Fragment of spot waste landfill
(photographer: K. Szydłowski)

All located waste landfills were divided into spot waste landfills, multi-point landfills, area landfills and linear landfills (Photo 1-4; Fig. 1), following the guidelines proposed by Kurnicki and Mularz (1998). The waste was classified following the assumptions presented in the work of Mizgajski and Łankiewicz (2007) as:

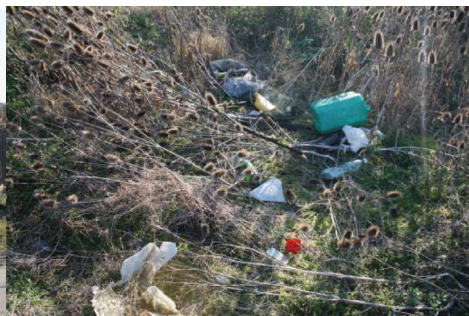
Photo. 2. Fragment of multi-point waste landfill
(photographer: K. Szydłowski)

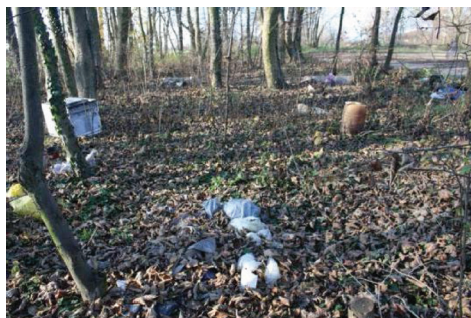
Photo. 3. Fragment of landfill area
(photographer: K. Szydłowski)
