Assessment of cast-on-strap joints of lead acid batteries

This paper presents the results of an examination of cast-on-strap joints of lead acid batteries with different discharge capacities. The galvanic joints of lugs of selected cells in lead acid batteries were analyzed. The study showed some defects that may occur in these joints. Examples of the defects that can affect battery lifespan were presented.

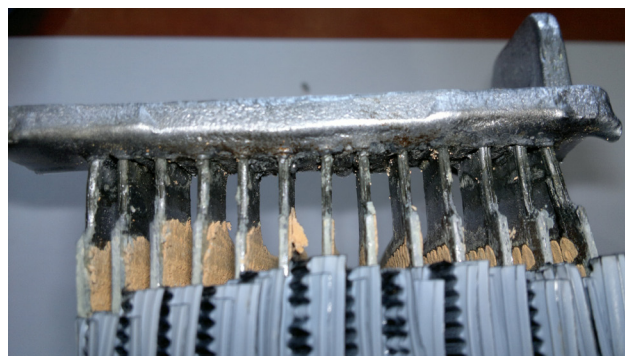
Fig. 2. The example of positive and negative joints of lead acid battery [photo E. Jankowska]

Cast-on-strap (COS) is a process of grouping individual plates of the same polarization (positive or negative) in each cell of a lead-acid battery. This process ensures the integrity of the whole components in the cell and an electrical connection between the individual plates with active mass [7–8]. The COS process involves immersion of the cleaned and stacked plate (positive and

negative) lugs into a preheated mold cavity filled with molten lead strap alloy. It is followed by the cooling of the cast bridge. The joining occurs by partial melting of the lug surface which then fuses with the strap alloy in its liquid state. The COS joints must be characterized by adequate mechanical strength, not only the bridge itself, but also the bridge-lug connection, have good corrosion resistance and low electrical resistance [9–10]. The example of joints of lead acid battery shows in the Figure 2.

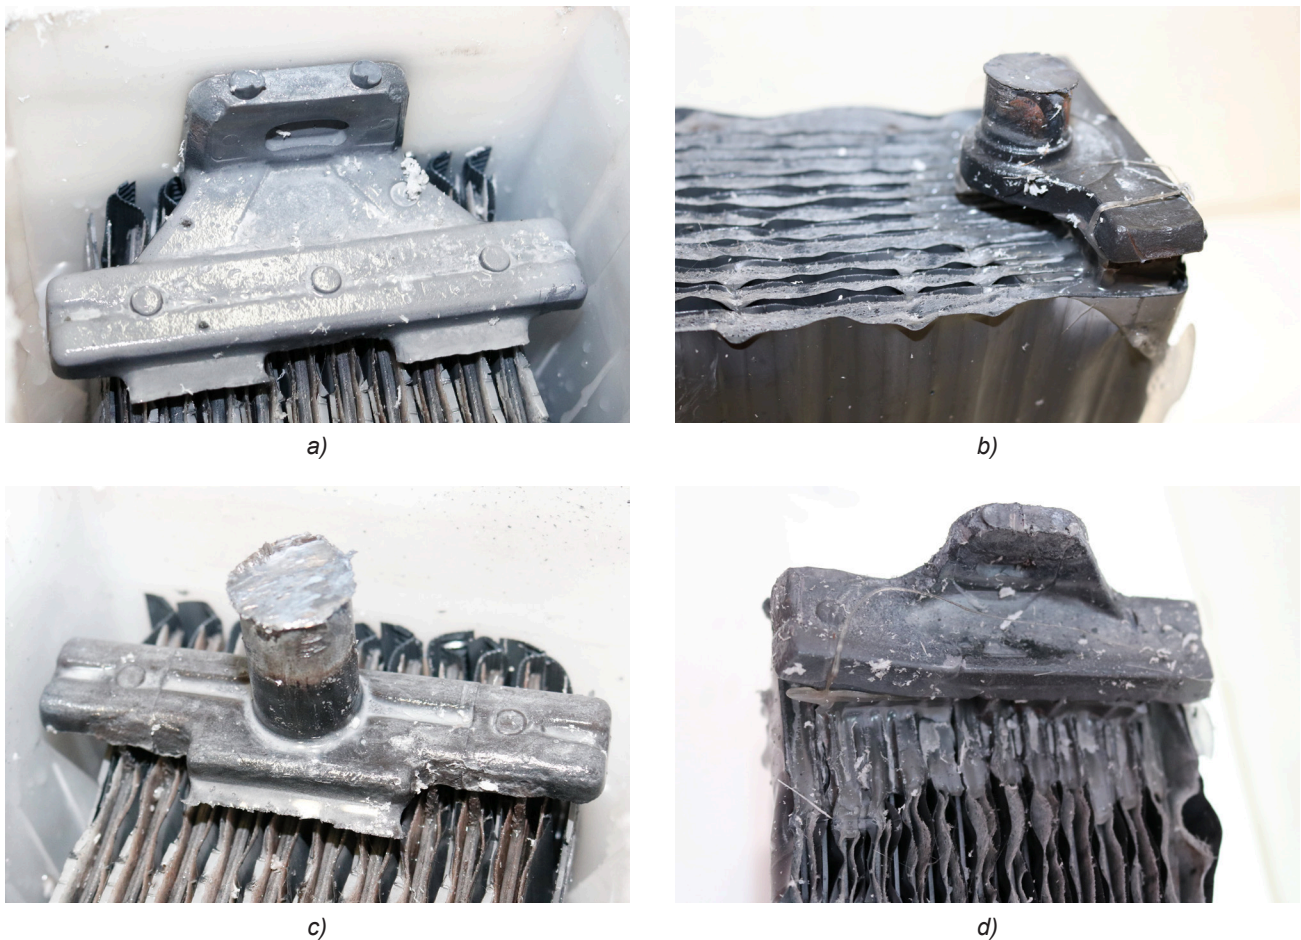
Fig. 3. The cast-on-strap positive and negative joints of a lead acid battery
[photo E. Jankowska]

In the first part of the study, bridge connections were selected from cells of lead acid batteries with different nominal capacities. The samples to be tested were taken from new lead acid batteries available on the market. The lead acid batteries were brand new. They were not laboratory tested. Examples of bridge connections from selected battery cells are shown in the Figure 3.

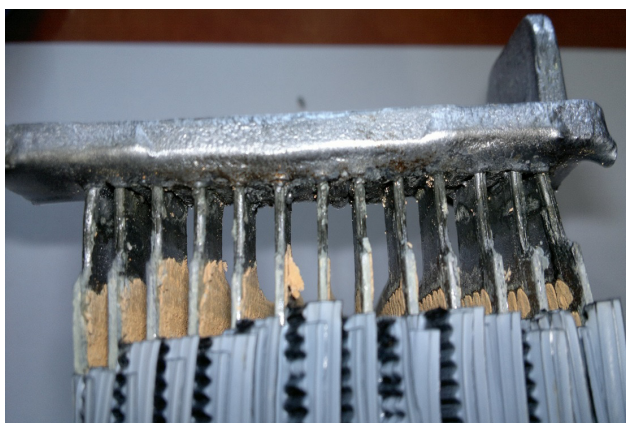
*Fig. 5. The positive plate pack's joints lugs-bridge
[photo K. Frączek]*

It is clearly visible that the position of the lugs is correct. There are no air bubbles or other possible defects when immersing the lugs in the bridge system. OT3 type alloy can be used for immersing the lugs in the bridge. This type of lead alloys has an antimony content of 2.5–3.5% and additives. The tested grids and lugs were made of lead-calcium alloys and antimony alloys with addition of tin. The examples of bridge joints with their defects are shown in [Figures 6–7](#).

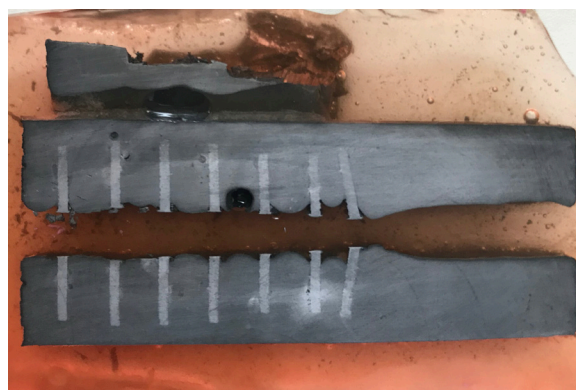
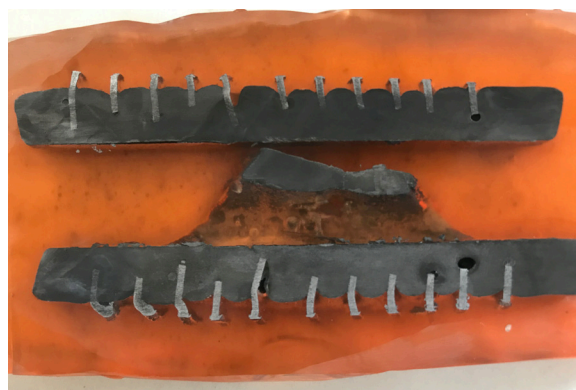
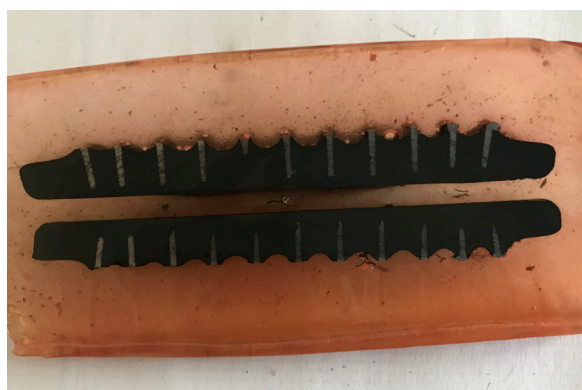
Fig. 6. The examples of bridge joints in lead acid batteries, positive and negative
[photo E. Jankowska]

Analysis of joints ([Fig. 6a–f](#)) showed defects in the form of irregular distribution of the lugs. This weakens mechanical strength and decreases electrical conductivity. It can be concluded that a strong lug melting at its entire length decreases its strength parameters. It has been noticed that the strength of the connections between the lug and the bridge is affected by the cooling rate. Faster cooling results in the formation of a fine-crystalline structure, which positively affects the strength of the connection. The formation of larger crystals increases the risk of joint cracking. Moreover, higher cooling rates can result in an incomplete flux evaporation and the presence the air bubbles in the connection. At the lower cooling rate, no air bubbles are observed ([Fig. 6c](#)). Connection failure ([Fig. 6d](#)) reveals a gap where the electrolyte may pass through, which may lead to corrosion and thereby to poor mechanical strength. In addition, the strength properties are influenced by factors such as the amount of flux on the lugs, the purity of lugs, the rate of immersing lugs in the form, the temperature of the forms or lead and the speed of cooling.

Furthermore, it is worth paying attention to the meniscus while presenting the quality of joints. The meniscus should not be concave ([Fig. 6f](#)) because it could lead to slotted corrosion.

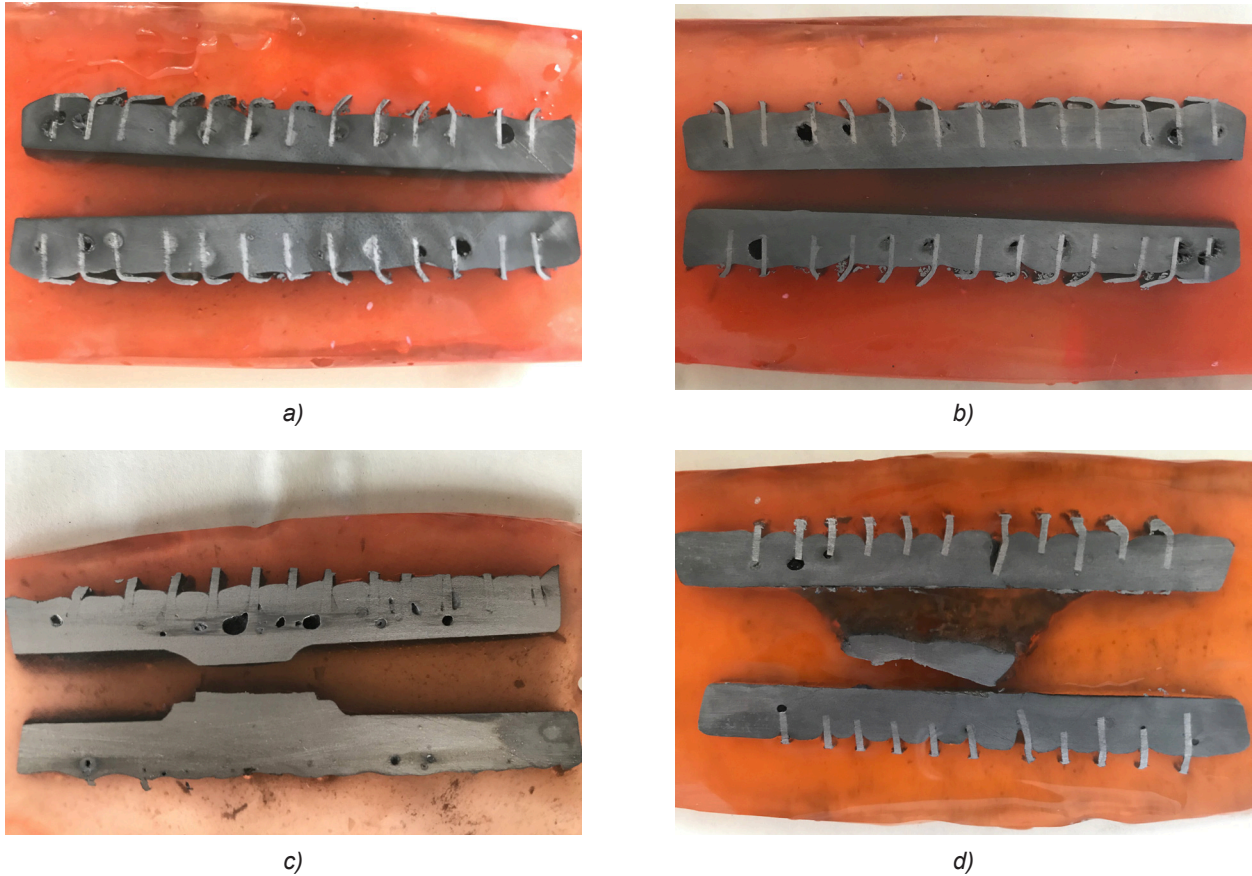
Fig. 7. Examples of bridge joints with defects, positive and negative [photo E. Jankowska]

A visual inspection of the quality of the samples showed that air bubbles can be observed in the examined joints ([Fig. 7a–d](#)). The presence of air bubbles may occur when the gas formed during flux evaporation could not escape towards the surface of the bridge due to a decreased speed of bubble transportation. This in turn is due to the low temperature of the alloy, which is associated with too little heat delivered to the alloy. It can also be related to too fast cooling or too much flux. After soaking the lugs in the flux, they must be dried before being immersed in the form of a bridge. The use of a suitable flux leads to the removal of the passive oxide layer from the flags, as in the case of mechanical cleaning of the lug surface. The use of flux or mechanical cleaning leads to slight roughness on the surface, which improves the contact of the lug with the bridge and also removes the passive oxide layer of lead on the lug.
